National Paediatric Hospital Project

Appendix 9.1 – Bat Surveys

**Bat Surveys of new children's hospital at St. James
Campus, and satellite centres at Tallaght & Connolly
Hospitals. Dublin.**

Document Title: Bat Survey

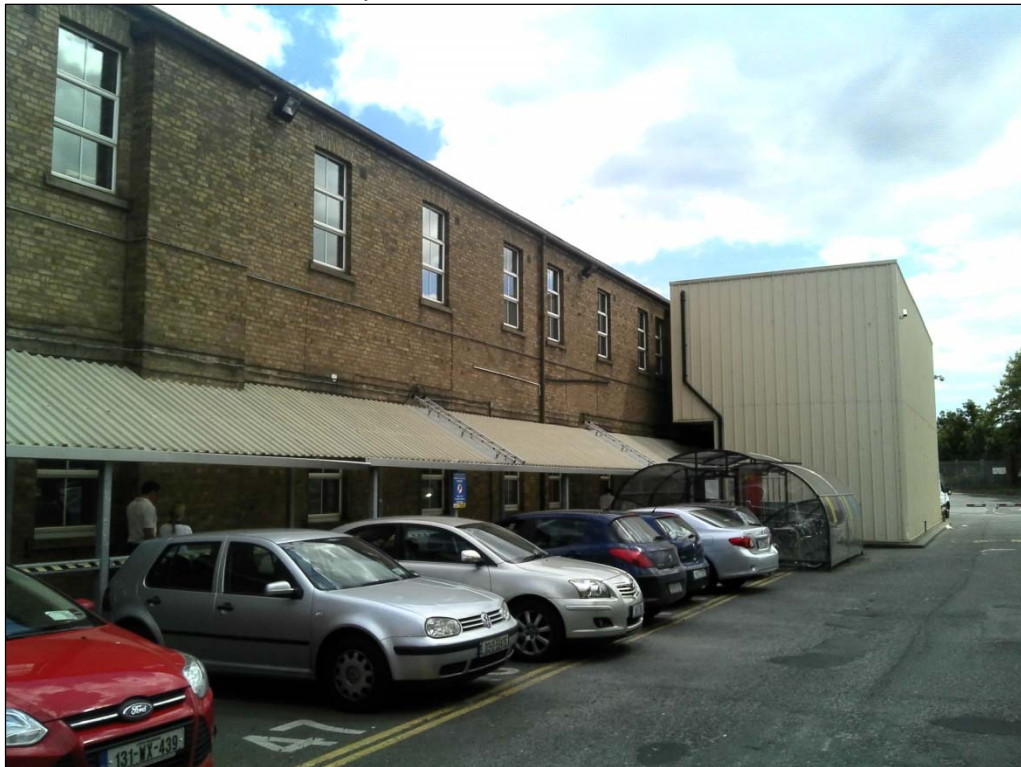
Plate 3.1. Old Brick section of hospital.

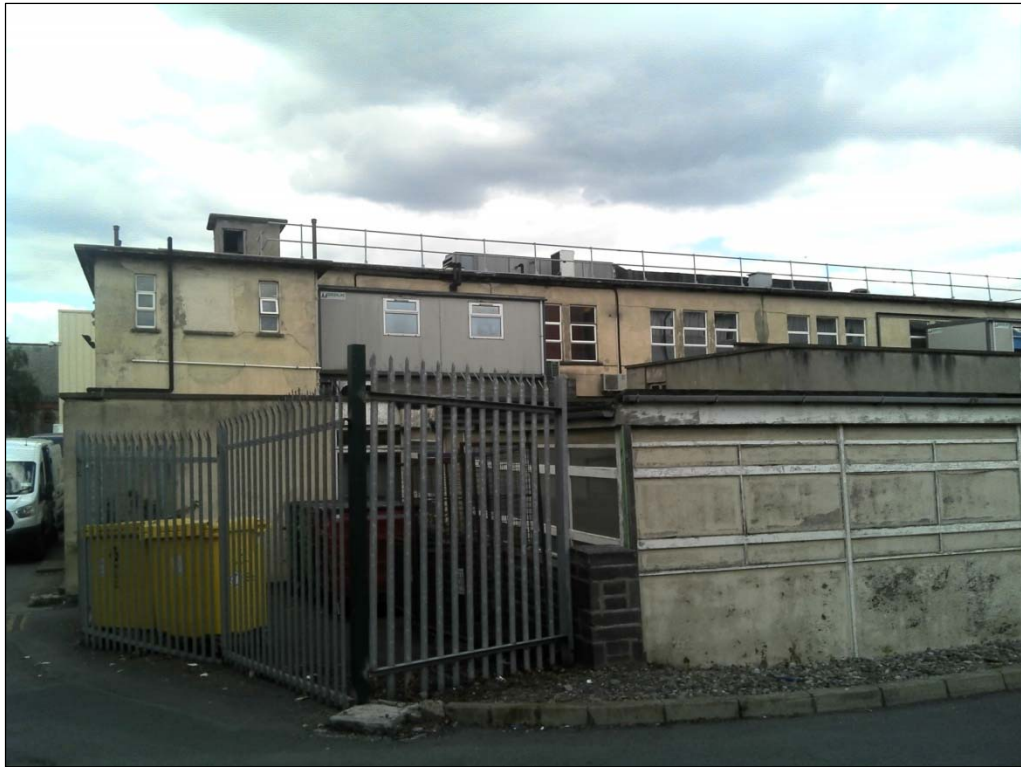
Plate 3.2. Flat roofed concrete sections of the building.

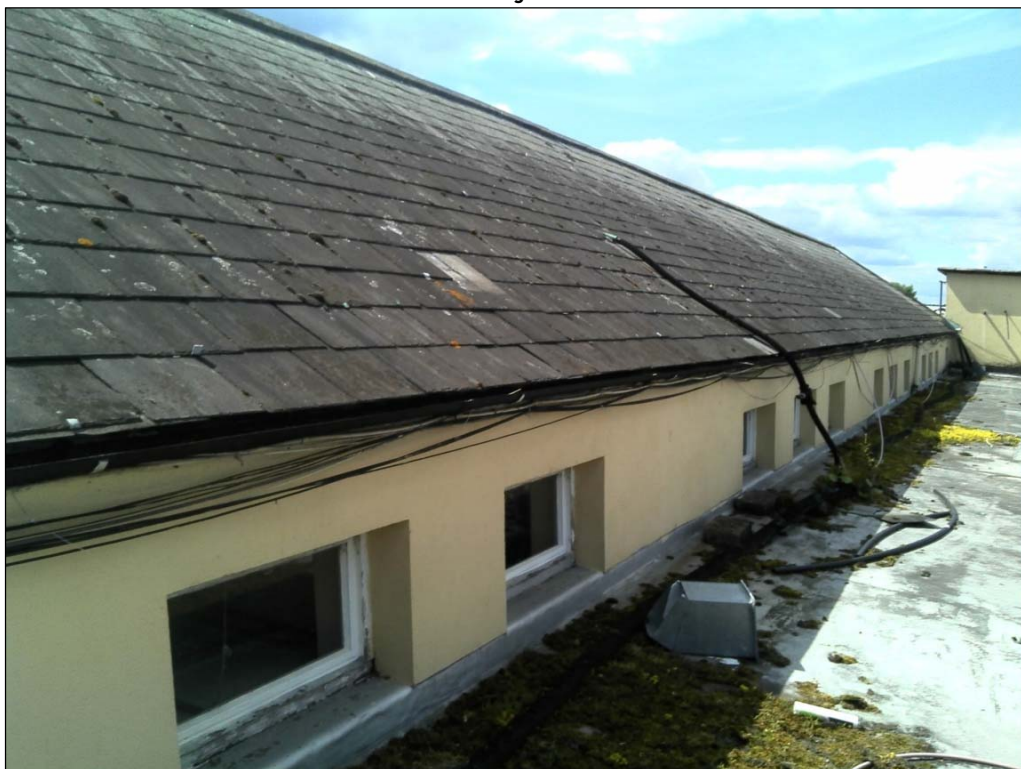
Plate 3.3. Slated, pitched roof as viewed from flat roofed extension.

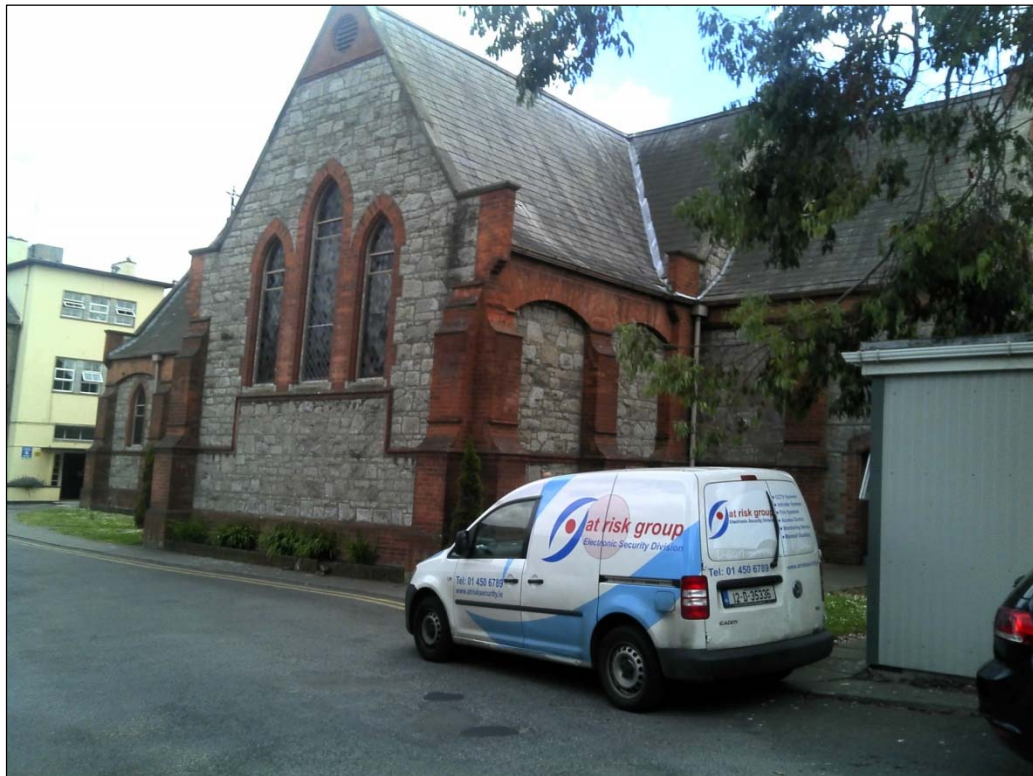
The interior of the church has a timbered ceiling and the entire church was searched for signs of activity such as droppings or staining. No such signs were recorded. No access to the roofspace was gained.

Plate 3.4. Hospital Chapel Building

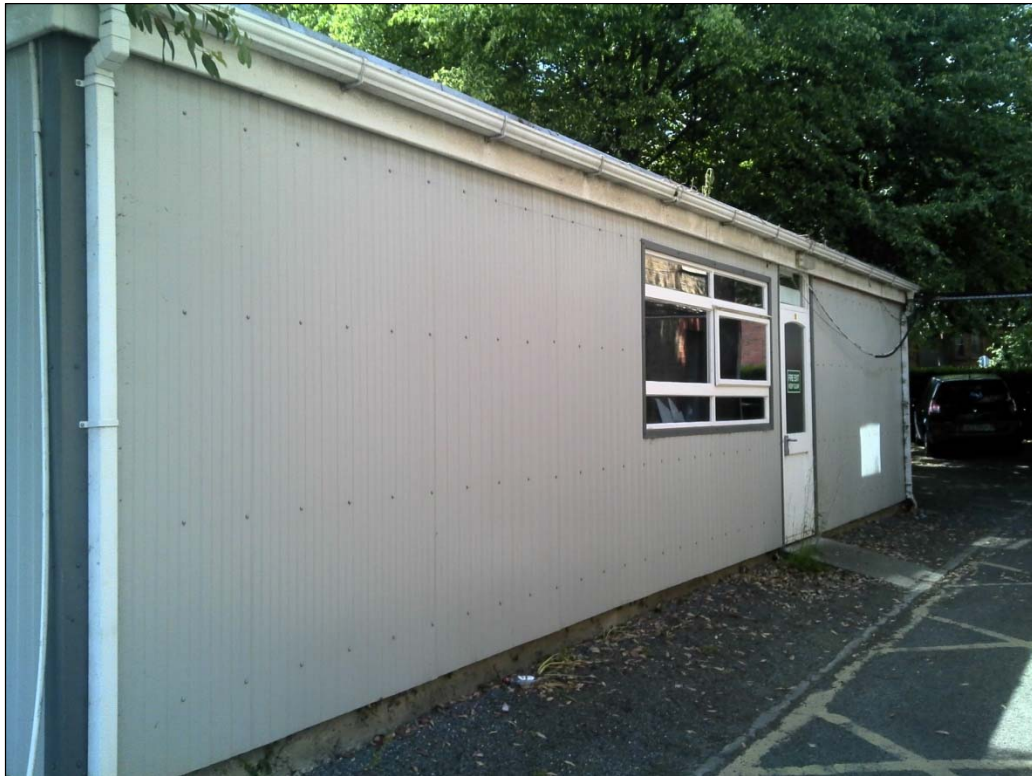
No access was gained to the interior of this building other than the working area that was not suitable for bats.

Plate 3.5. Building 30. Prefabricated building with Lower Bat potential

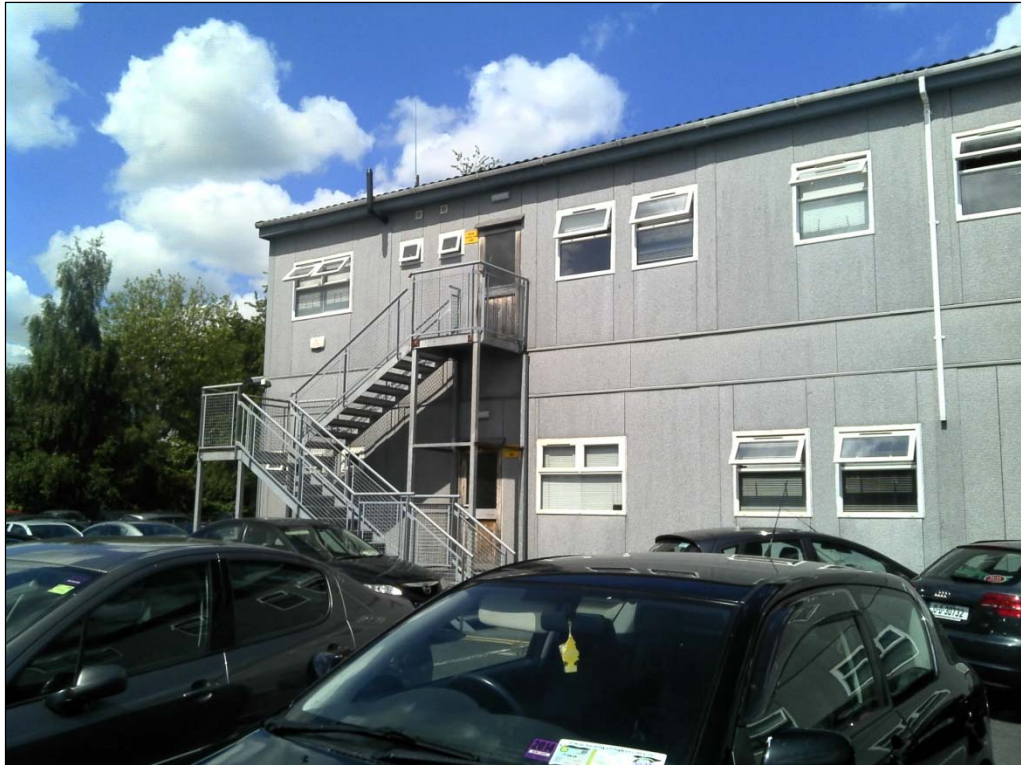
No access was gained to the interior of this building other than the working area that was not suitable for bats.

Plate 3.6. Building 31. Prefabricated building with Lower Bat potential

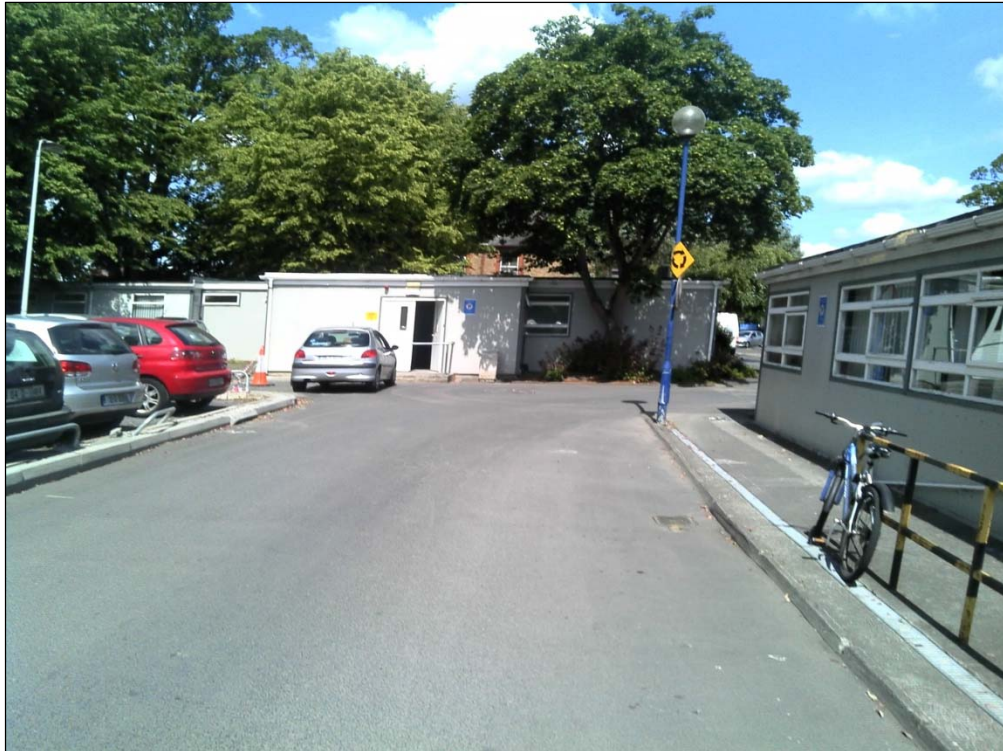
No access was gained to the interior of this building other than the working area that was not suitable for bats.

Plate 3.7. Building 33 Lower bat potential.

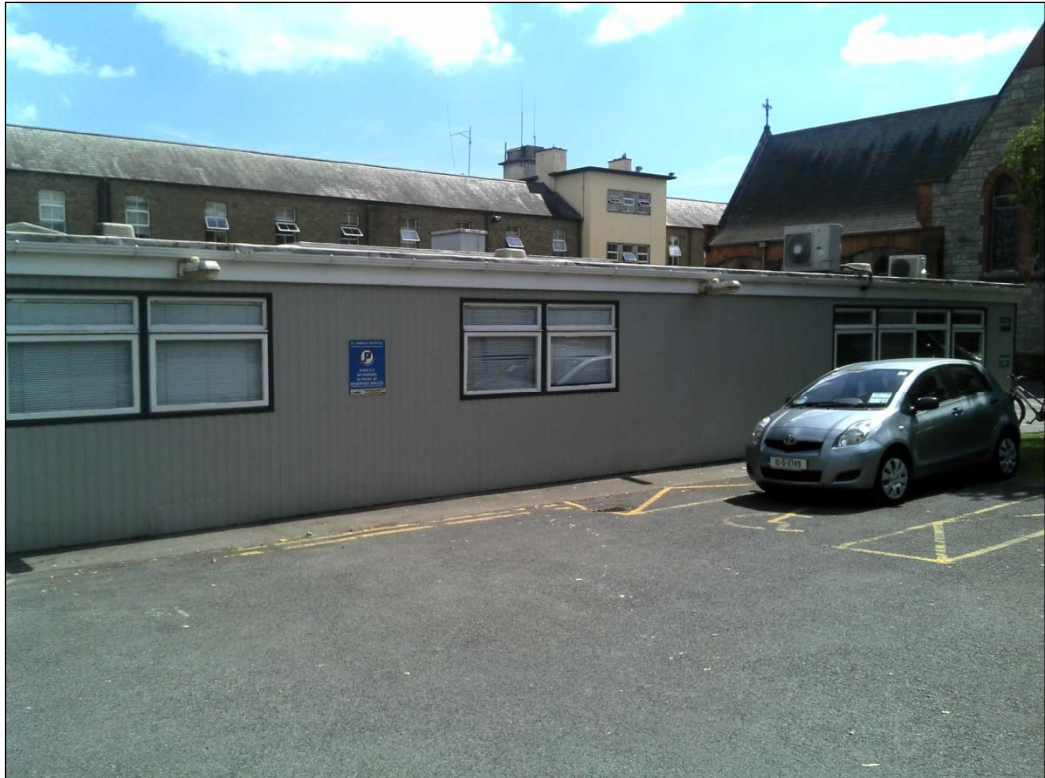
No access was gained to the interior of this building other than the working area that was not suitable for bats.

Plate 3.8. Building 34 Lower bat potential.

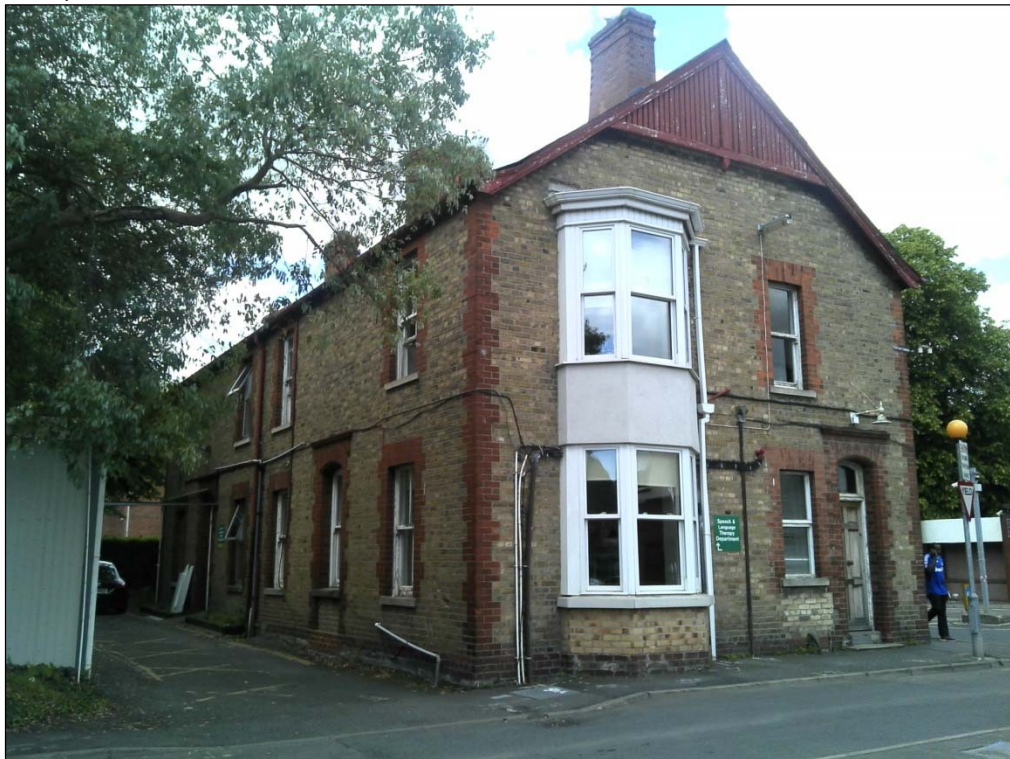
This was an early 20th century brick built construction with two storeys and a pitched slate roof. The fascia and soffit were in a poor state of repair and there were gaps in the roof slates. It was considered to have **Higher** potential to support bat species. See Plate 3.9.

Access was gained to the interior of this building and the entire roofspace was searched for signs of bat activity, though none were found. The roofspace was open to the rafters with all areas visible. The remains of wasps nests were recorded in this roofspace.

Plate 3.9. Building 35 with Higher bat potential.

It is not considered necessary to complete further night time detector surveys on the site but recommended that the buildings 27, 29, 35, 38 and 46 that support good bat roosting habitat are re-inspected by a suitably qualified ecologist prior to demolition to ensure that no bats are present at that time and to ensure that should bats be encountered, they are appropriately cared for.

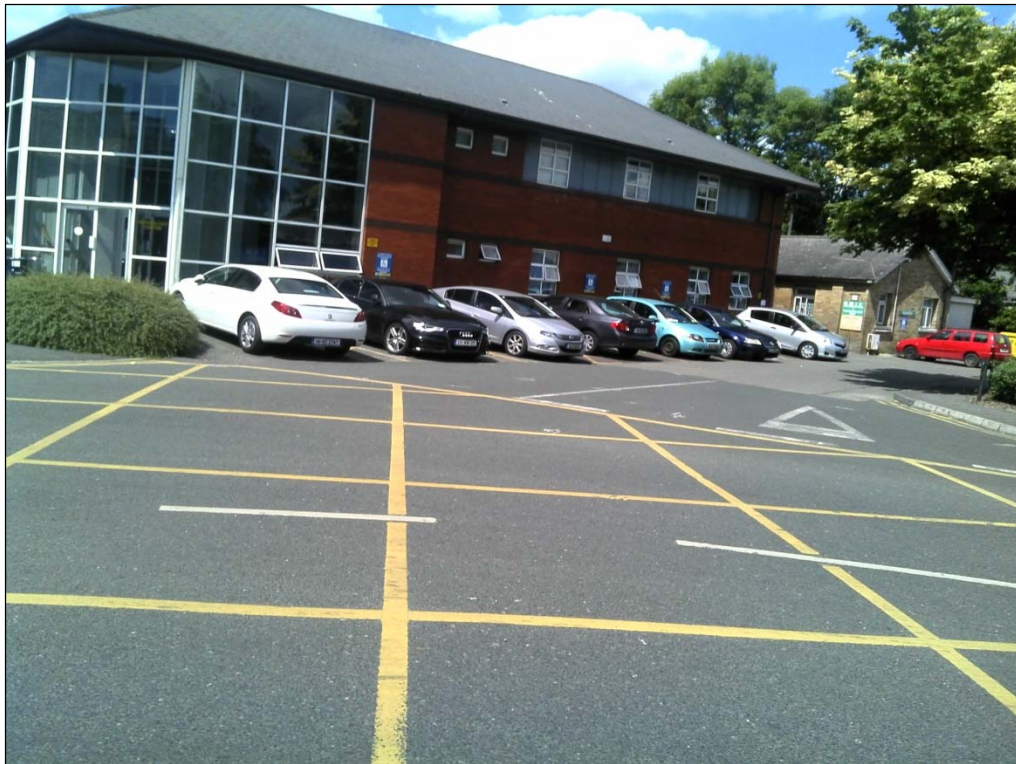
No access was gained to the interior of the buildings other than the working area that was not suitable for bats.

Plate 3.10. Buildings 36 & 37 with Lower potential for bats.

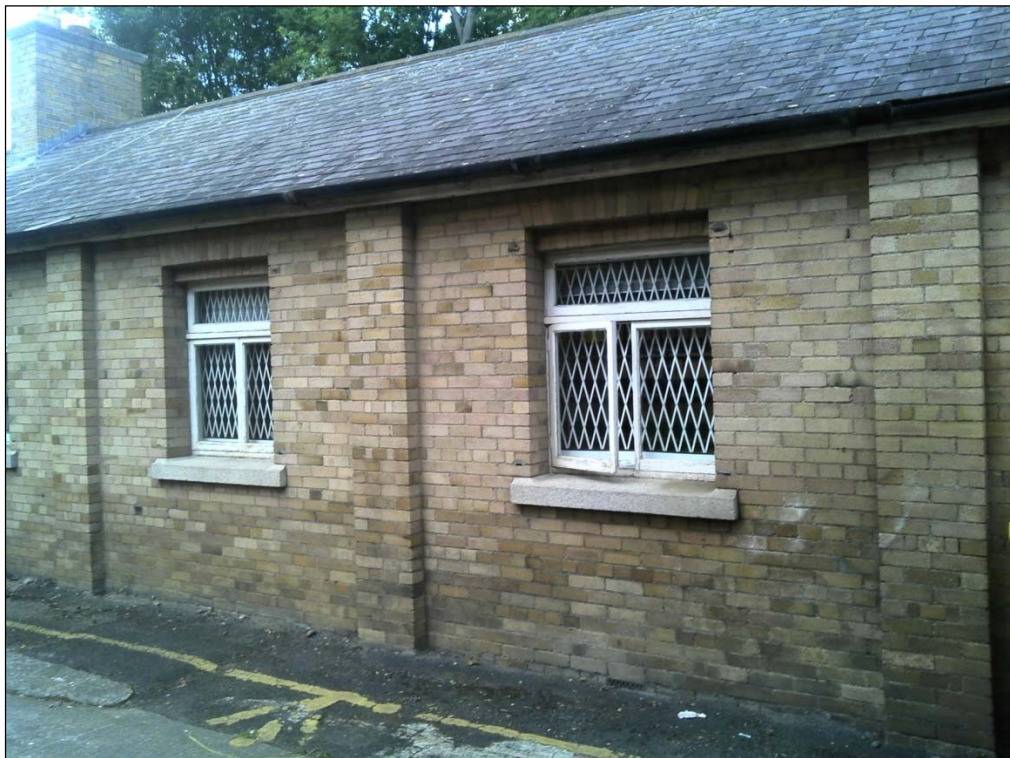
This was an early 20th century brick built construction with a single storey and a pitched slate roof. The fascia and soffit were in a poor state of repair and there were gaps in the roof slates. It was considered to have **Higher** potential to support bat species. See Plate 3.11.

There was no access to the roofspace in this building with the interior working area of the building taking up most of this area and no access point to the roof.

Plate 3.11. Building 38 with Higher Bat Potential.

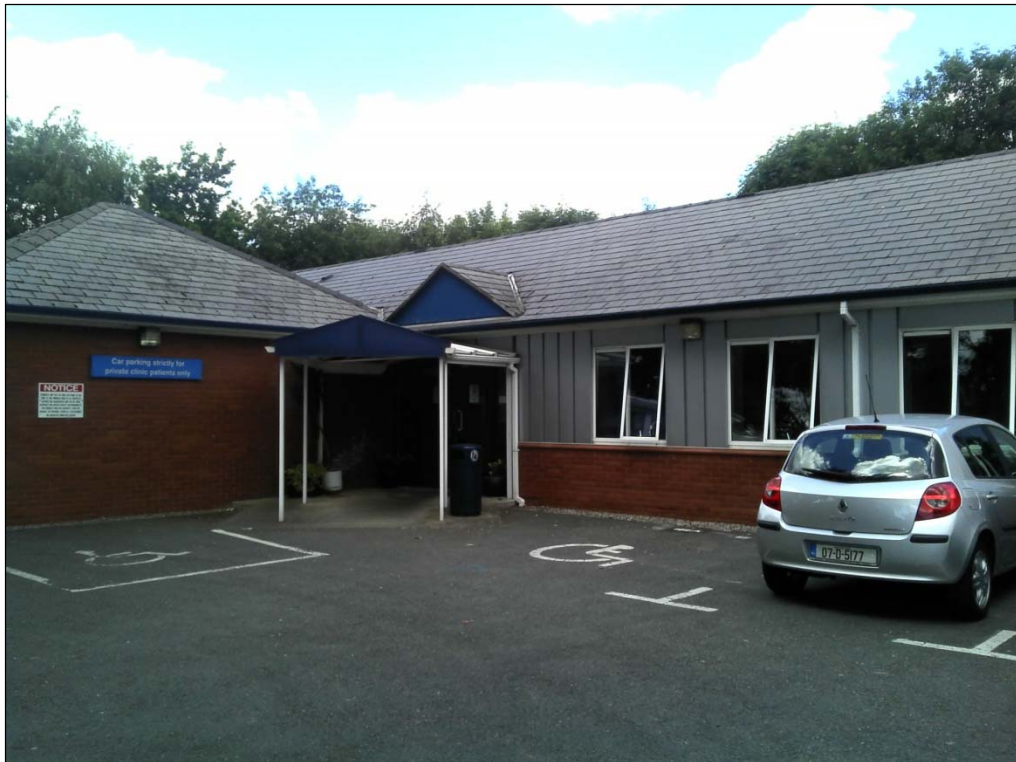
No access was gained to the interior of the building other than the working area that was not suitable for bats.

Plate 3.12. Building 39 with Lower Bat potential.

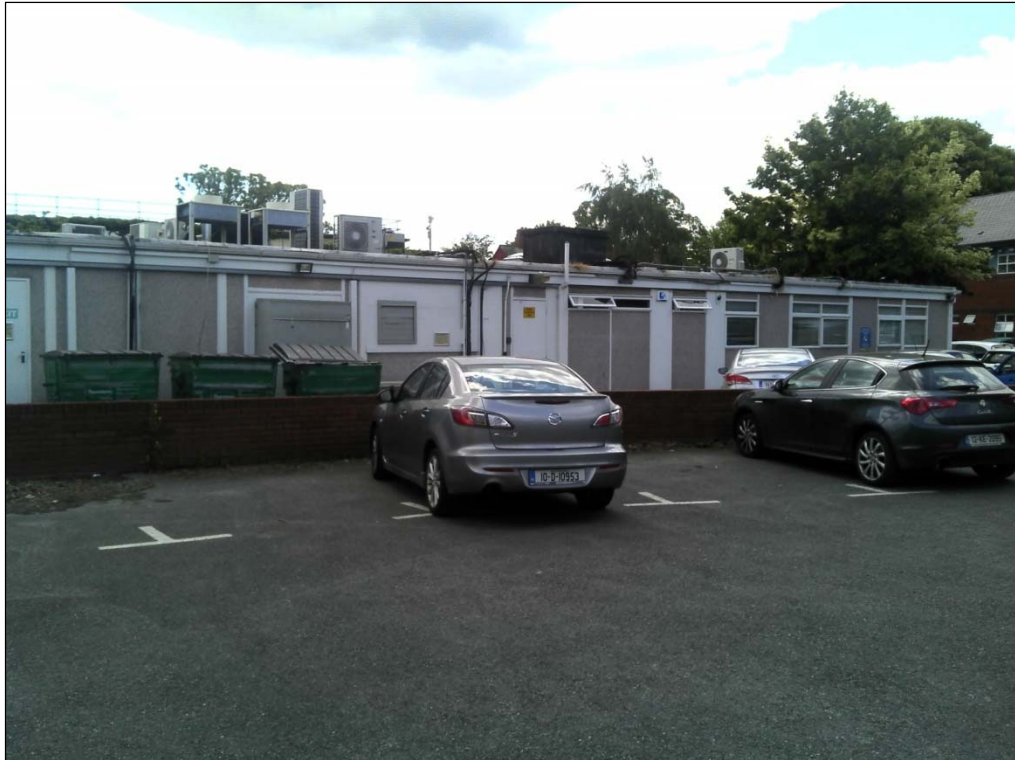
No access was gained to the interior of this building other than the working area that was not suitable for bats.

Plate 3.13. Building 40 with Lower Bat Potential.

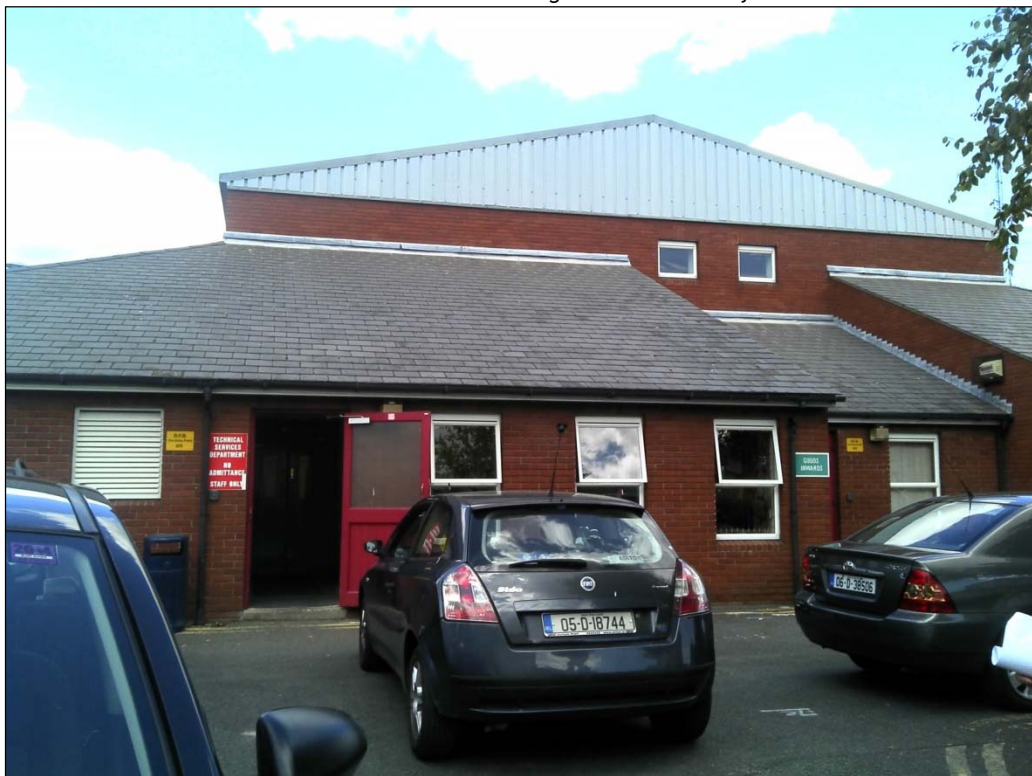
Access was gained to the interior of the building including the pitched roofspaces. These were modern and well sealed with no signs of bat activity recorded.

Plate 3.14. Building 41 with Lower bat potential.

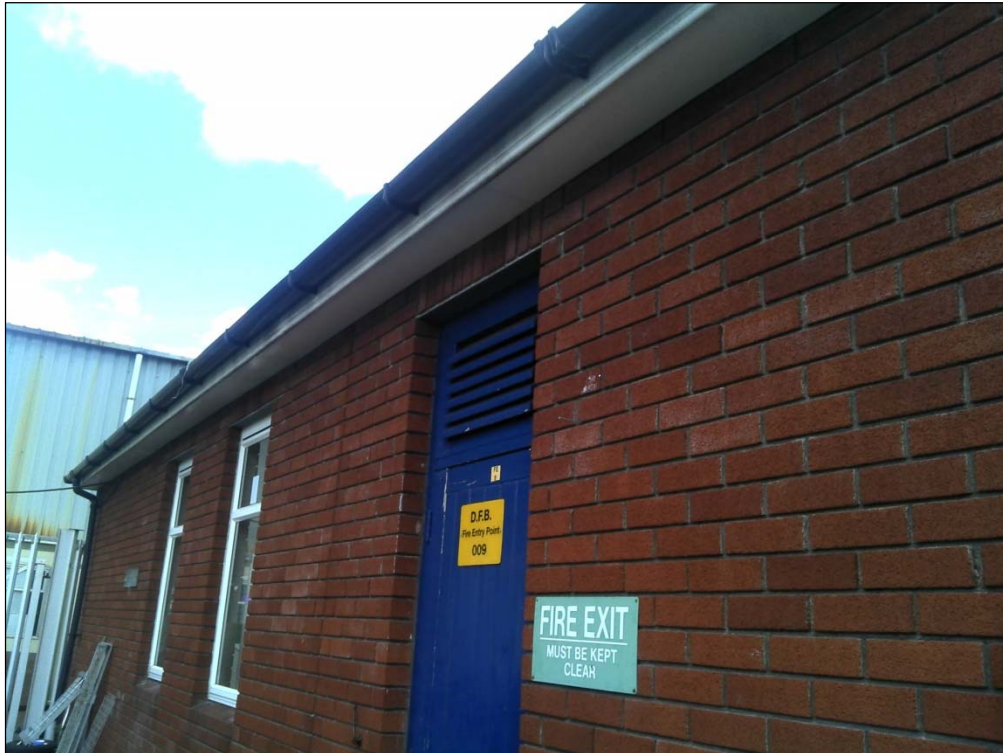
No access was gained to the interior of the building other than the working area that was not suitable for bats.

Plate 3.15. Building 42 with Lower Bat potential.

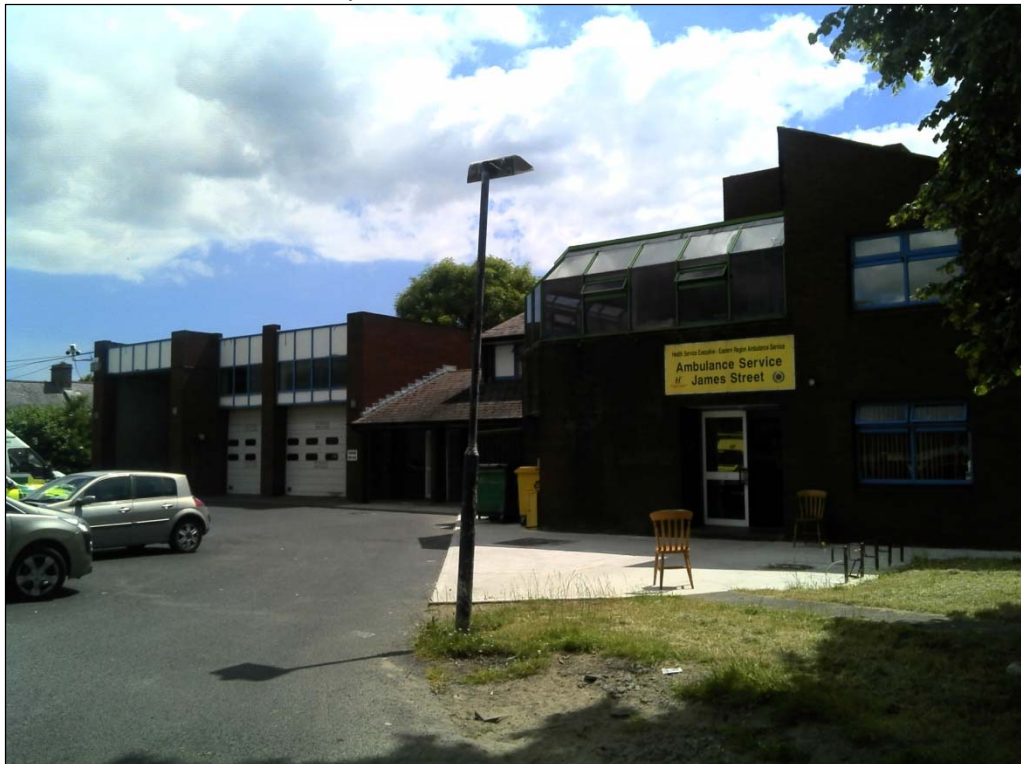
Access was gained to a small section of the roofspace. It was modern and well sealed with no evidence of bat activity recorded.

Plate 3.16. Building 43 with Lower Bat potential.

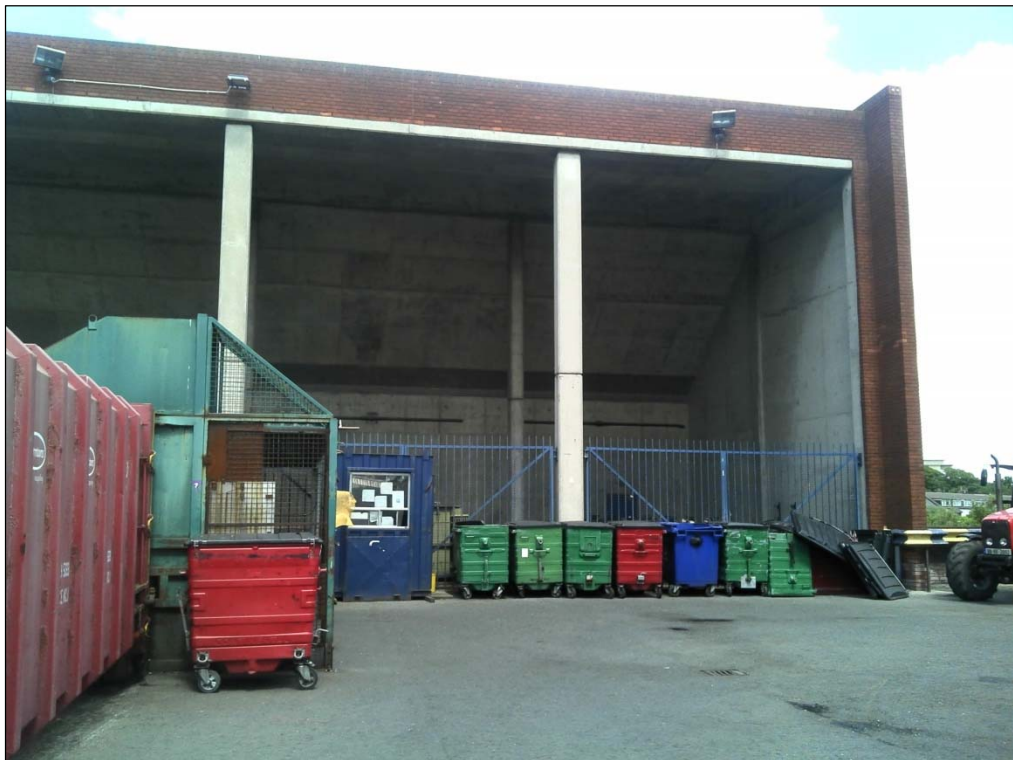
These buildings were largely open to the roof and supported little suitable bat habitat.

Plate 3.17. Buildings 44 & 45 with Lower Bat potential.

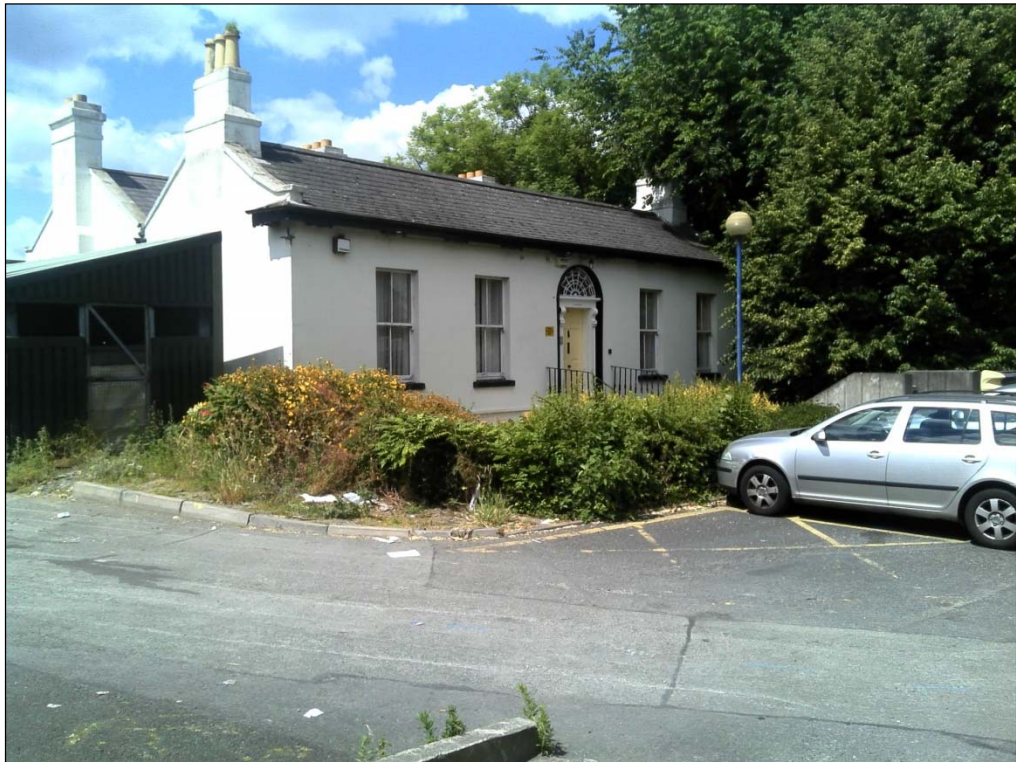
This was an early 20th century construction with rendered walls. It had two storeys and a pitched slate roof. The fascia and soffit were in a poor state of repair and there were gaps in the roof slates. It was considered to have **Higher** potential to support bat species. See Plate 3.18.

Access was gained to the interior of this building and the entire roofspace was searched for signs of bat activity, though none were found. The roofspace was open to the rafters with all areas visible. The remains of wasps nests were recorded in this roofspace.

Plate 3.18. Building 46 with Higher bat potential.

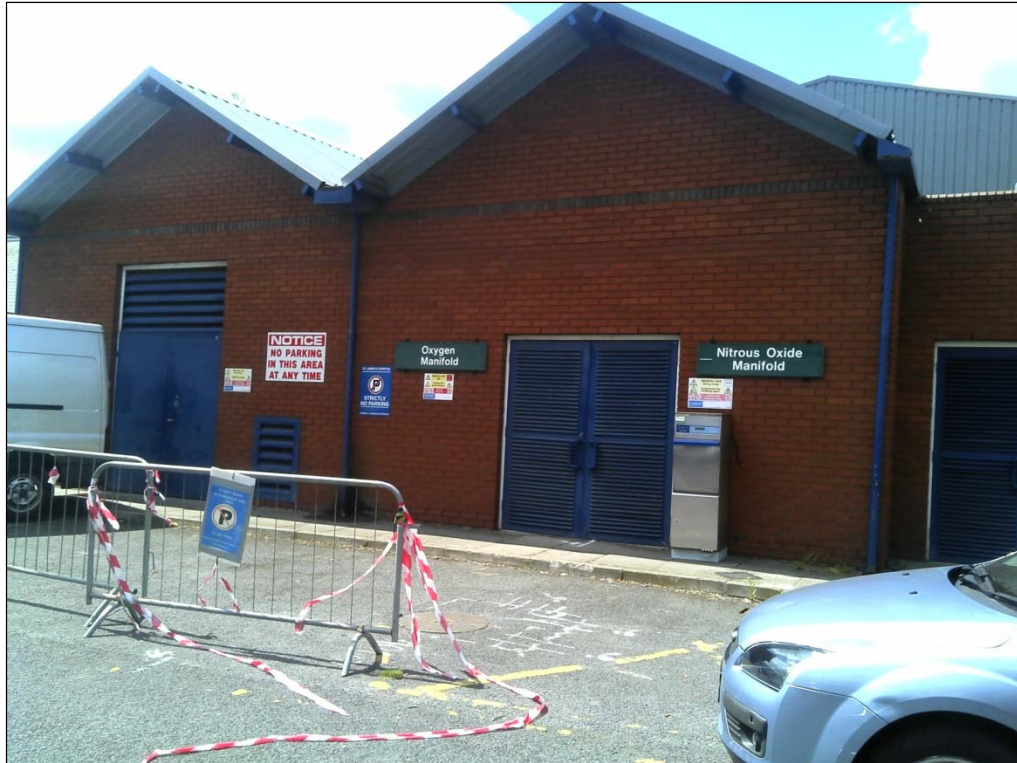
These buildings were largely open to the roof and supported little suitable bat habitat.

Plate 3.19. Buildings 47 & 48 with Lower bat potential.

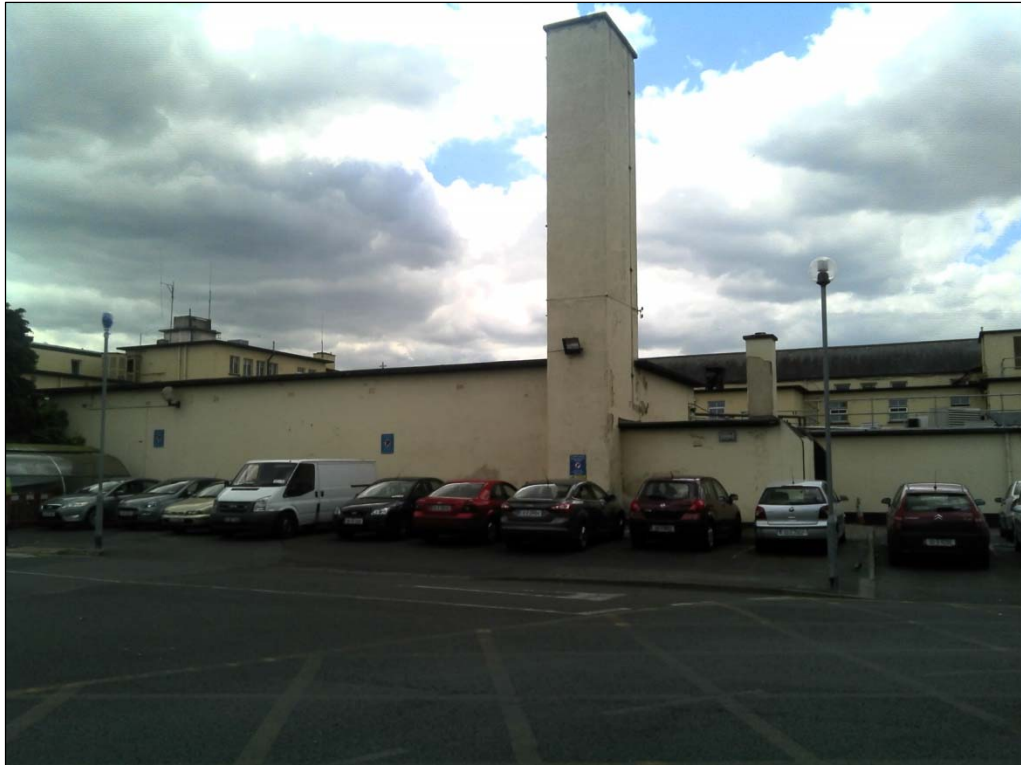
No access was gained to the interior of this building other than the working area that was not suitable for bats.

Plate 20. Building 49 with Lower bat potential.

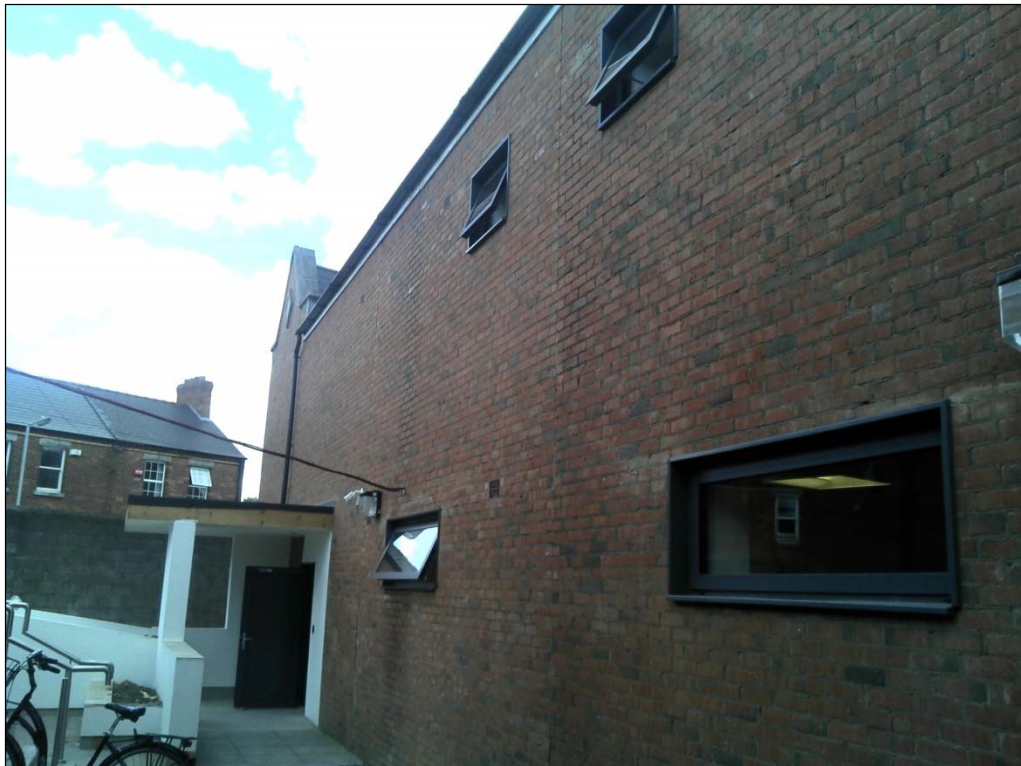
No access was gained to the interior of the building other than the working area that was not suitable for bats.

Plate 3.21. Building 53 with lower bat potential.

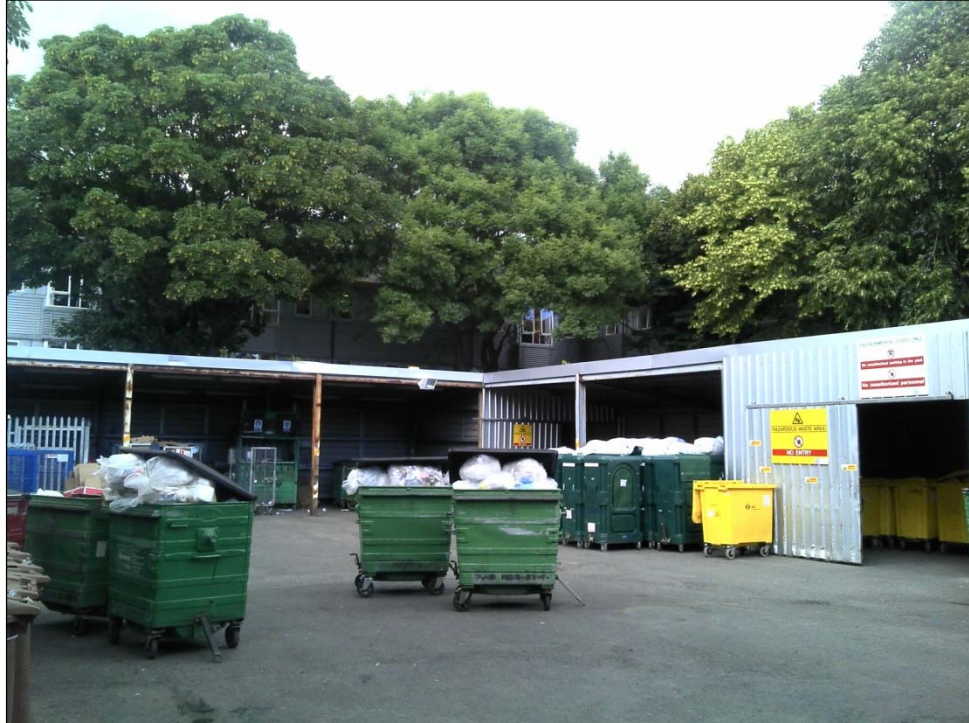
5. This area is located within an existing recycling compound within the hospital grounds. Any development of this area should seek to retain and protect the existing trees surrounding this site. The existing buildings at this site consist of single storey metal buildings with open fronts. They offer very low bat roosting potential.

Plate 3.23. Recycling area where facilities are proposed

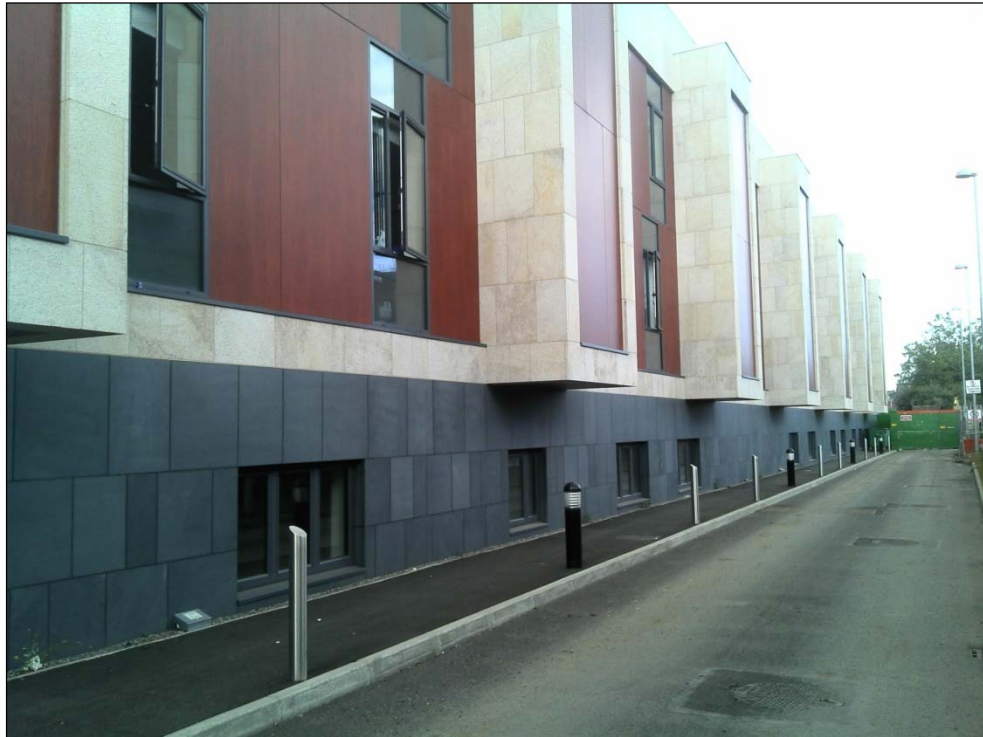
6. This is a large, recently completed building. The fitting out of this building is highly unlikely to impact on bats. No access was gained to the internal areas of this building but it is flat roofed and without attic spaces or other suitable areas and offers little bat habitat.

Plate 3.24. Recently Constructed building. Fit out is unlikely to impact on bats.

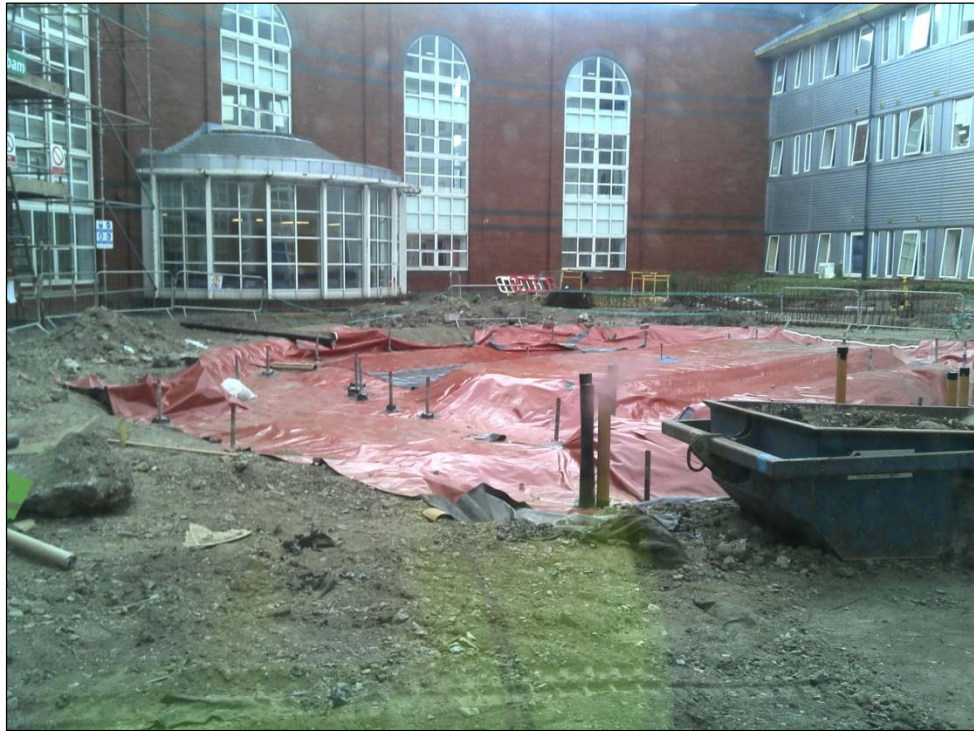
7. The development of this area is currently underway on an area of amenity grassland that is surrounded on all sides by hospital buildings. Development of this site is highly unlikely to impact on bats. The surrounding hospital buildings will remain in position following completion of the chapel and are unlikely to be impacted upon by this development. The surrounding hospital buildings are flat roofed constructions that have **Lower** potential to support bat species.

Plate 3.25. Construction of new chapel underway

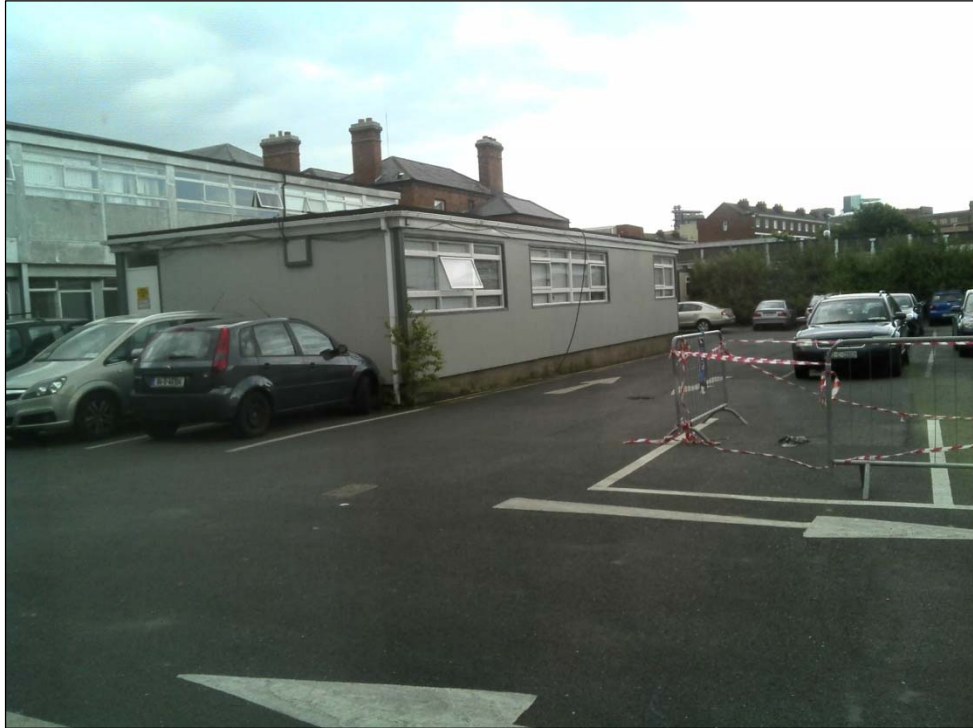
were searched from ground level using binoculars where necessary. No signs of bat activity were recorded during the external inspection. No access was gained to the interior of this building other than the working area that was not suitable for bats. Development of this site is highly unlikely to impact on bats.

Plate 3.26. Car park and prefabricated buildings where the works are proposed.

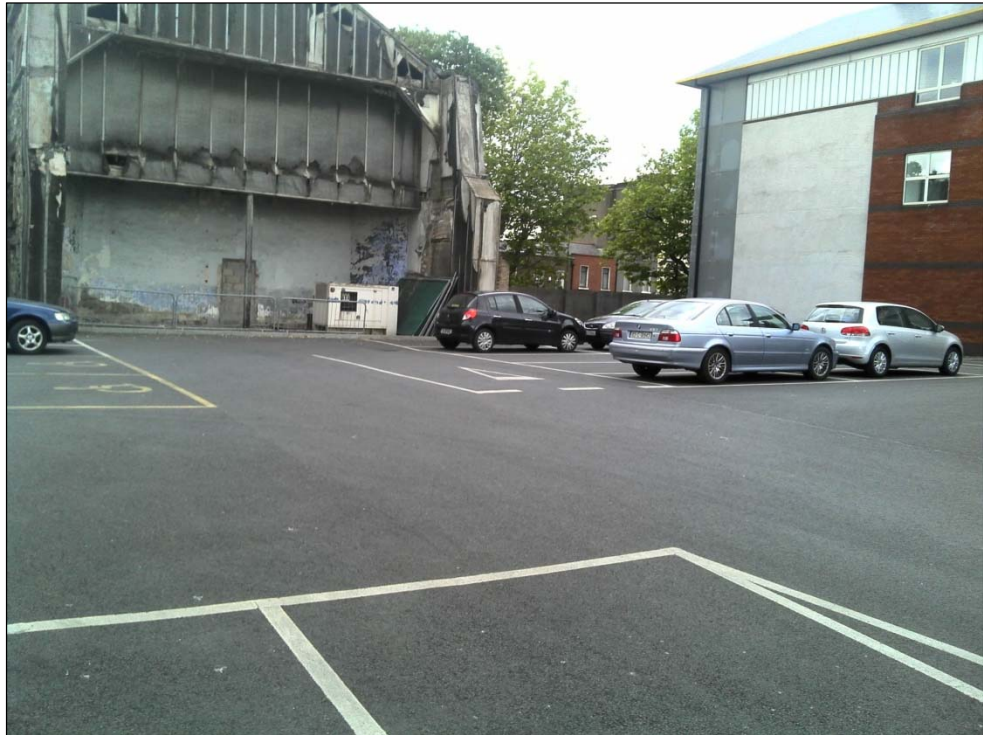
11. This area is currently in use as a car park and development of this site is highly unlikely to impact on bats. The surrounding buildings are of stone construction but are unlikely to be impacted upon by the temporary modular units that are proposed at this location.

Plate 2.27. Car park area where some temporary modular units are proposed.

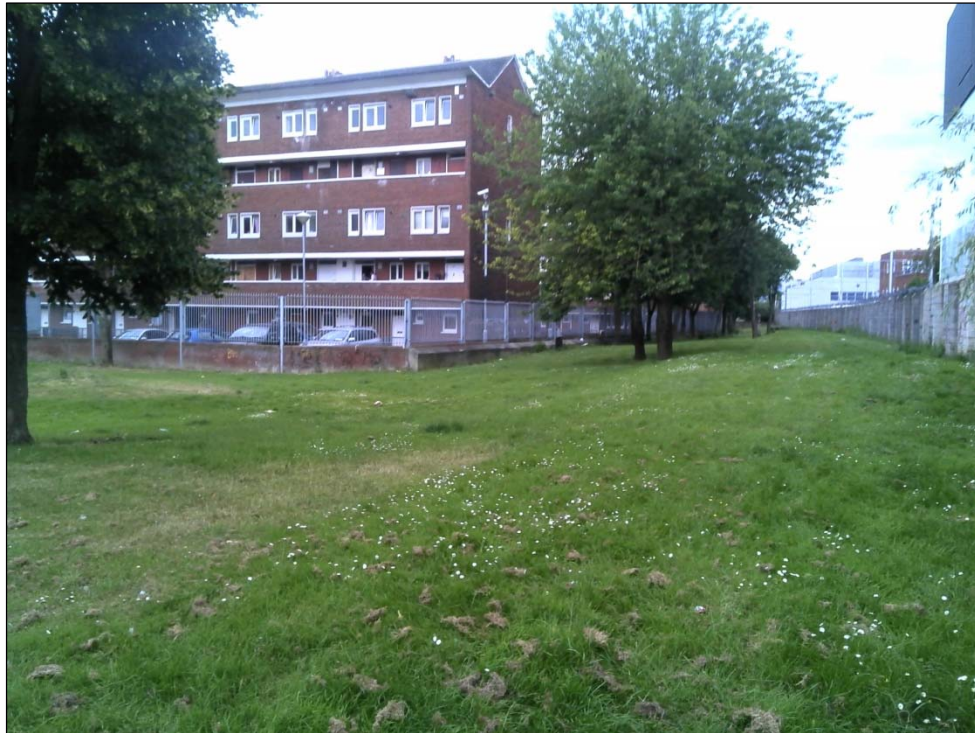
12. This site is located in amenity grassland in the vicinity of neighbouring flats. There are some small trees in this area but not that are considered likely to support significant bat roosting habitat given their size, age and general condition. Development of this site is highly unlikely to impact on bats.

Plate 3.28. Greenfield area where development is proposed.
