National Paediatric Hospital Project

Appendix 9.1 – Bat Surveys

**Bat Surveys of new children's hospital at St. James
Campus, and satellite centres at Tallaght & Connolly
Hospitals. Dublin.**

Document Title: Bat Survey

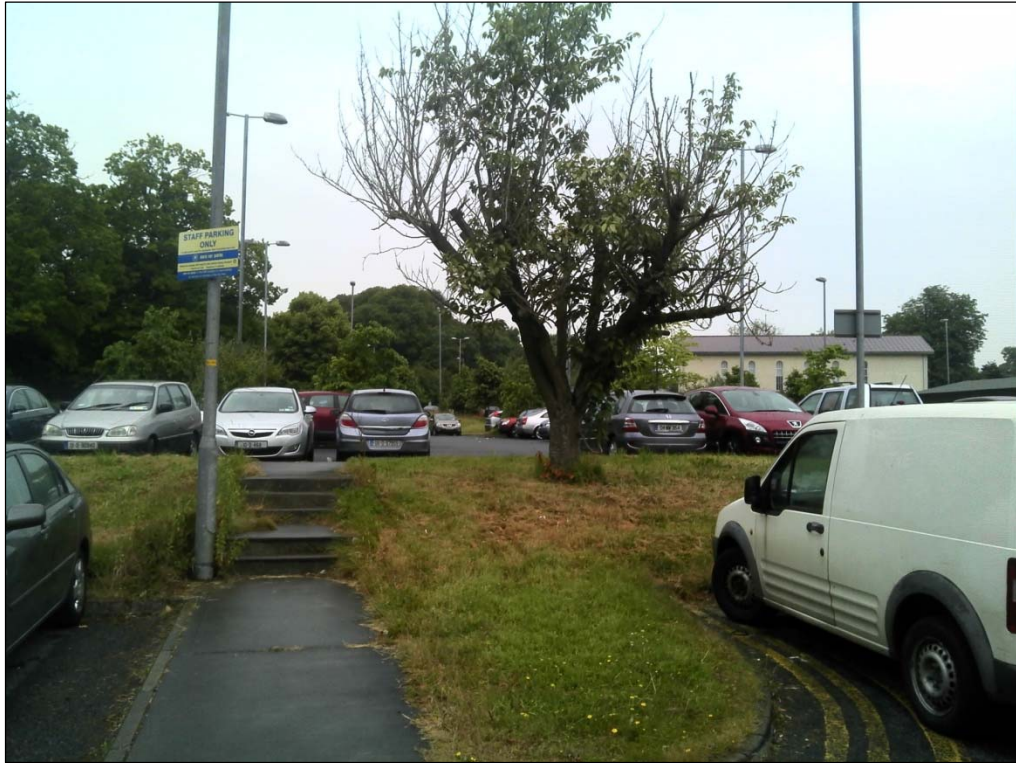
This site was located within the curtilage of the existing Buildings at Connolly Hospital. It is located on an area that is partly in use as a car park and partly amenity grassland surrounding the car park. There were a number of small, amenity trees planted around this area, none of which were considered to offer good potential bat roosting habitat or to provide significant cover for commuting or foraging. A section of the site was in use as a construction compound at the time of the site visit in June 2014. There was street lighting throughout this area. There were broadleaved woodlands located to the north and west of this The Tolka River was located within these woodlands and flowed to the west of the hospital.

Plate 3.22 Car Park and Amenity Grassland with small trees at the site of option 1.

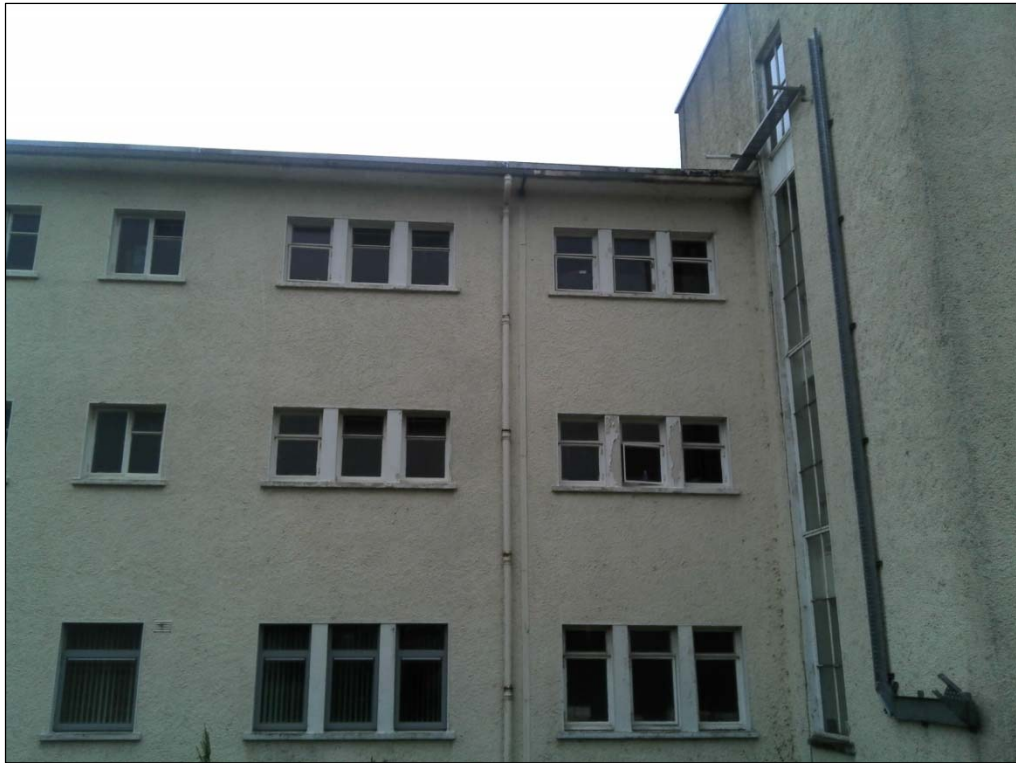
In addition, a known bat roost was located in one of the older hospital buildings approximately 50metres to the south of the proposed site. Staff described surveys of this roost having been undertaken in the past and bats having been recorded emerging from an expansion joint in the flat roof of the hospital (Plate 3.23). Some staining was noted around this joint but no other signs of bat activity were recorded from ground level or when searching through high powered binoculars. The location of this roost is shown in Figure 1.3.

Plate 3.23. Bat roost in expansion joint in roof of hospital building (adjacent to drain pipe).

It is recommended that no lighting is focused onto areas of ecological sensitivity such as the woodlands surrounding the buildings

It is recommended that the tree lines and individual trees be retained where possible and that the proposed new development includes proposals to plant new areas of vegetation to shield the development from the surrounding area and woodlands. This is especially important in relation to Option One, where vegetative screening between any building and the adjacent roost should be included in the design to provide both cover and a commuting route in and out of the roost site

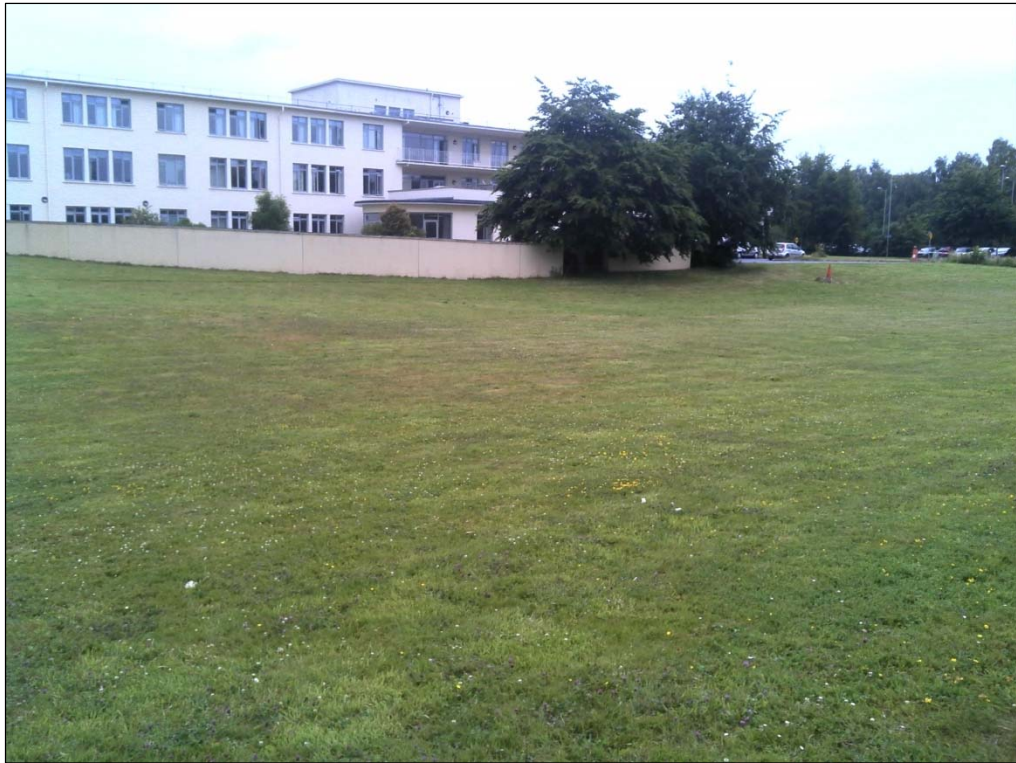
This site was also located within the curtilage of the existing hospital complex between the main entrance and the main public car park. It was centred on an area of amenity grassland with only two young Beech trees located adjacent to the existing hospital building (Plate 3.24). No other trees were located within the site area. However some saplings had been planted in the south eastern section of the grassed area in the recent past. No anecdotal evidence of roosts in this area was recorded. The two trees on the site were classified as category two trees with some potential as roosting habitat but with no big cracks or fissures with the potential to be used by multiple bats or to support a significant roost. Neither did the site provide habitat features to offer good quality foraging habitat or to provide linkage between other foraging areas.

Plate 3.24. Amenity Grassland where Option 2 is proposed

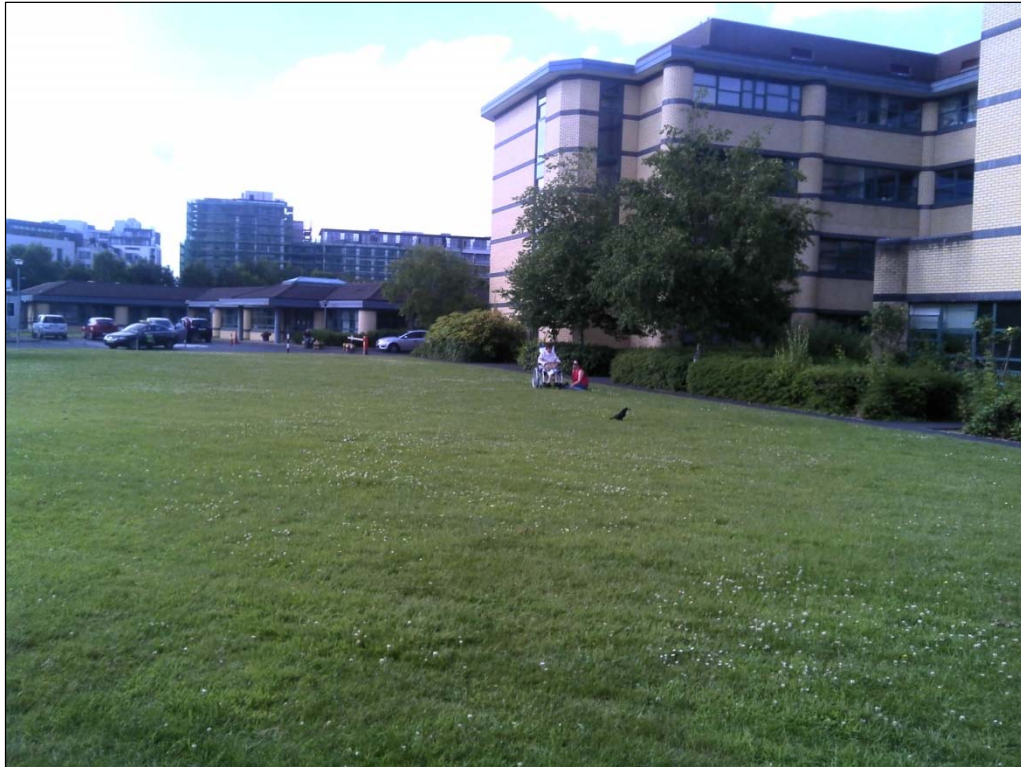
The section of Tallaght Hospital where the building is proposed was surveyed for its suitability as bat roosting, foraging or commuting habitat. The proposed building is located on a lawn of amenity grassland that is located to the east of the existing hospital building (Plate 3.25). There are a number of young trees and shrubs within the garden area of the hospital. None of this vegetation was considered to have potential as a bat roosting habitat but some of the surrounding vegetation was considered to offer some potential foraging habitat in an otherwise very urban area. The desk study revealed no records of bats within one kilometre of the site and it is located in a very urban setting. The hospital building itself is modern and there was no access to a roofspace. It was considered to have low potential as bat roosting habitat and was inspected from the ground using high powered binoculars. No signs of bat activity were recorded on this building.

Plate 3.2.5. Area where the new building is proposed on lawns associated with Tallaght Hospital

It is recommended that vegetation surrounding the site be retained where possible and that the proposed new development includes proposals to plant new areas of vegetation to replace any that are lost and to increase vegetative cover on the site if possible.

It is recommended that in order to increase potential bat roosting habitat, some such habitat is incorporated into the design of any proposed building on the site. This could take the form of simple bat boxes or bat bricks and should be designed in conjunction with a bat ecologist.

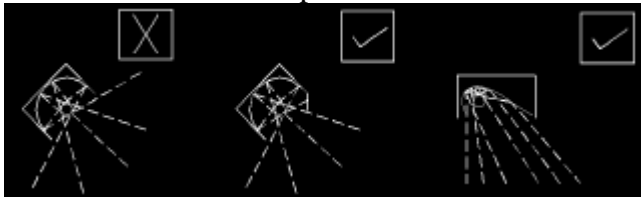
The use of asymmetric beam floodlights (as opposed to symmetric) orientated so that the glass is parallel to the ground will ensure that the light is cast in a downward direction and avoids horizontal spill.
