# National Paediatric Hospital Project

## Planning Application

### Appendix 16.1 – Chapel Survey

## Appendix 16.1 Chapel

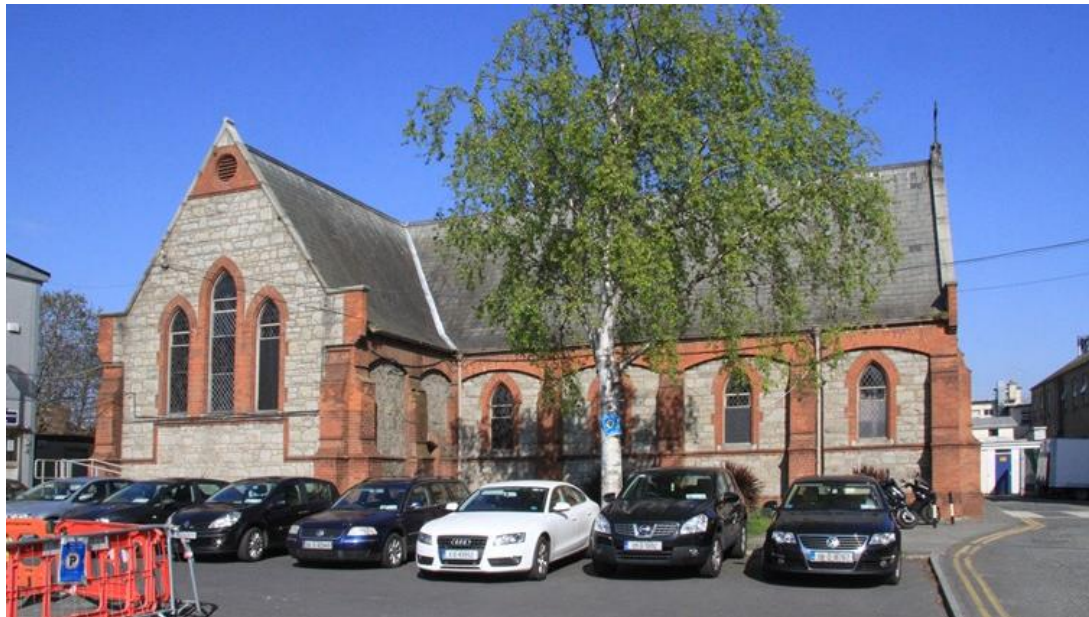
*Plate 1: Southern elevation of chapel*

The chapel on the campus of St James's Hospital is cruciform in plan and is not aligned to the traditional ecclesiastical cardinal points. The main door faces almost towards the north-east, rather than the west and the altar is at the south-western end, instead of the east. This orientation appears to have been chosen so that the main entrance is directly on the line of the original avenue leading from the South Dublin Union workhouse across to the Auxiliary Workhouse site. This avenue led through the centre of the building that is now known as Hospital 7 and towards the doorway to the chapel.

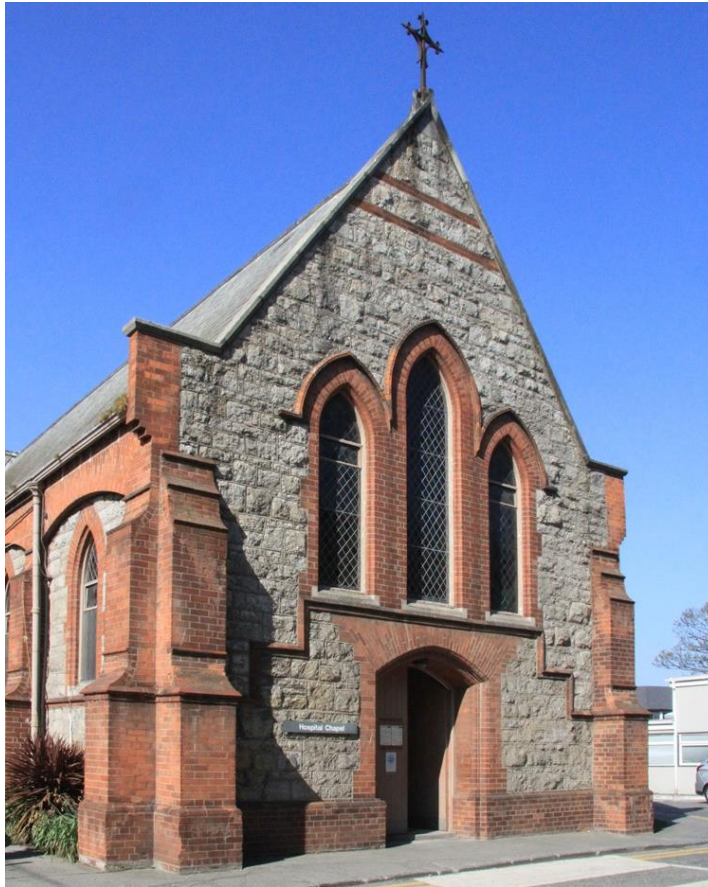
*Plate 2: Gable end of nave and main entrance*

The gable end of the chapel facing Hospital 7 has the main entrance to the nave at its centre. This is the north-eastern end of the chapel, though the ecclesiastical west end.

The base of the building is a red brick plinth with seven courses of brick laid in English garden wall bond and capped with a course of moulded brick. Above this the walling is of granite rubble with stones of random size, roughly squared and brought to course of approximately 300mm. Two courses of brick cross the gable near the apex. The gable is topped by chamfered cut granite copings at an angle of approximately forty-five degrees. This is crowned by an apex stone with cruciform roll mouldings on the upper surface, from which a wrought iron cross rises. At the base of the coping the walling runs out to cover the eaves terminating in a brick wall seventeen courses high and 500mm wide, corbelled out to run beyond the gutters at the side of the nave.

At each corner a pair of buttresses runs out, one to the front, the other to the side. These are of red brick, laid in English garden wall bond and each is approximately 650mm wide. At the base of each is a continuation of the main plinth, above which the shaft of the buttress rises fifteen courses to meet a projecting course on which sits a moulded brick drip course. Above this the face of the brick curves in to meet the upper section of the buttress, which runs in again in two stages near, but not at, the top of the wall.

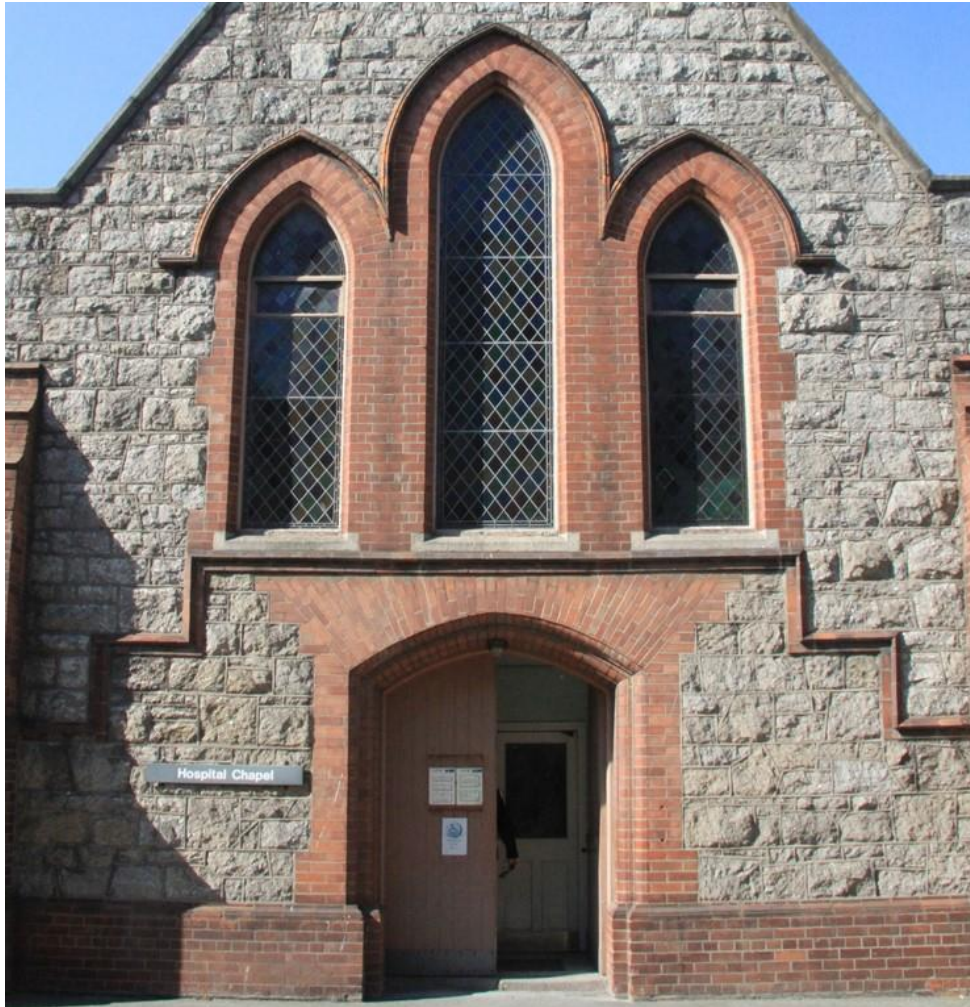
*Plate 3: Main door and windows*

The doorway to the chapel is lined with brick. This rises from the plinth at a width of approximately 400mm, stepping in to c.300mm after five courses and running up to the level of the spring of the arch. The margin of the ope is in two orders, each with ovolo mouldings. The arch over the doorway is three-centred and faced with gauged brick which rises approximately 250mm at the crown of the arch to reach the underside of the string course below sill level. Across the full width of the arch the brickwork splays to the string course, executed in gauged brick. The spandrel rests on a series of skewbacks, each formed with three courses of brick.

The windows are diamond-leaded and set with coloured glass. Two narrow bands of coloured glass run around the margins. A small bottom-hung casement extends across each of the flanking windows, just below the springs of the arches. The window glazing is set in a timber frame.

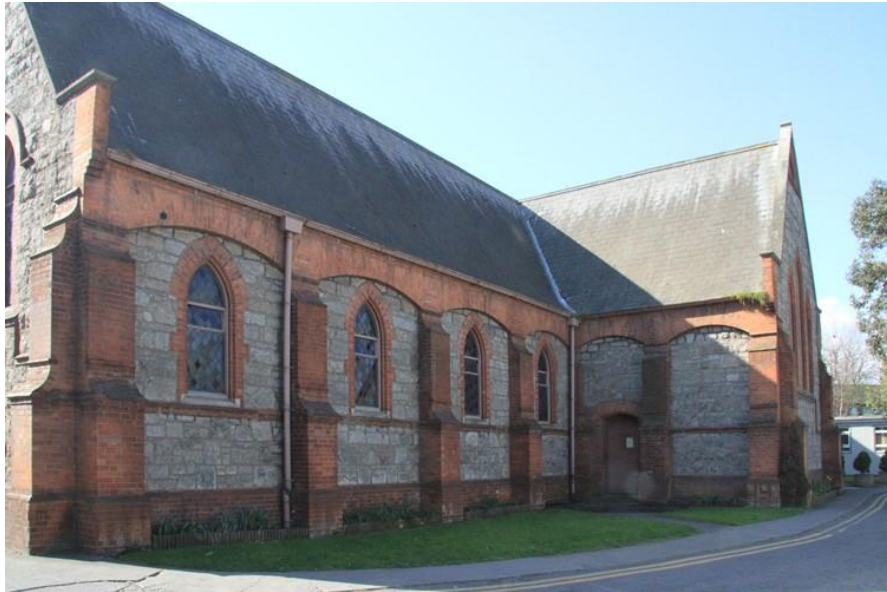
*Plate 4: North-western side of chapel*

The external features on the other sides of the chapel repeat the language of the entrance front, with variations on the theme. The north-western side, which is the ecclesiastical south, is seen in the photograph above. This is four-bay along the nave and two-bay at the sides of the transept.

The walling is of granite rubble, brought to courses and with a two-brick string course below sill level, continuing the mouldings of the buttresses.

The windows along the sides of the nave are smaller versions of those in the gable end. They have granite sills and brick linings with cavetto mouldings and have pointed segmental gothic arches. The windows have diamond-lead glazing with two narrow glazed bands at the margins and all of the glass is coloured. A bottom-hung casement is placed just below the spring of the arch.

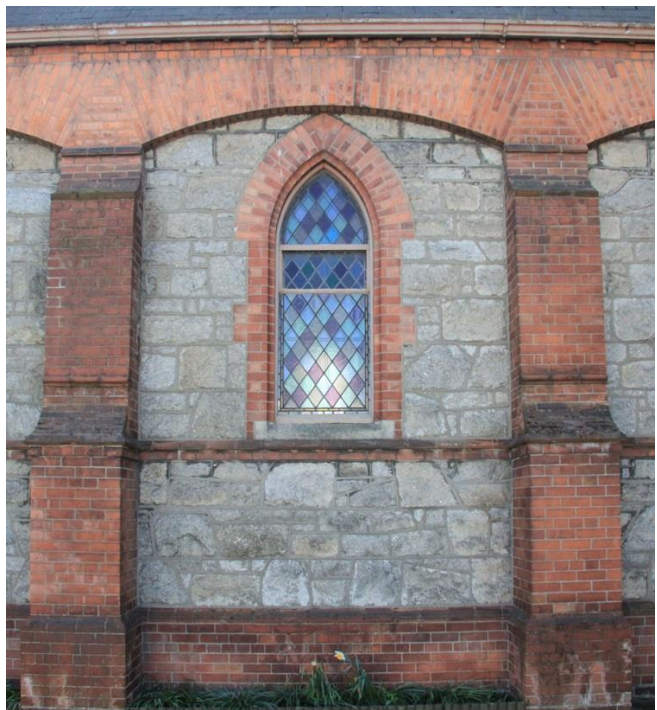
*Plate 5: Detail of north-western wall*

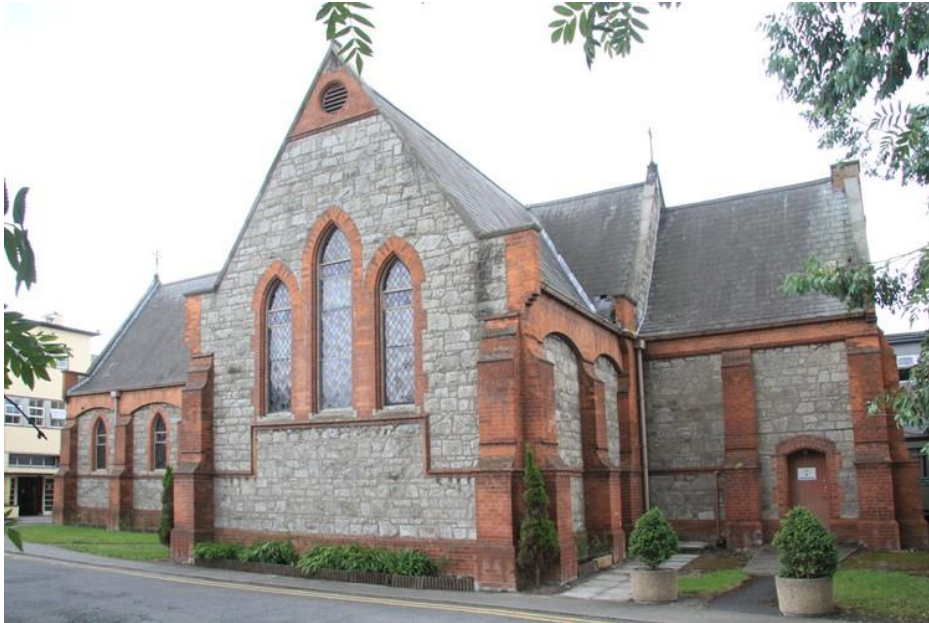
*Plate 6: North-west-facing transept*

The transept on the north-western side has a tripartite window in the gable, similar to that above the entrance to the chapel. The windows are lined with brick, with gothic arches and have coloured diamond-lead glass with slender margins. The gable has chamfered granite copings terminating in projecting brick walls. The apex of the gable is of brick, rising from a brick string course and with a louvered vent. The capping of the apex is of granite, with a roll moulding.

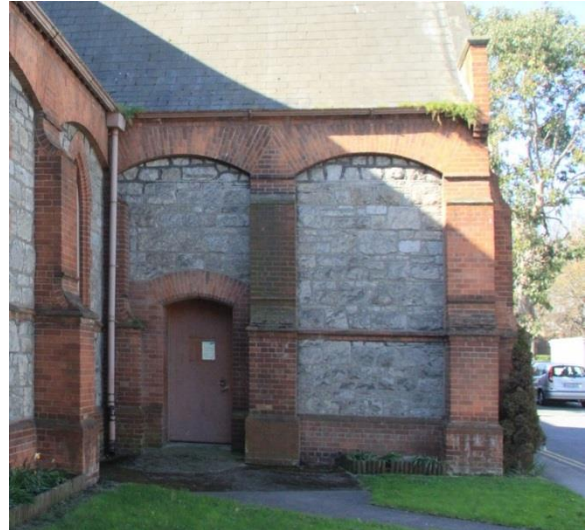
*Plate 7: Eastern face of transept*

The two sides of the transept have walling similar to that of the nave, described above. Each side of the transept is two-bay and the buttresses support segmental brick arches. On the eastern face of the transept is a doorway lined with brick with an ovolo moulding and with a simple segmental arch. The door is timber-sheeted.

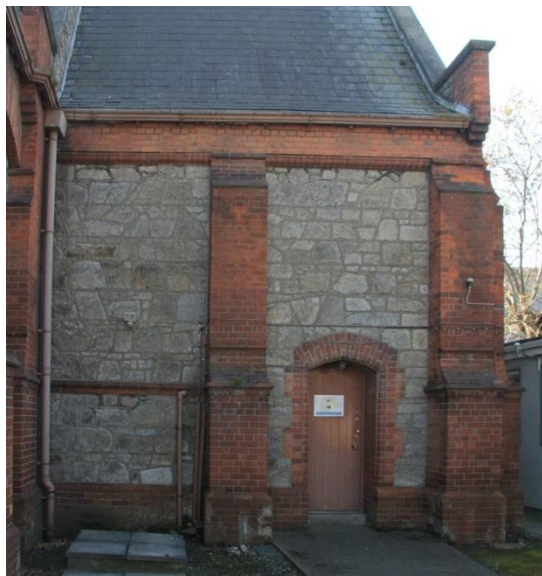
The walling on either side of the chancel is simpler than that on the nave and lacks the gauged brick arcade. Instead, the buttresses support a brick corbel with ovolo moulding, above which are five courses of red brick on which sits the ogre-profiled cast iron guttering. There is a uPVC hopper and downpipe.

*Plate 10: Side wall of chancel*

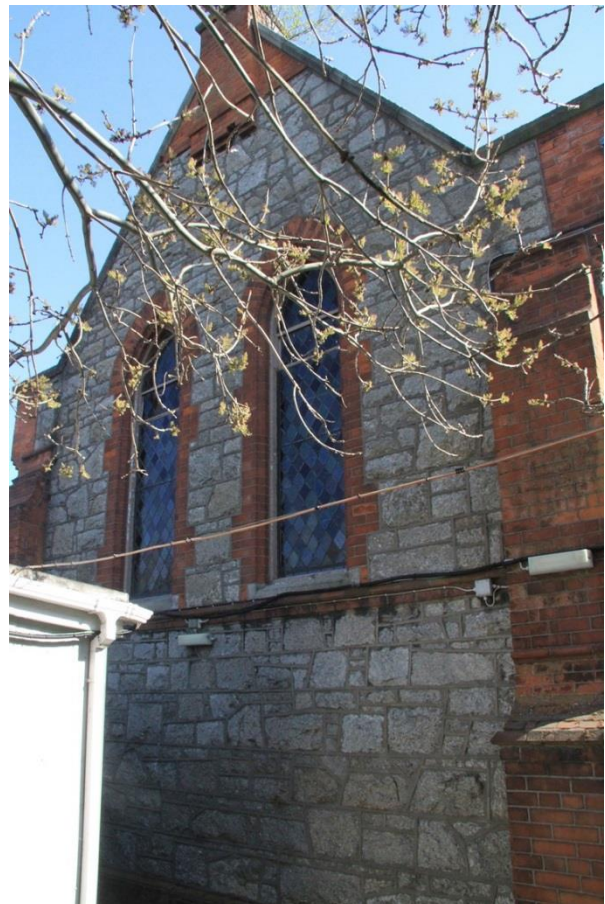
The gable of the chancel is flanked by brick buttresses. The walling is of rubble granite and a brick string course crosses below sill level. There are two lancet windows in this gable, both of similar description to those described above, with brick linings and coloured glass. At the apex of the gable there is a small brick chimneystack

*Plate 11: Gable end of chancel*

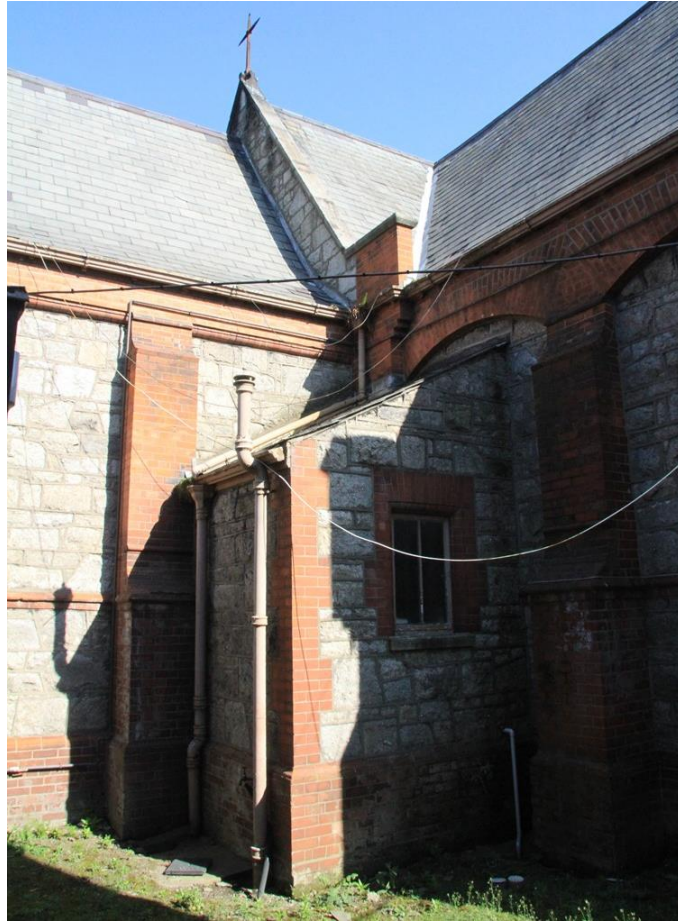
*Plate 12: Lean-to in corner between chancel and transept*

In the corner between the chancel and the transept on the southern side of the chapel there is a small lean-to structure. This is constructed of the same materials as the rest of the chapel, though in a simpler style. The roof is of slate and the walls of rubble granite, rising off a brick plinth. The one free corner has brick quoins. A small cast iron window is set in an ope lined with brick, with ovolo mouldings. The sill is of granite. There is no external door to this projecting element. The gutter is ogee-profiled cast iron and feeds into a cast iron hopper and downpipe; these are fixed to a timber fascia. There is a cast iron soil vent pipe.

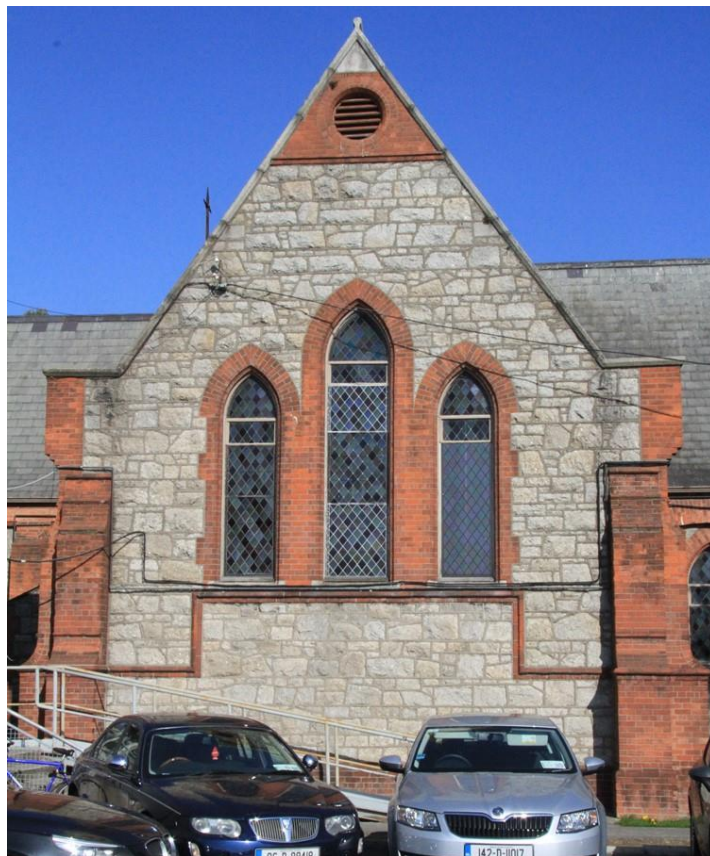
*Plate 15: Gable of transept on south-eastern side of chapel*

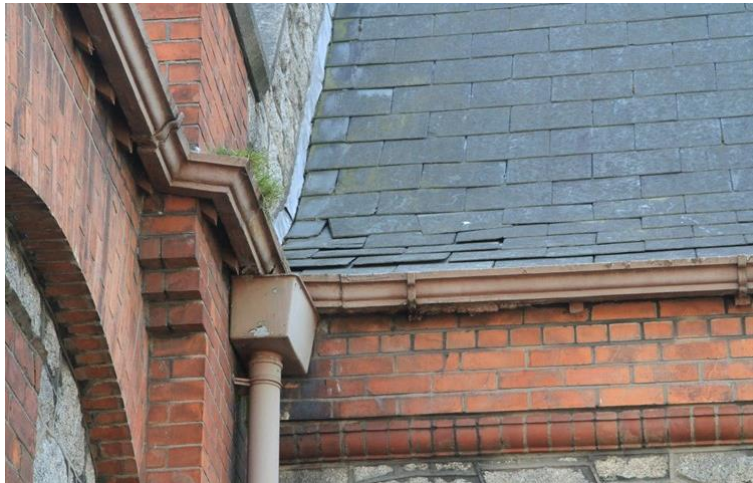
The roof of the chapel is steeply-pitched and has a covering of slate, with sprocketed eaves. The ridge tiles are ceramic, with a roll moulding on the top surface. The gables are parapetted with granite copings and with wing walls terminating the parapets. The gutters are ogee-profiled cast iron.

*Plate 17: Eaves and guttering at junction of transept and chancel*

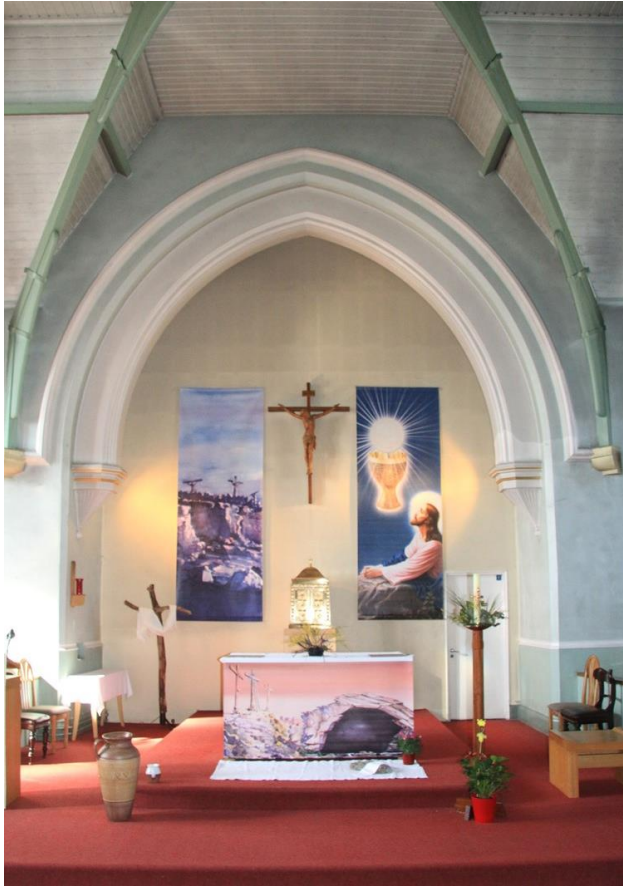
*Plate 21: Chancel arch*

The shallow chancel stands behind a pointed segmental chancel arch with an inner arch supported on conical corbels. A pointed segmental hood mould runs parallel to the chancel arch. Behind the chancel arch the ceiling of the chancel slopes down on either side from a ridge.

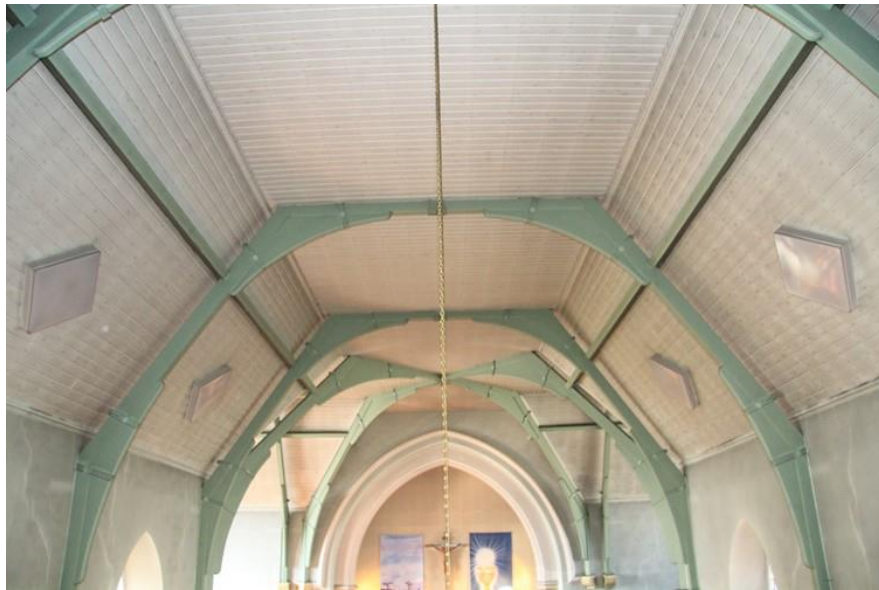
*Plate 25: Ceiling of chapel*

The ceiling of the chapel is clad in timber sheeting, running lengthways down the sloping sections of the ceiling on either side and crossways on the flat section in the centre. High up on the sloping section at a point equivalent to the mid-point of the rafters, a purlin runs on each side of the roof structure. These are supported on a series of trusses running at the intermediate points between the windows and supported on painted granite corbels. Each of the trusses is bound with wrought iron straps at the joints, where they are reinforced by timbers moulded to the angles. At the crossing trusses run diagonally, meeting in the middle, where there is a small pulley, evidently intended for the suspension of a lamp. A cruciform strap is bolted to the trusses where they meet at the crossing. The boarding of the flat sections of the ceiling runs to the intersection of the trusses in the crossing, forming a square pattern towards the centre.

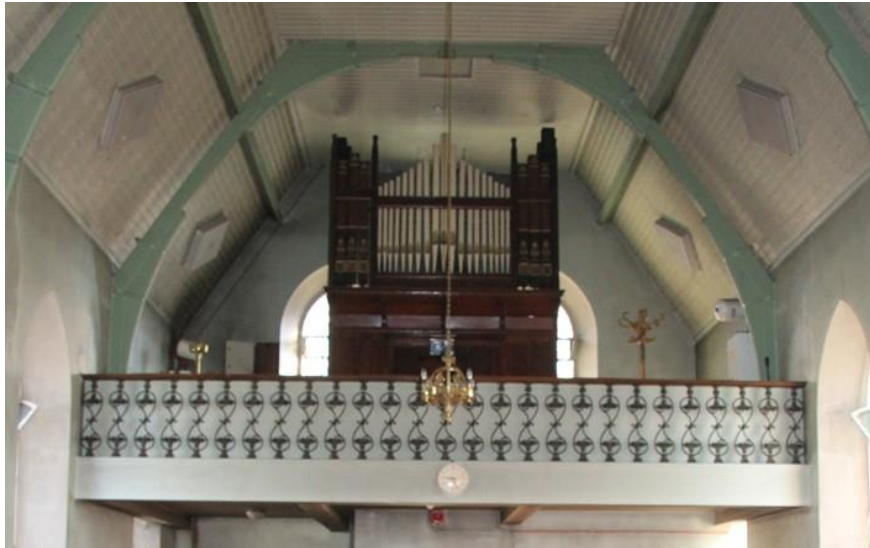
*Plate 28: Balcony or organ loft*

The balcony at the rear of the chapel, over the entrance porch, runs forward across the first window to a point just short of the second window ope. At the front of the balcony is a balustrade with decorative cast iron balusters supporting a timber handrail.

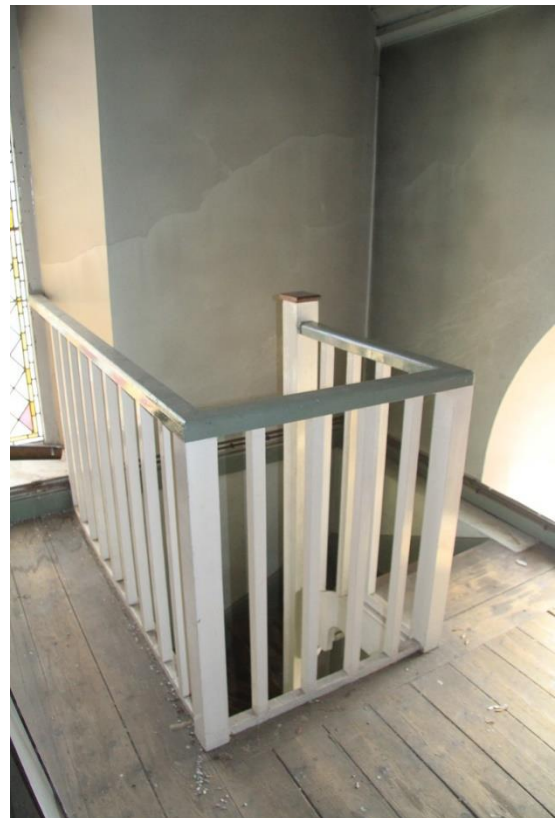
The balcony is accessed via a winding stair guarded at the top by a simple balustrade with stick balusters.

*Plate 29: Balustrade at stairs*

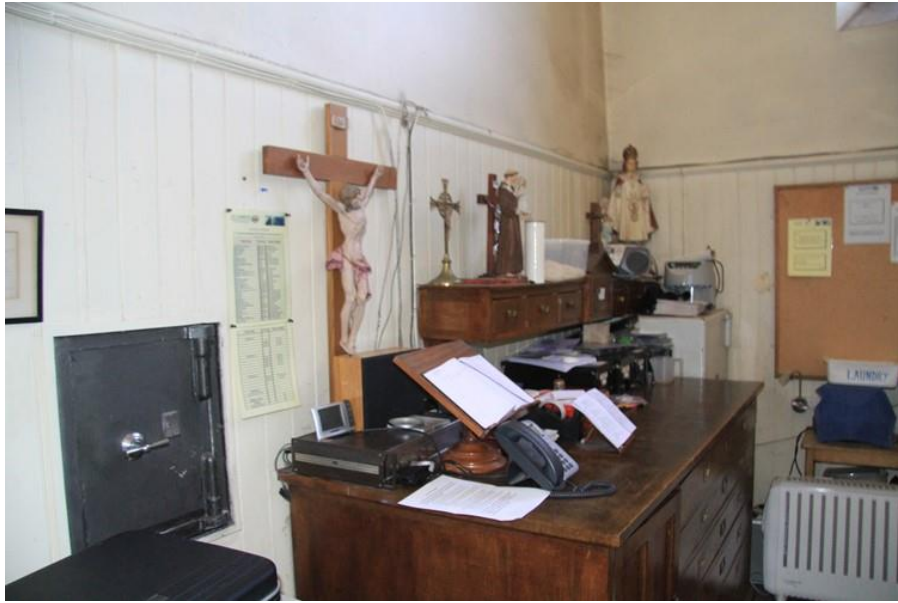
The sacristy is generally plain with no decorative features or fixtures. There is no hearth or chimneypiece, notwithstanding the presence of a chimney stack on the apex of the gable. The only surviving early features are two doors, examined below, and tongued and grooved wainscoting that covers the three external walls to above the heads of the doors. This extends into the doorway leading to the WC, described below.

*Plate 34: Wainscoting on external walls of sacristy*

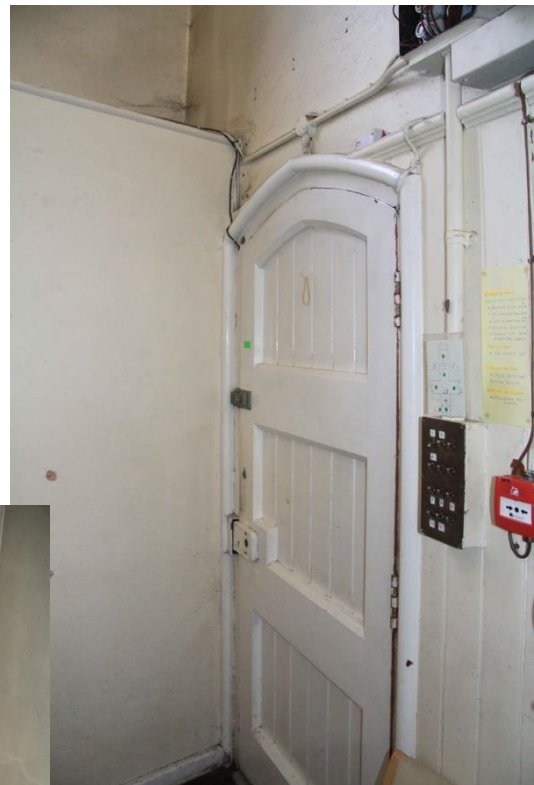
There is an external door on the north-western side of the sacristy. This is a framed and sheeted door with a segmental head, set in a timber architrave with roll moulding.

*Plate 35: External door*

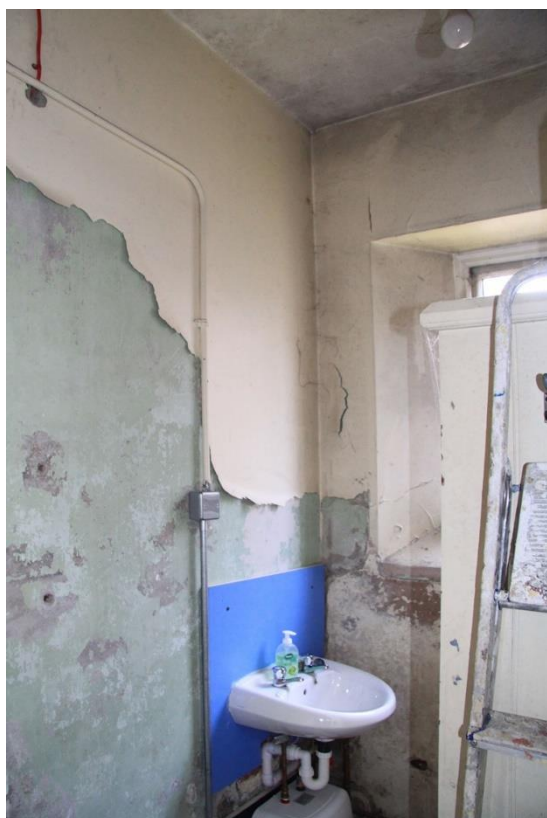
The wc is lit by a timber casement window in a simple splayed opening. The sanitary fittings are of more recent date, probably late twentieth century. There is a significant level of damp in this wc. There is also paint peeling from the walls, probably through inappropriate choice of paint type and damp.

*Plate 39: WC in lean-to to side of sacristy*

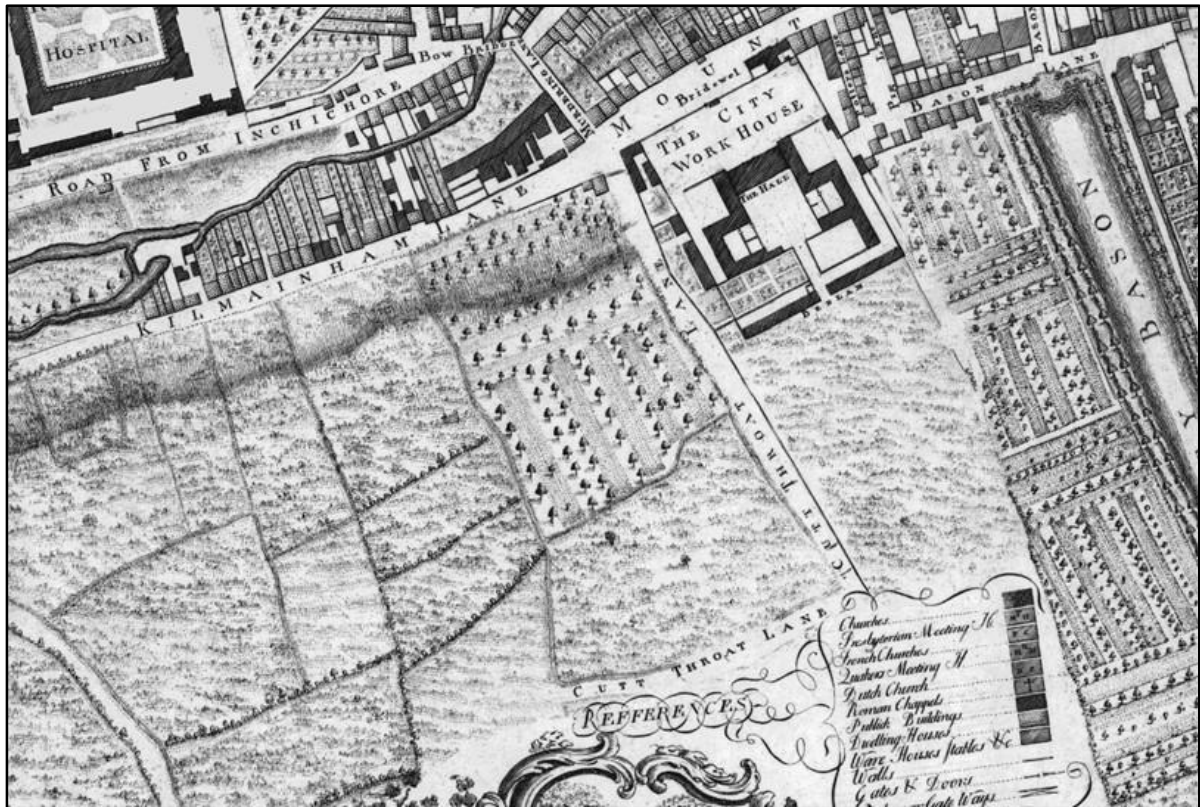
Figure 1: Rocque's map of 1756

The majority of maps of Dublin city that were published in the eighteenth and early nineteenth centuries restricted their area of coverage to the built-up area of the city and did not extend as far west as Garden Hill. Some did, however, as these show the site as it was on various dates. John Rocque's maps of Dublin city, published in 1756, and Dublin county, published in 1760, show the future site of Garden Hill – on the 1756 map it is at the western margin. The land is depicted as fields on the maps and no buildings were shown.

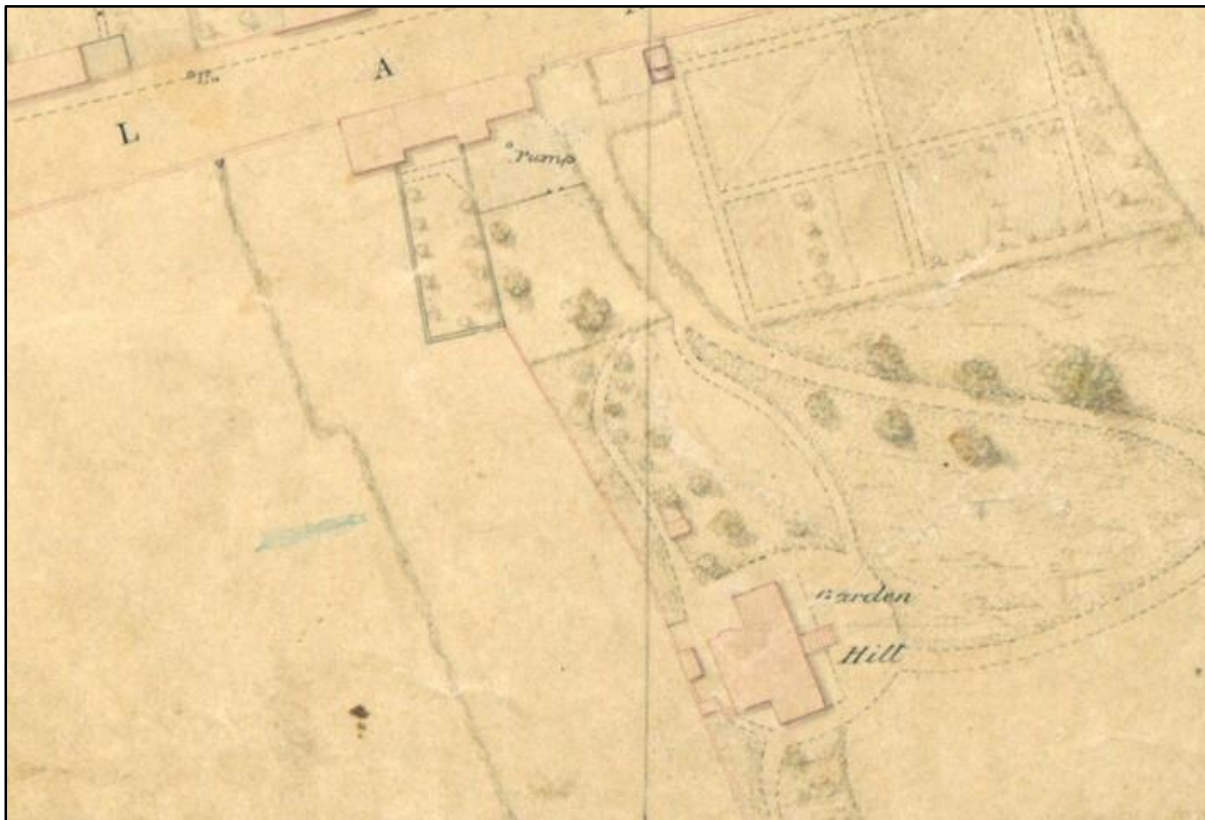
*Figure 3: Detail of OS manuscript map 22, 1838-43*

The first map evidence for the existence of Garden Hill appears on the unpublished Ordnance Survey six-inch map of 1837. This is seen more clearly in the larger scale manuscript map produced in the following year by the Ordnance Survey and this was updated in 1843. Garden Hill may be seen in the extract below.

The house appears at the bottom left of the map and hence is off-centre in the extract above. The extract shows the house approached from Mount Brown by a long curving driveway through gardens.

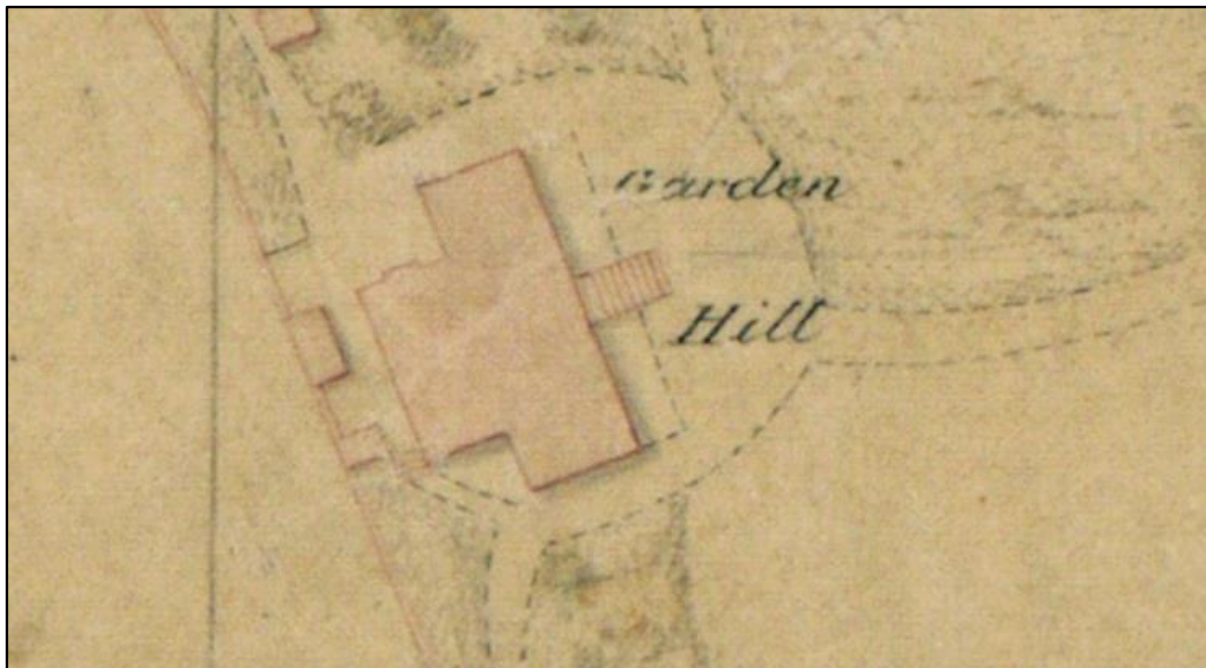
*Figure 4: Enlarged detail of Ordnance Survey map of 1838-43*

The enlargement of this map reproduced above shows the house as T-shaped, with a slight projection on the northern side of the projecting rear return. A flight of steps leads down at the south-western corner of the house.

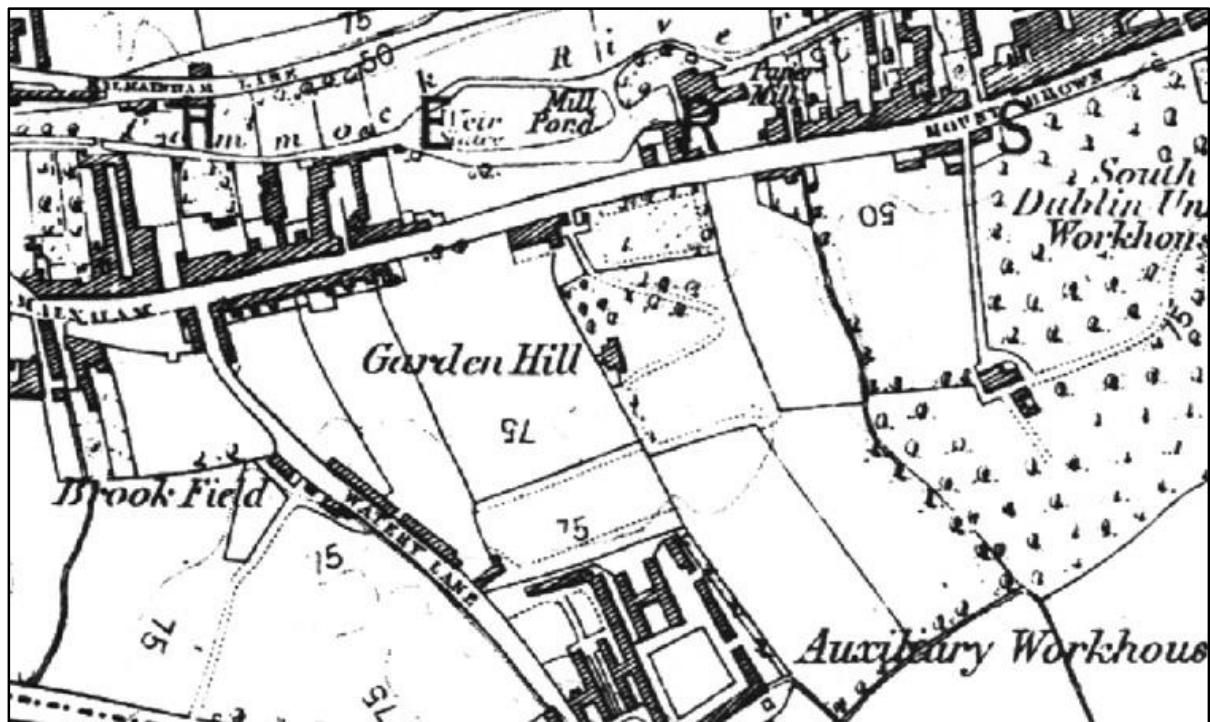
*Figure 6: Detail of OS map of 1876*

The Ordnance Survey map of 1876, reproduced below, shows the house and its grounds at that date. The house is still depicted as having a narrower rear section, as shown on the earlier maps.

A major change that is seen on the 1876 map is the appearance of an auxiliary workhouse on the land to the south of Garden Hill, off Watery Lane and South Circular Road.

The architectural evidence supports this suggested original layout and the dating. It is evident in the plan in figure 11 above that the windows on the rear elevation are concentrated within the coloured area. It was also noted in the building survey descriptions of the chimney stacks, as given above, showed that those in the front section of the house are quite different to those at the rear – the latter having a later style and simple cylindrical pots, which are also indicative of a later period. The northern chimney stack in the rear of the house is not located on the northern gable, but a distance in from the gable. This corresponds with the suggested original end of the building and it is noted that the large-scale Ordnance Survey maps reproduced in figures 5 and 6 above show a projecting chimney stack on the northern elevation at the rear.

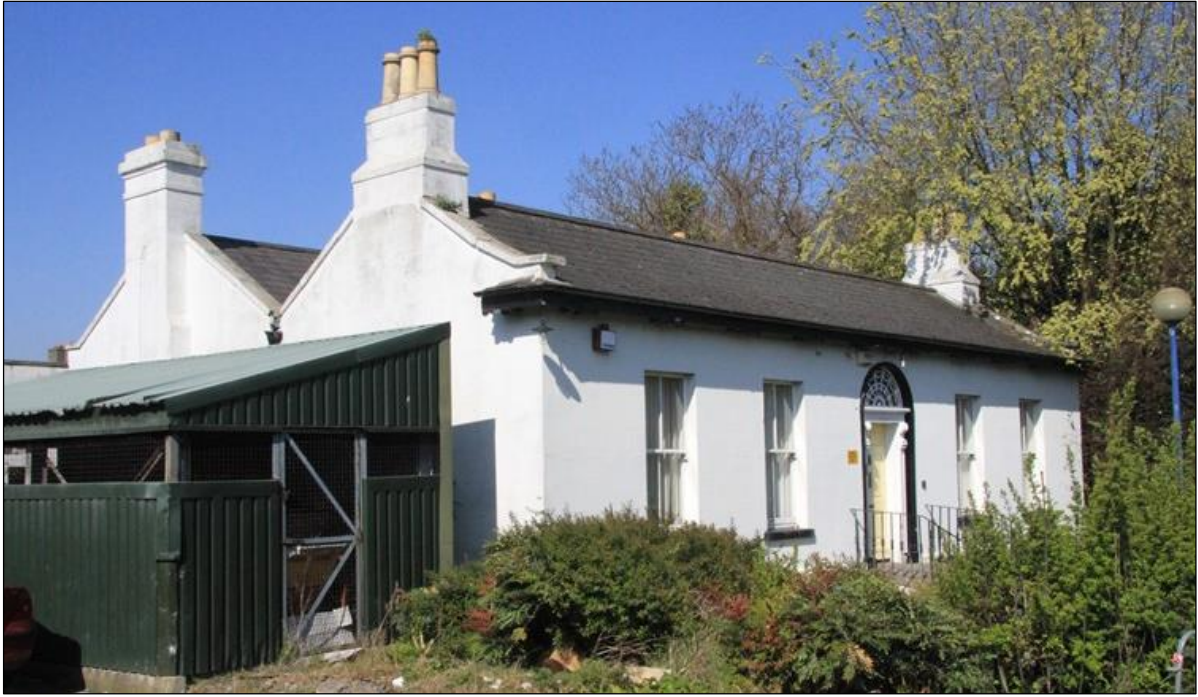
*Plate 1: Garden Hill, seen from the south-east*

Garden Hill is a double-pile, five-bay, single-storey over basement villa-type house dating from the second quarter of the nineteenth century. The façade is rendered, ruled, lined and painted on both levels, with a projecting stone string course at entrance floor level. The four windows in the front façade on the entrance floor are two-over-two timber sliding sashes, while those at basement level are similar, though smaller.

The front door is approached via a broad flight of seven granite steps flanked by wrought iron railings with a wrought iron hand rail and with a volute at the lower end on each side. The mid-point of each baluster is marked by a cast iron boss. The front door has six raised-and-fielded panels and is flanked by timber pilasters carrying scroll brackets supporting a frieze and simple cornice. The doorway is surmounted by a near-semi-circular fanlight with its original divisions. The whole assemblage is surrounded by a plaster roll moulding and sits on a pair of plinths. The roof has a moderately low pitch and is slated with ceramic ridge tiles; the eaves are sprocketed. The parapet walls at the gables are capped with painted granite coping stones. The rainwater goods are of cast iron and the gutters are held on a timber fascia; the soffit has paired scrolled brackets.

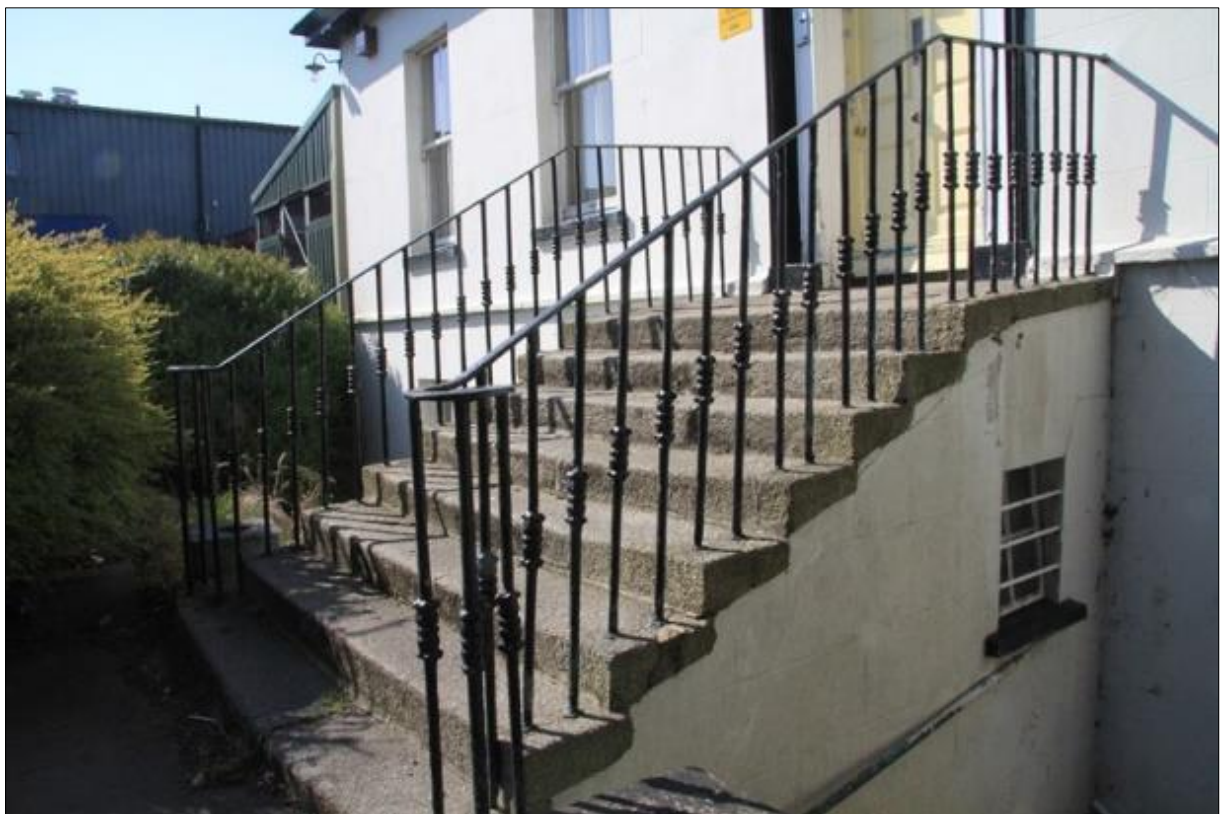
*Plate 3: Steps to front door*

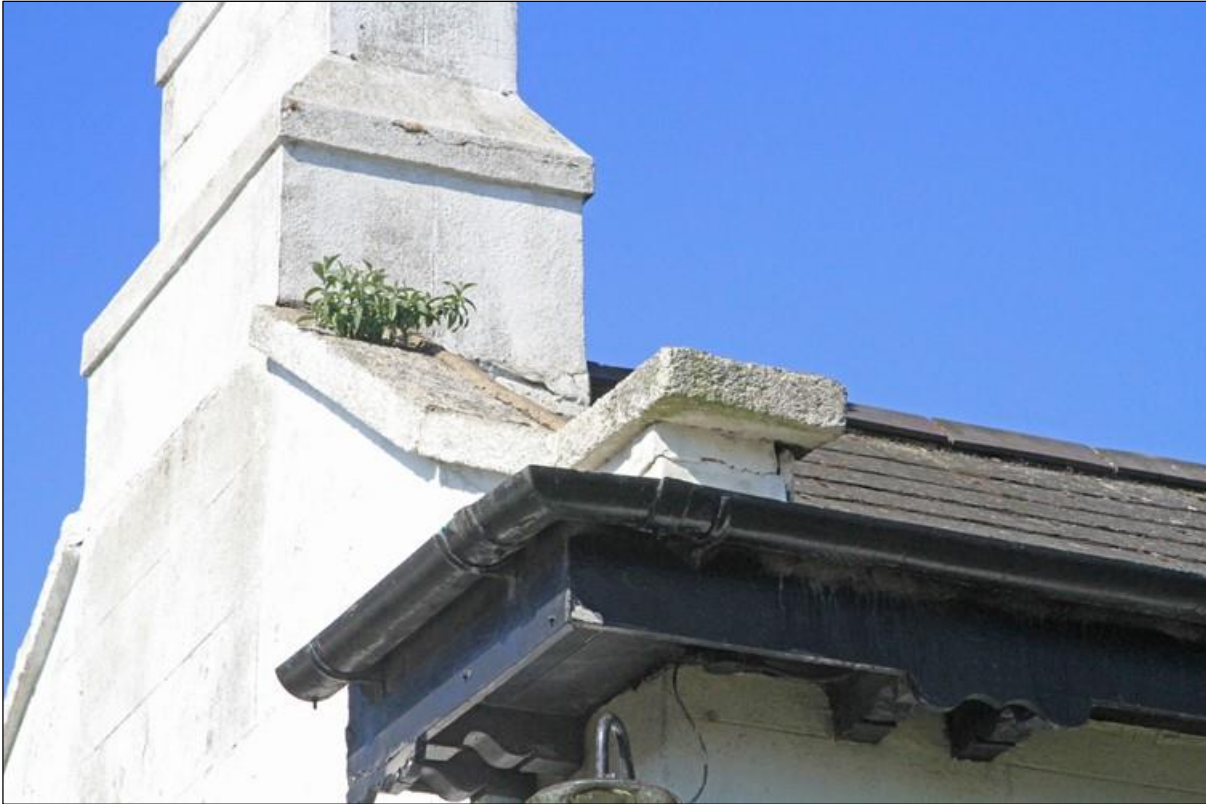
*Plate 6: Gable and chimney stack*

The front section of the roof has chimney stacks at the gables, rising from the ridge. These rise straight from the top of the gable as broad stacks before reaching a slender moulding, above which they narrow by means of a pyramidal fillet, to a more slender stack, finishing with a slightly-projecting broad moulding. Each stack carries three Dublin-style pots in a straight line.

The stacks on the rear section of the roof are quite different, the shafts rising through the full height with the basic width unchanged, except for a slight projecting moulding as a collar and a corbelled section near the top. The stack on the southern gable end at the rear projects from the gable through its full height and carries two simple cylindrical pots. Two further stacks rise from the ridge of the rear section and both are of similar style to the southern stack, though wider and carrying three cylindrical pots each. There is no stack on the northern gable at the rear.

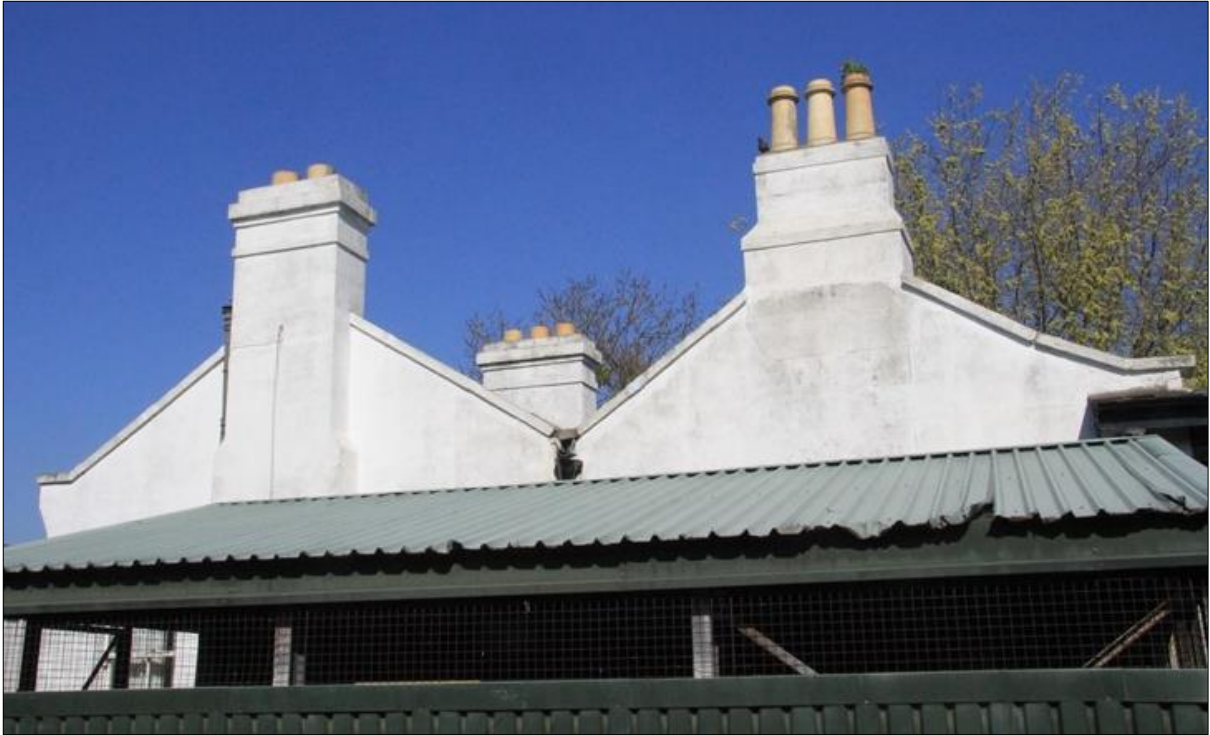
*Plate 7: Southern gable end*

At the southern gable end a drain runs from the central valley and feeds to a cast iron downpipe. A cast iron soil stack rises alongside the projecting rear stack on this elevation and vents above roof level.

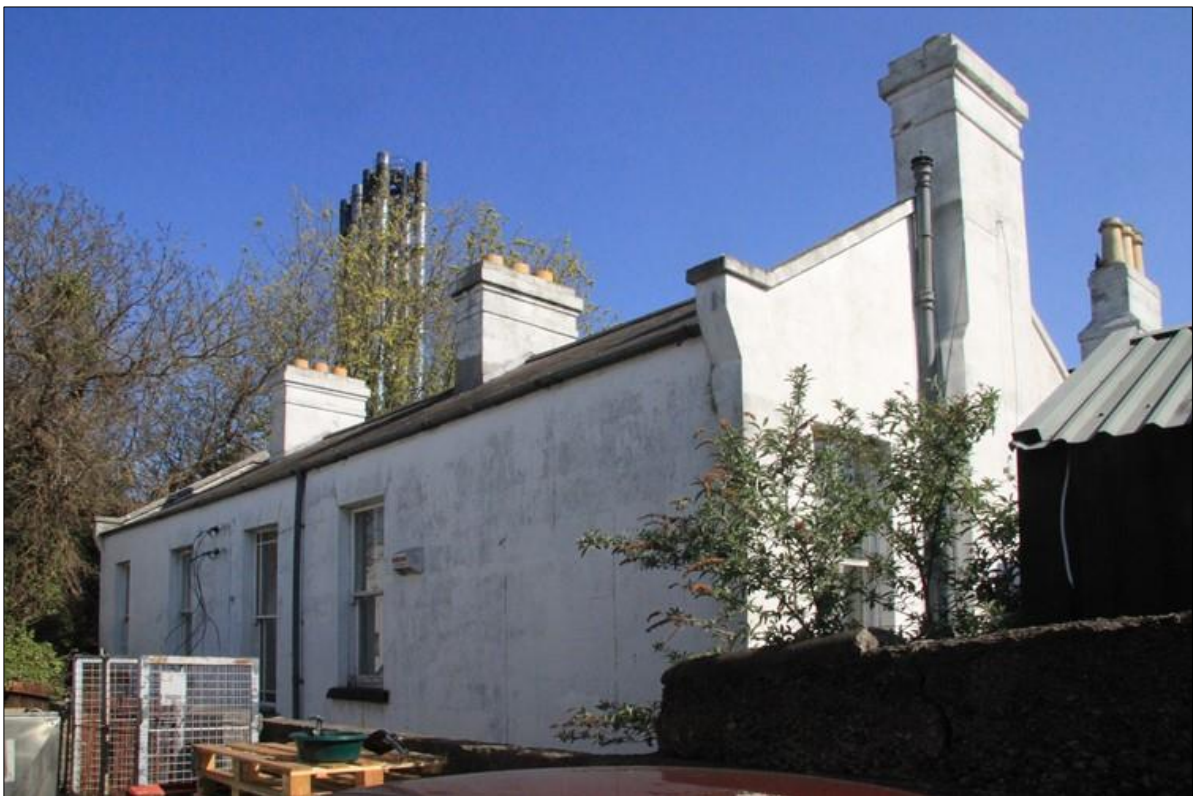
*Plate 8: Rear of Garden Hill, viewed from the south-west*

At the rear of the house there is an asymmetrical array of windows on the upper level, with a blank wall facing the rear towards the southern end. There is a scar in the render near the southern end that suggests there was a window here in the past. The head of this apparent window seems to have been lower than the other windows and would have been near the level of the mid-point of the upper sash of the adjacent surviving window.
