# National Paediatric Hospital Project

## Planning Application

### Appendix 16.1 – Chapel Survey

## Appendix 16.1 Chapel

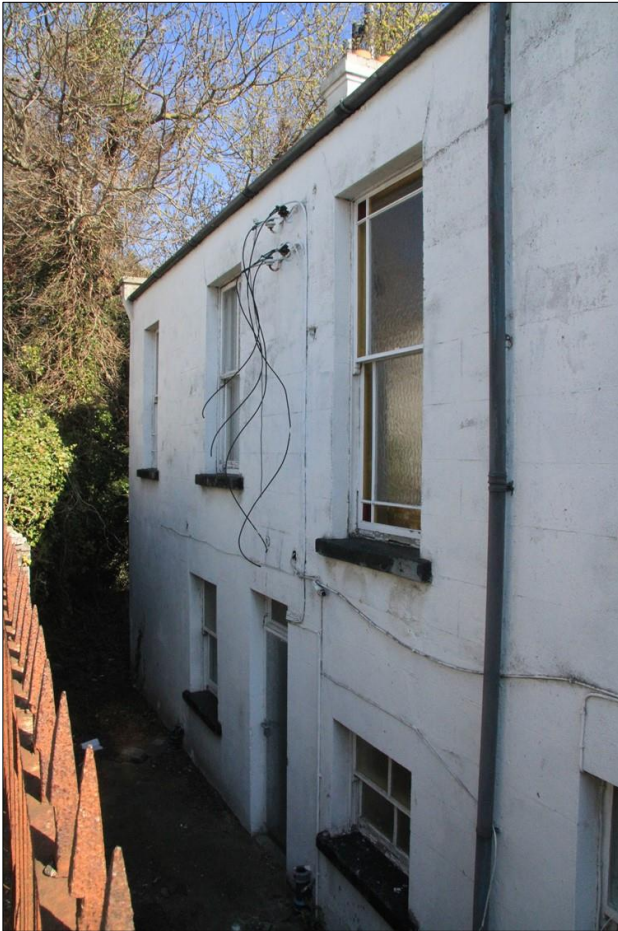
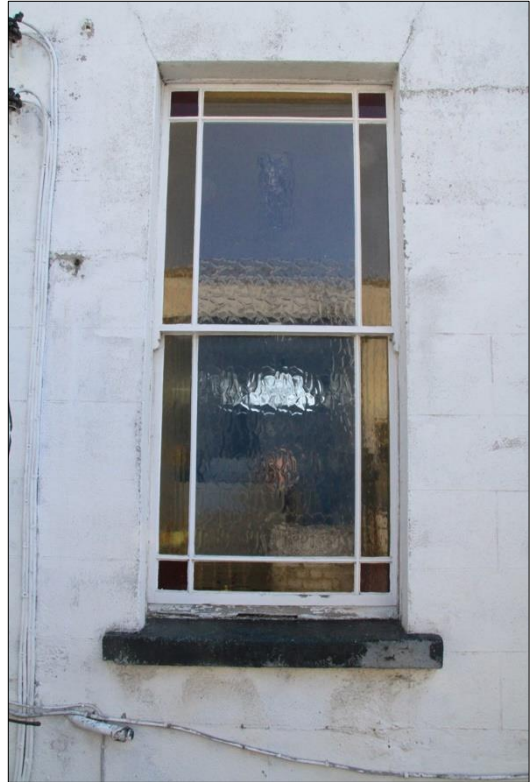
*Plate 10: Staircase window*

The staircase window has obscured glass central panes with coloured glass margin lights.

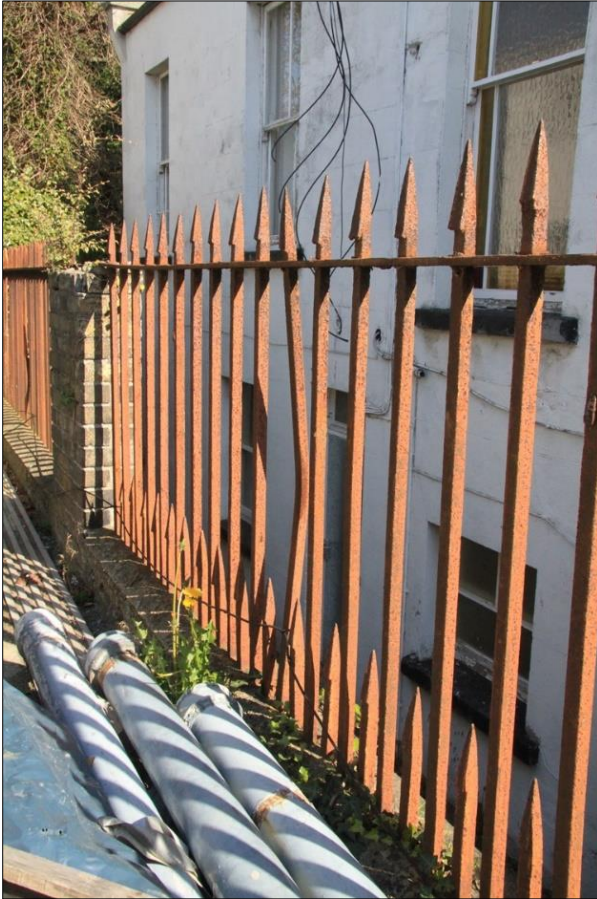
The basement at the rear of the house is below ground level, with a narrow basement area. This area is protected by a wrought iron railing with spiked finials and intermediate spikes on the bottom rail. Mid-way across the width of the house there is a pier of yellow Dolphin's Barn brick, while towards the southern end the railing gives way to a wall faced with sand and cement render and with a rounded top.

*Plate 13: Railing at rear of Garden Hill*

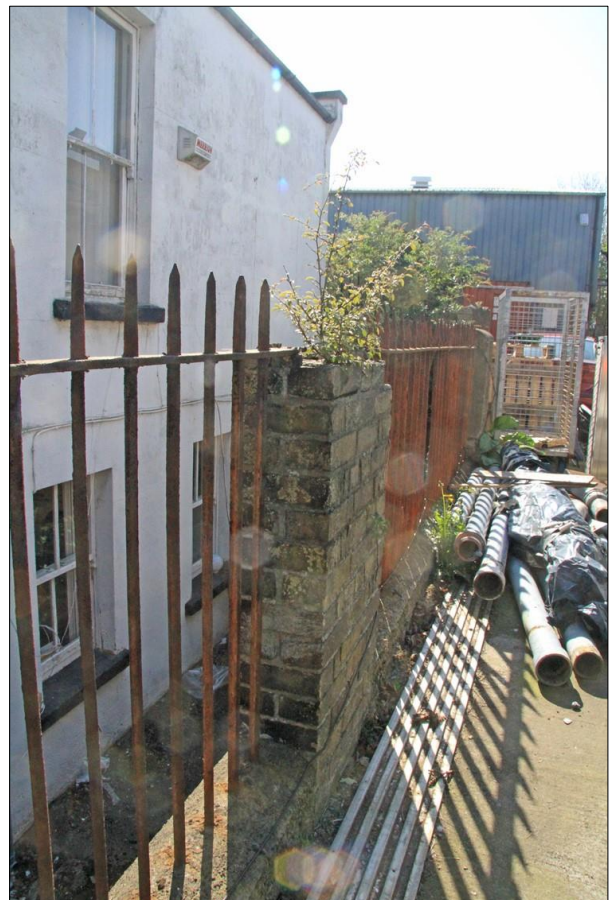
*Plate 14: Railing and brick pier*

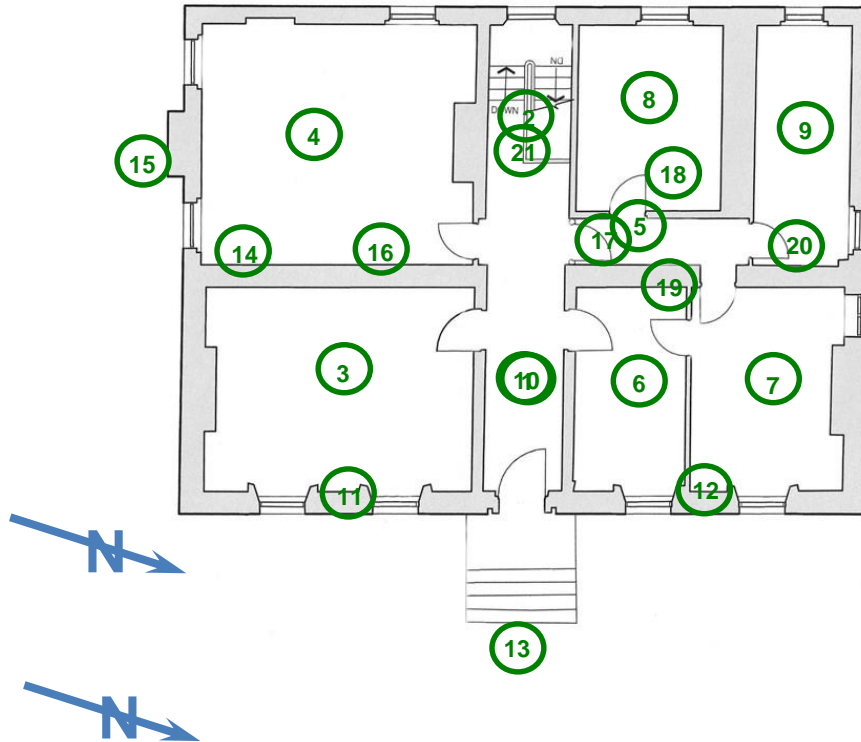
The floor plans below show the rooms on each of the two floors, with the room numbering adopted for the purposes of this report.

*Figure 8: Floor plan at entrance level*

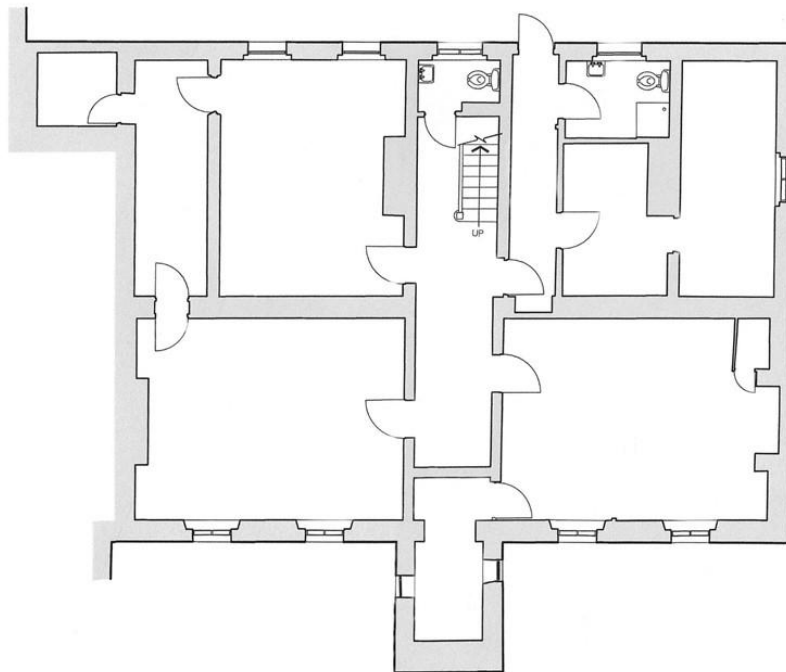
*Figure 9: Floor plan at lower level*

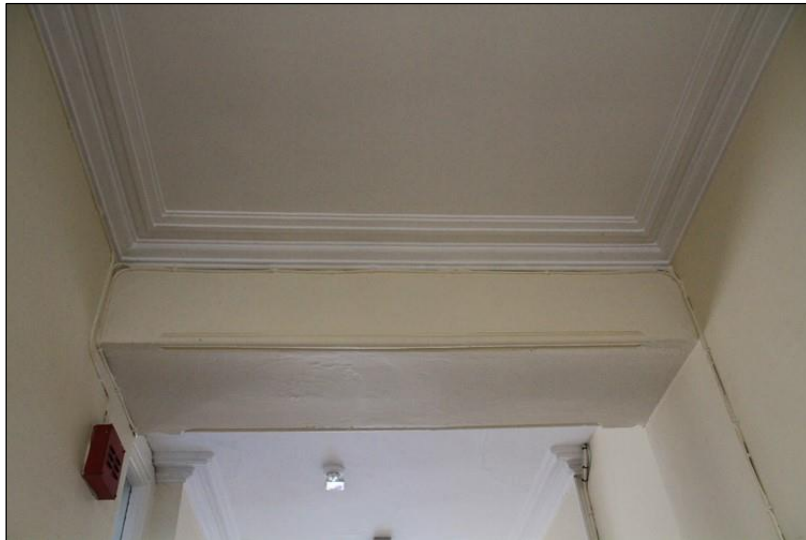
At the rear of the hall there is a beam projecting down from the ceiling and this has stopped roll mouldings at the two visible edges. A doorway leads off the hall on either side, immediately to the front of the beam. Each of these doorways has a moulded timber architrave and a six-panelled door.

*Plate 18: Beam at rear of front entrance hall*

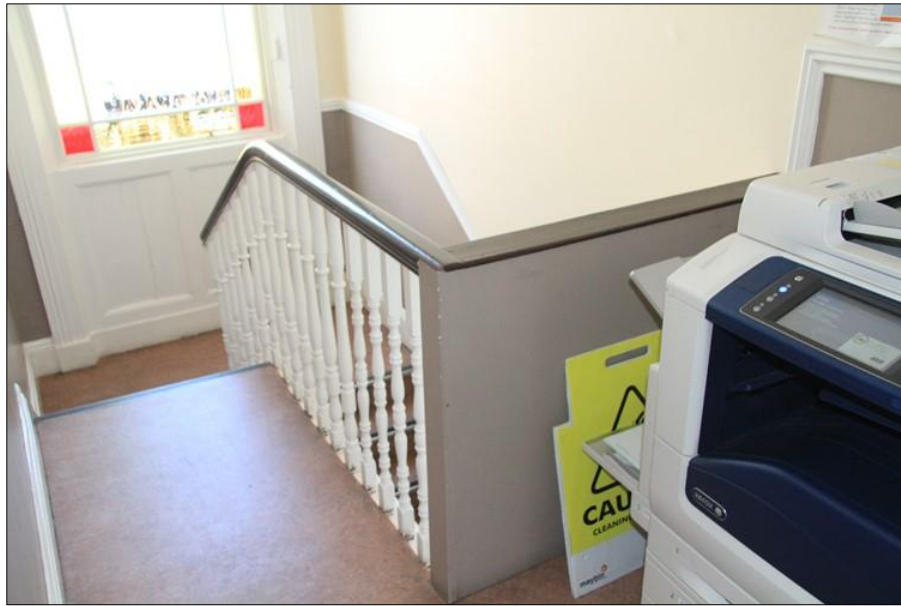
*Plate 21: Upper level of staircase*

The staircase leads down at the rear of the entrance hall. This is an open-string staircase with plain tread-ends and with turned balusters supporting a hardwood handrail. The return of the balustrade at the rear of the entrance hall is solid. The stair leads down through a dog-leg to the floor below.

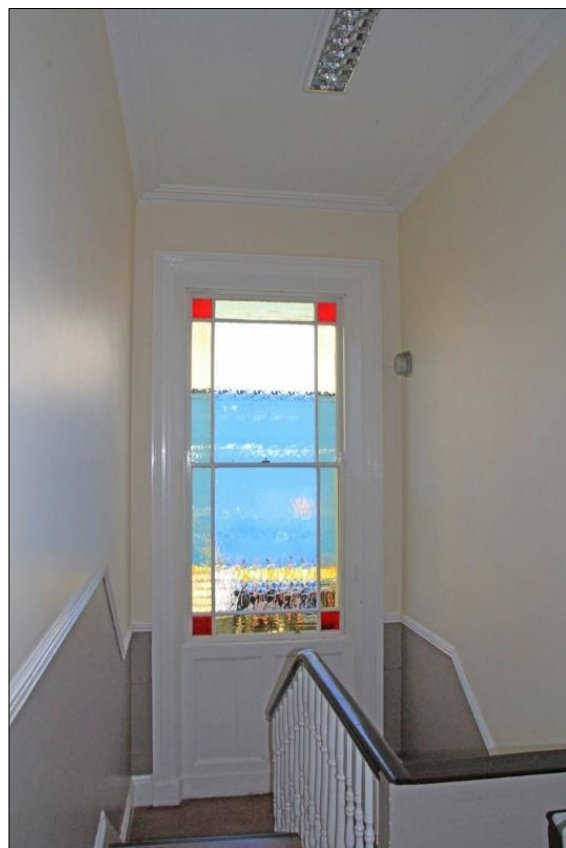
*Plate 22 (above): Window above staircase*

At the turn in the stair there is a timber sash window with a large central pane of obscured glass in each sash and with coloured side-lights. The window is set in a moulded timber architrave and below it is a panelled base board.

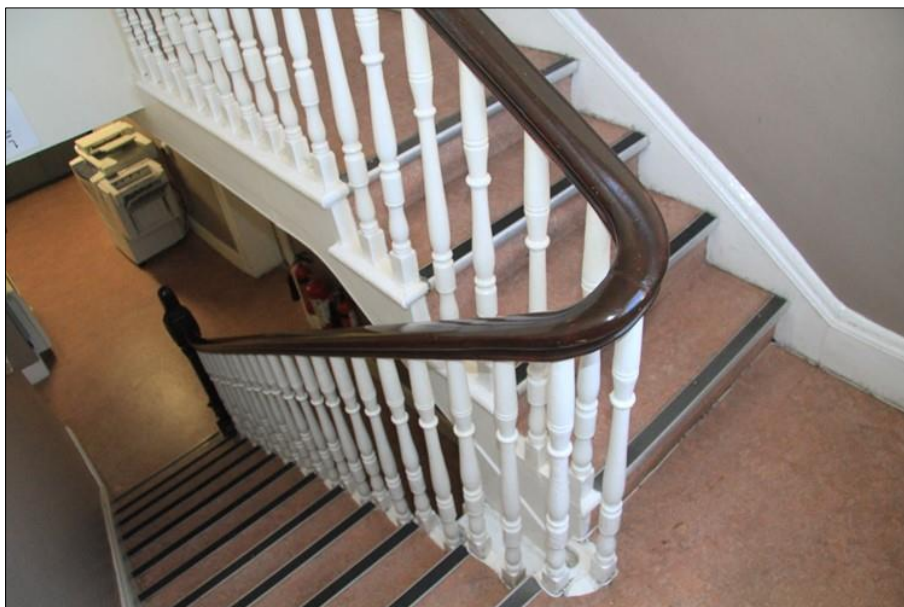
*Plate 24: Turn of balustrade at half landing*

The balustrade runs through a curve at the turn in the stair and at the base it terminates at a substantial turned newel with a finial. This newel is unusual for the period of the house and may have been inserted later in the nineteenth century.

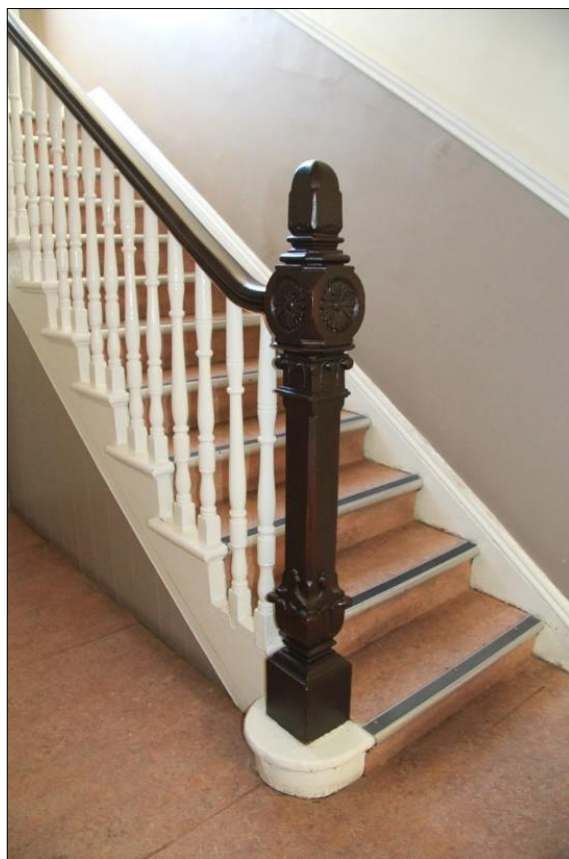
*Plate 25: Newel at foot of stairs*

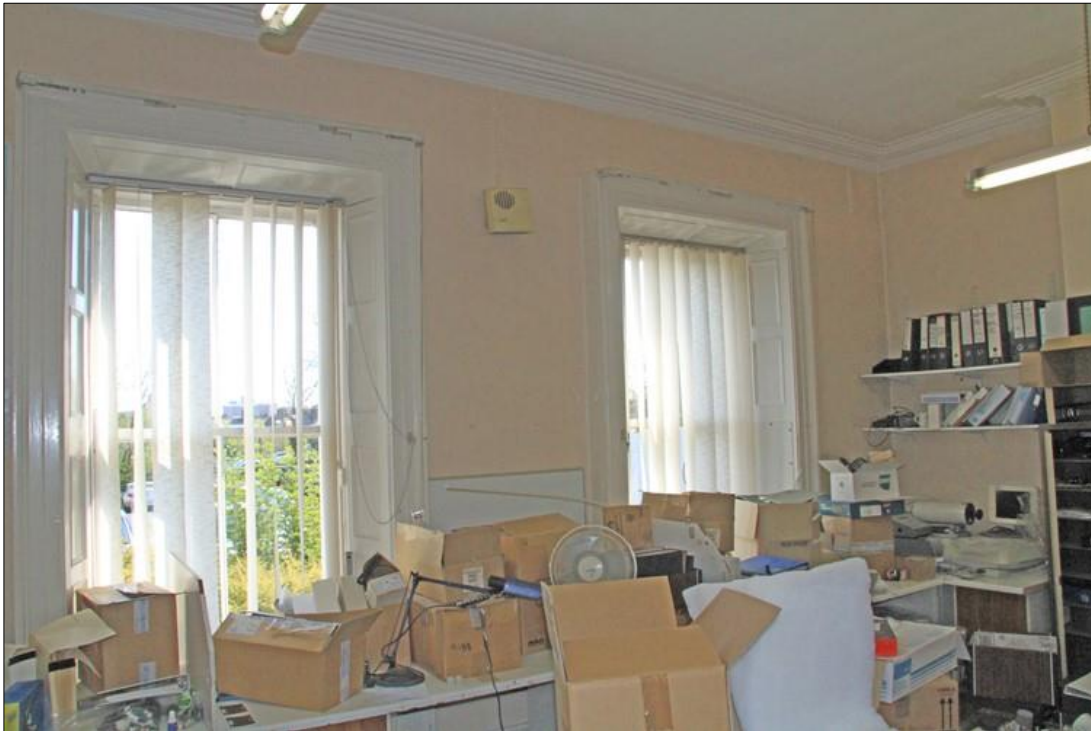
*Plate 27: Windows to front*

The larger front room is in the south-eastern corner of the house. It has two windows facing the front, each of which is a two-over-two timber sliding sash, set in a moulded timber architrave and with panelled shutters. There is a plain run cornice and no centrepiece to the ceiling. A chimneybreast projects into the room from the southern wall, though the hearth has been stopped up and there is no chimneypiece.

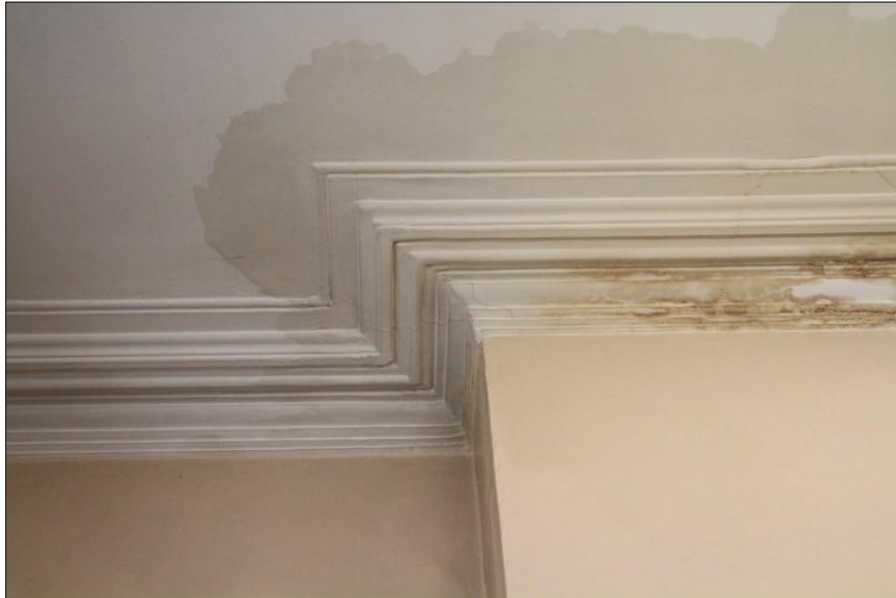
*Plate 29: Cornice over chimneybreast*

There is staining over the chimneybreast, suggesting that there is a problem with the flashing of the chimneystack, or some similar problem.

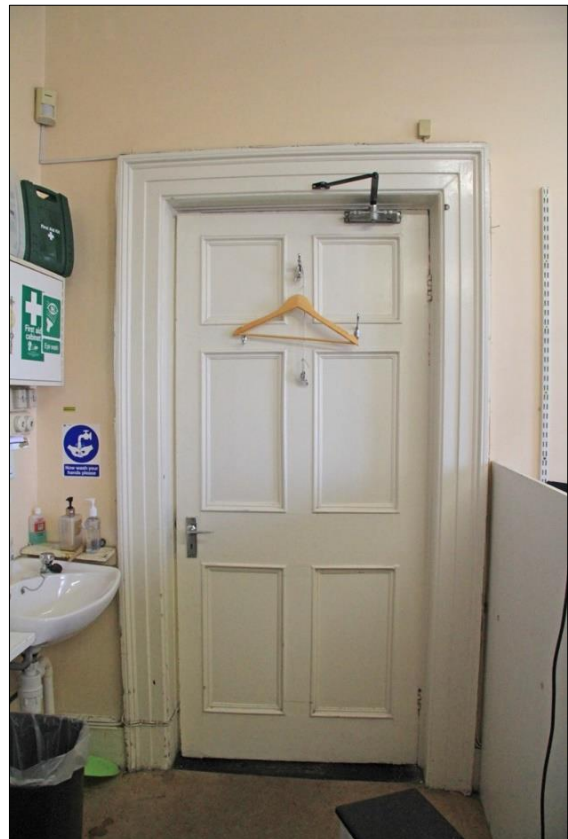
The door from the entrance hall is six-panelled and is set in a moulded timber architrave. The door set is chrome plated and is of later twentieth century date. There is a self-closer at the top of the door.

*Plate 30: Door*

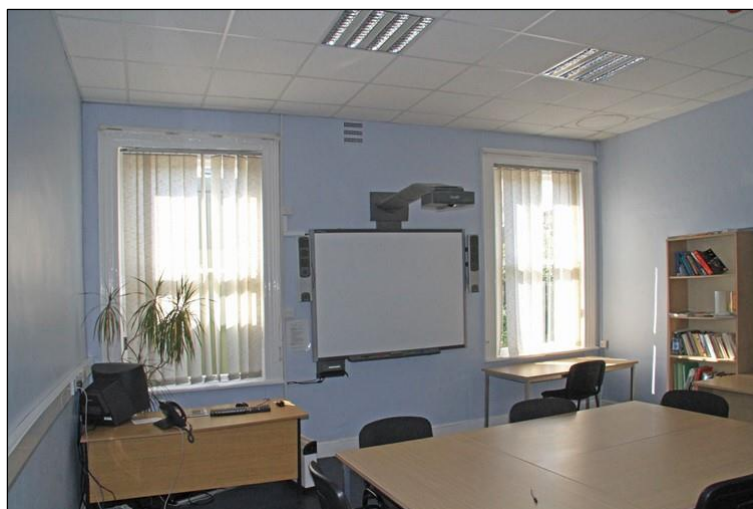
*Plate 32: Southern wall of room 4*

The larger room at the rear is in the south-western corner of the entrance level. This room has two windows in the gable end of the house, facing south, and one at the northern end of the rear elevation. Each of these windows is a two-over-two timber sliding sash with curled horns and is set in a moulded timber architrave without shutters.

The ceiling in this room is suspended, with acoustic tiles and recessed fluorescent light fittings. A chimneybreast projects into the room from the northern wall, but the hearth is stopped up and there is no chimneypiece.

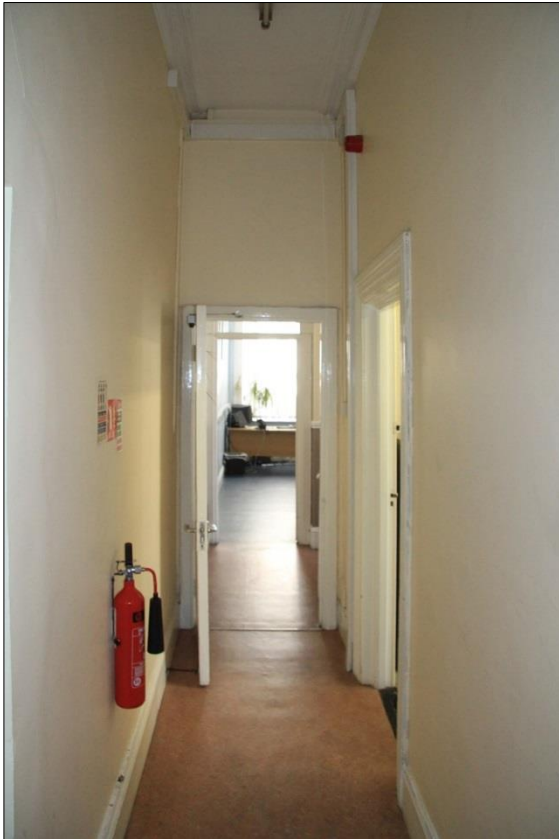
*Plate 35: View northwards along corridor*

Leading off the rear of the hall towards the north there is a doorway to a corridor, which in turn gives access to two small rooms. The doorway has a simple architrave on each side, without mouldings; the door is six-panelled. This corridor has a simple run cornice on either of the long sides of the ceiling, though not on the short sides. The wall between the corridor and the hallway appears to be a later partition.

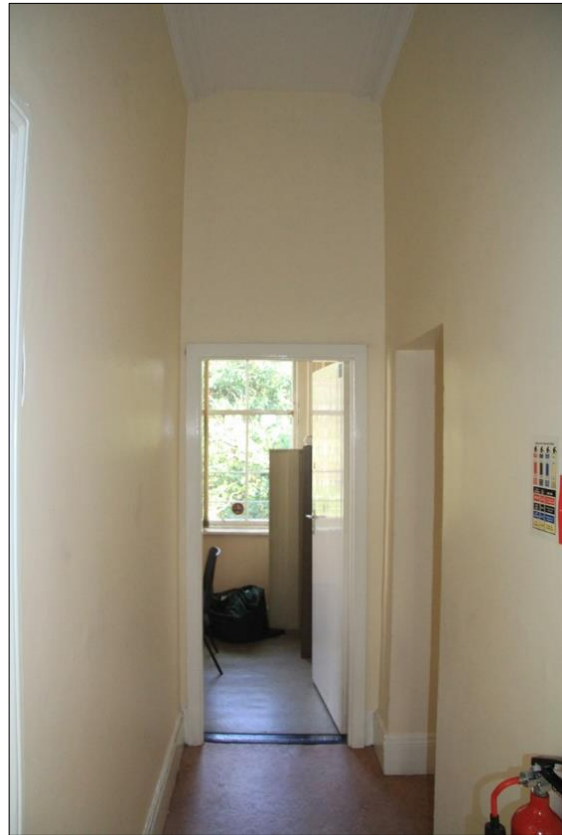
*Plate 36: View southwards along corridor*

The doorway at the southern end has a simple architrave without mouldings and a hollow door of late date. A doorway without architrave leads to room 7 at the front of the house. A doorway with moulded timber architrave leads to room 8 at the rear.

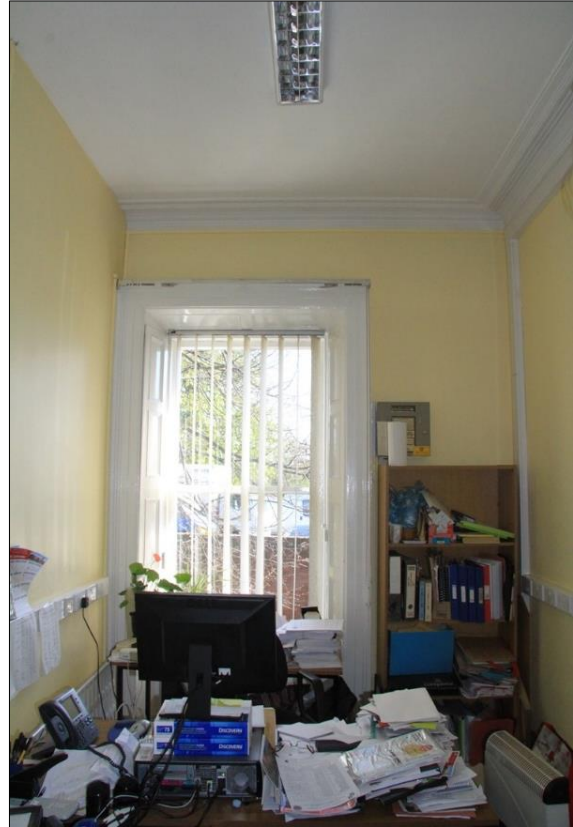
*Plate 38 (above): Front of room and window*

The window faces the front of the building and is a two-over-two timber sliding sash with curled horns, set in a moulded timber architrave with panelled shutters.

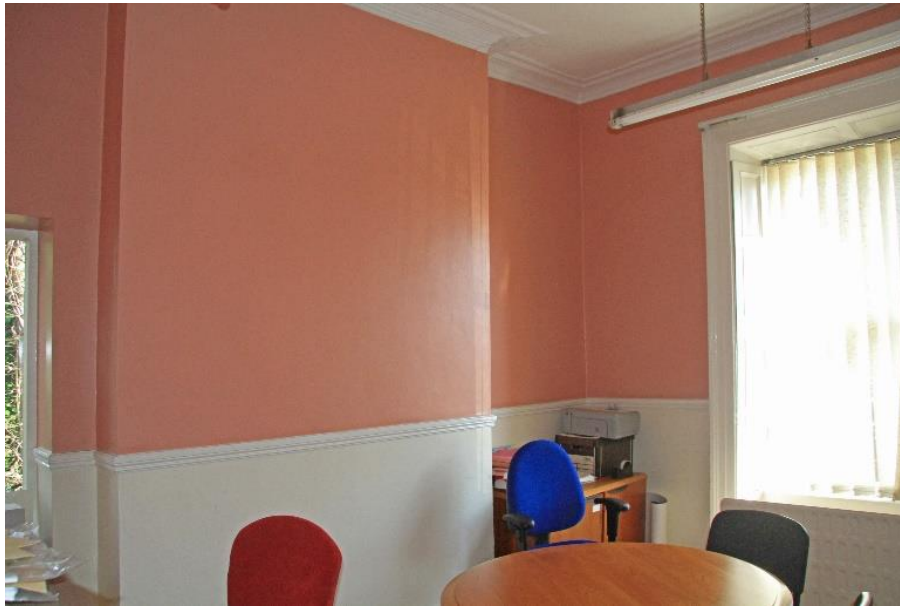
*Plate 41: North-eastern corner of room*

The small office at the north-eastern corner of the entrance floor has a chimneybreast projecting into the room on the northern gable end wall, though the hearth is stopped up. There is a small timber casement window to the western side of the chimneybreast. There is a simple run cornice around three sides of the ceiling, the exception being the partition wall separating this room from room 6, in which there is a doorway with a hollow door and a plain timber architrave. A similar doorway with a hollow door and simple timber architrave leads to the corridor at the rear (room 5). There is a simple timber dado, apparently of late date.

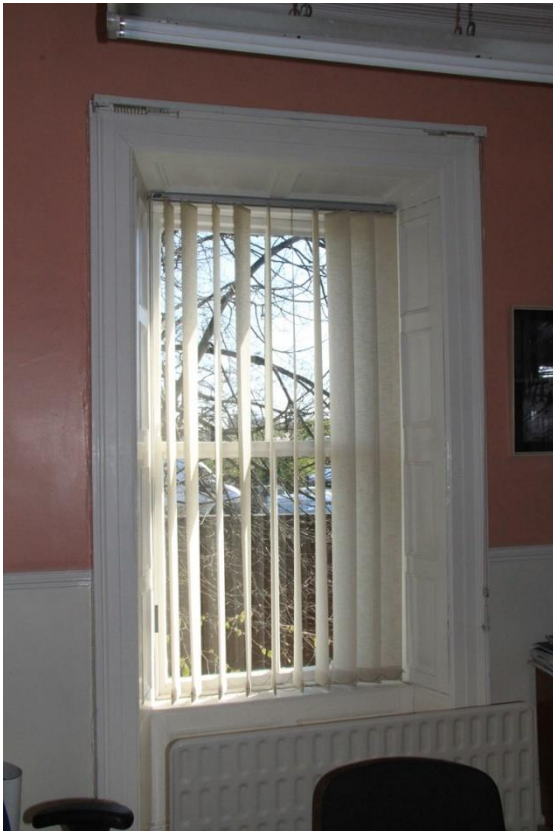
*Plate 42: Western wall with door to rear*

The north-facing casement window is visible at right in the photograph above.

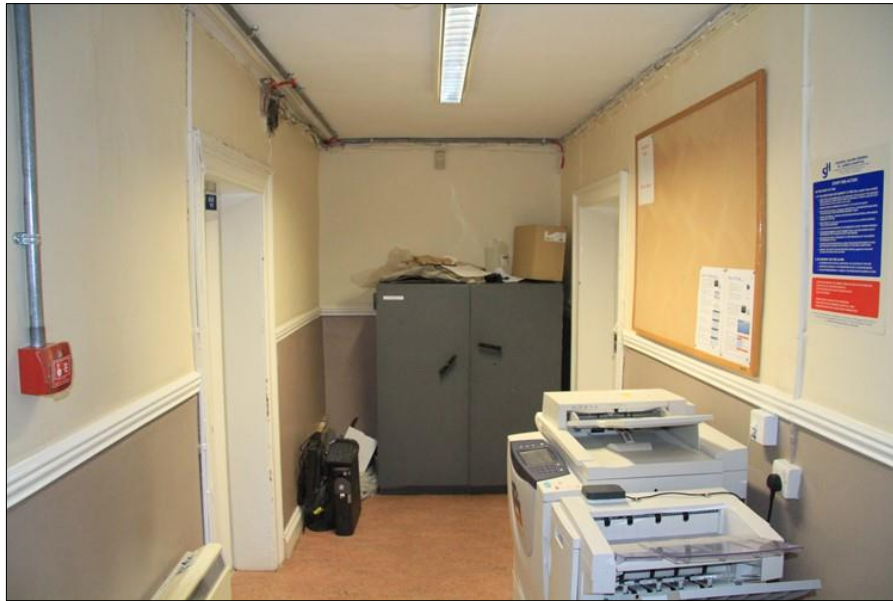
*Plate 53: Corridor on lower level*

At the foot of the stairs on the lower level there is a corridor leading back towards the front of the building. This is an enclosed space with no windows, other than the window at the half-landing above. There is no cornice. There is a dado rail, probably of late date.

Four doorways lead off this corridor, three of which have moulded timber architraves. The exception is the doorway leading towards the north at the foot of the stairs.

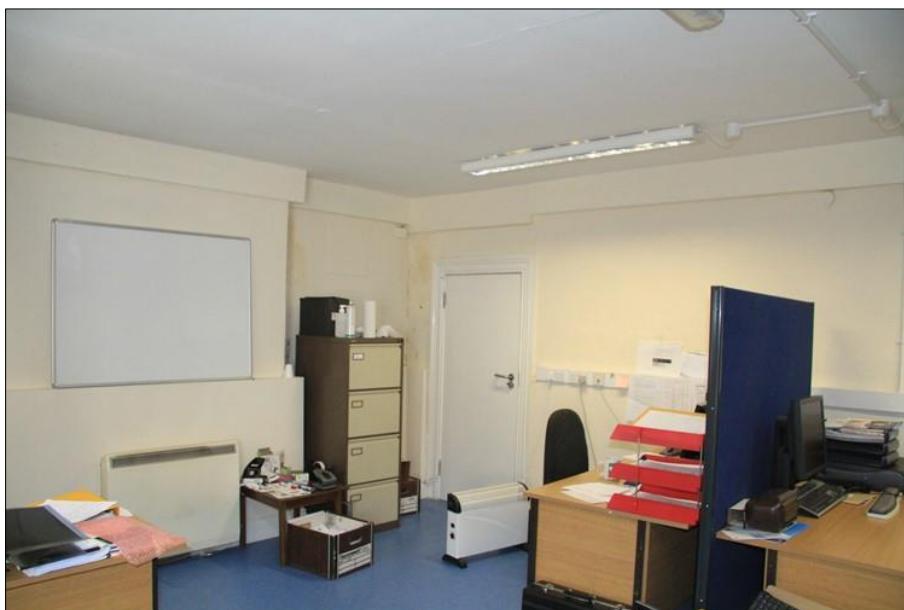
*Plate 55: South-western corner of front room*

The front room on the southern side of the lower floor is in use as an office. There is a projecting chimneybreast on the southern wall, though the hearth has been stopped up. The room is entered via doorway in the middle of the northern wall. The door is six-panelled and there is a moulded timber architrave. Another door, also with a moulded timber architrave, leads towards the rear from the south-western corner of the room. This has a solid door and leads to room 14. The two windows to the front of this room are two-over-two timber sliding sashes without

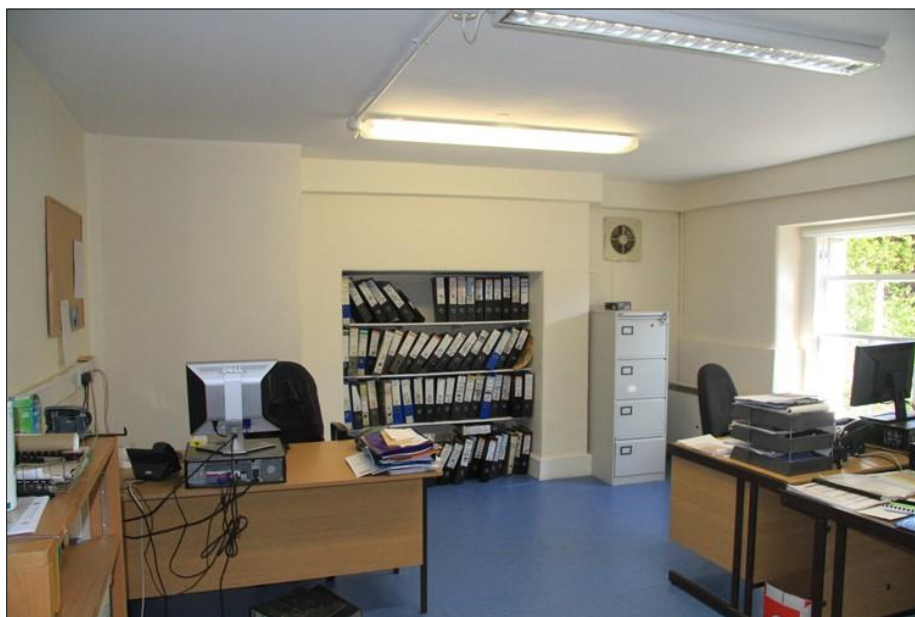
*Plate 59: Northern wall, with hearth*

The front room in the north-eastern corner of the building has two windows facing the front, both of which are two-over-two timber sliding sashes with curled horns and without architraves or shutters. This appears to have been the original kitchen, as there is a substantial open hearth on the northern wall, now converted to book shelves and seen in the photograph below.

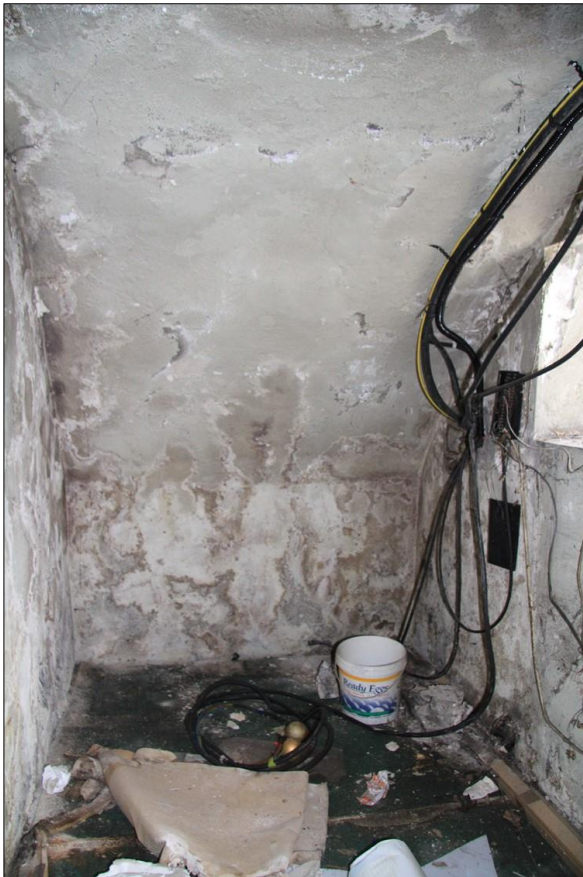
The area beneath the steps to the front door is plastered and painted, the soffit of the steps being vaulted. There is extensive evidence for damp, with the walls blistering and the plaster bursting.

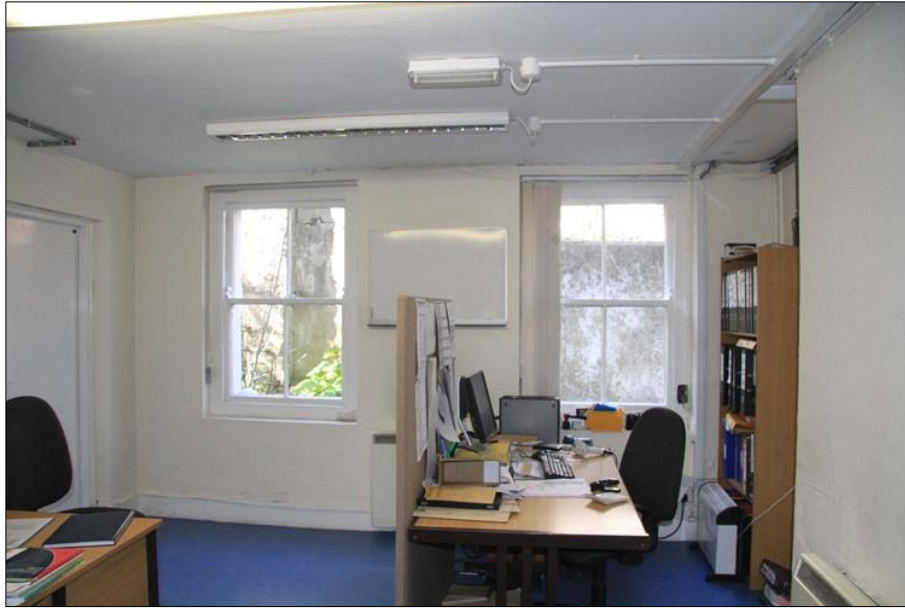
*Plate 69: Rear room*

The rear room in the south-western corner of the building has two windows facing into the rear basement area. These are two-over-two timber sliding sashes with curled horns and do not have architraves or shutters.

A chimneybreast projects into this room from the northern wall, though there is no hearth or chimneypiece. The walls and ceiling have coverings of hard-wall plaster.

The door into this room is six-panelled and is set in a moulded timber architrave. The door to the adjacent file store (room 14) is flat and is set in a frame with no architrave.

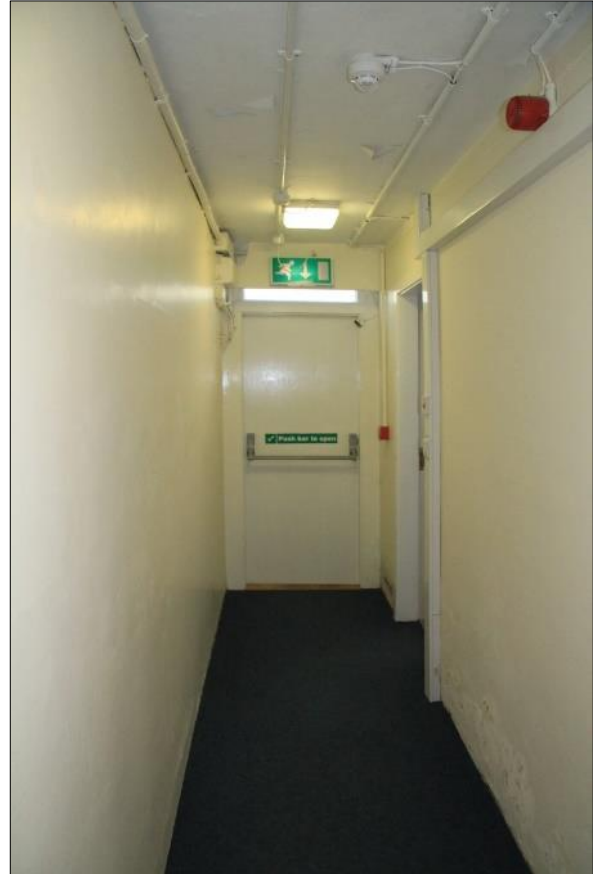
At the eastern end of the corridor there is a niche in the wall, suggesting that there is a stopped-up doorway here that formerly led to the room to the front (room 12).

*Plate 72: View westwards along corridor*

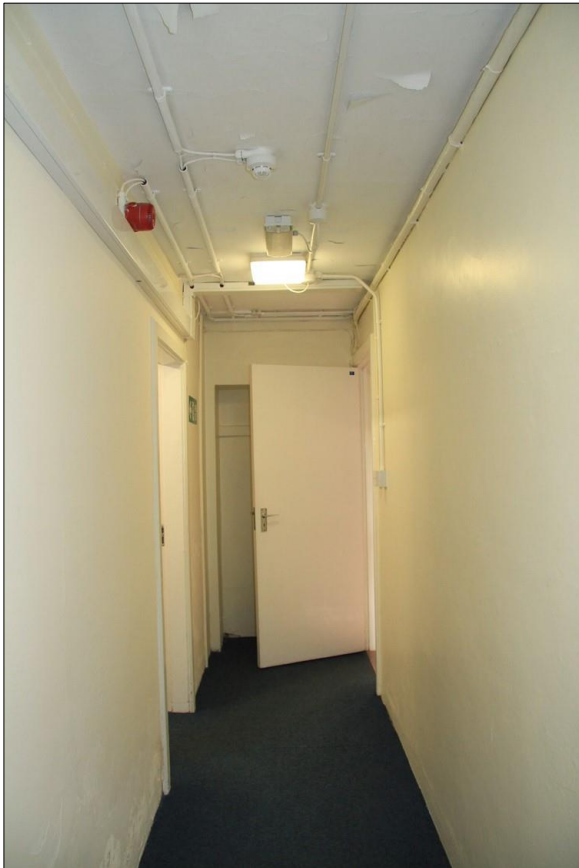
*Plate 73: View eastwards along corridor*

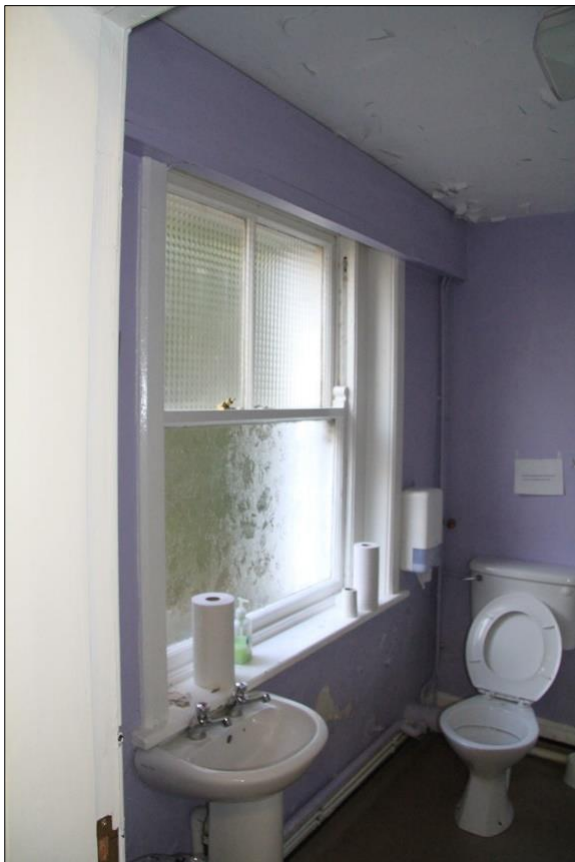
*Plate 75: Window in shower/WC*

The room is lit by a two-over-two timber sliding sash with curled horns and with obscured glass. This window has no shutters or architrave. The window is squat in shape to accommodate it to the low ceiling height.

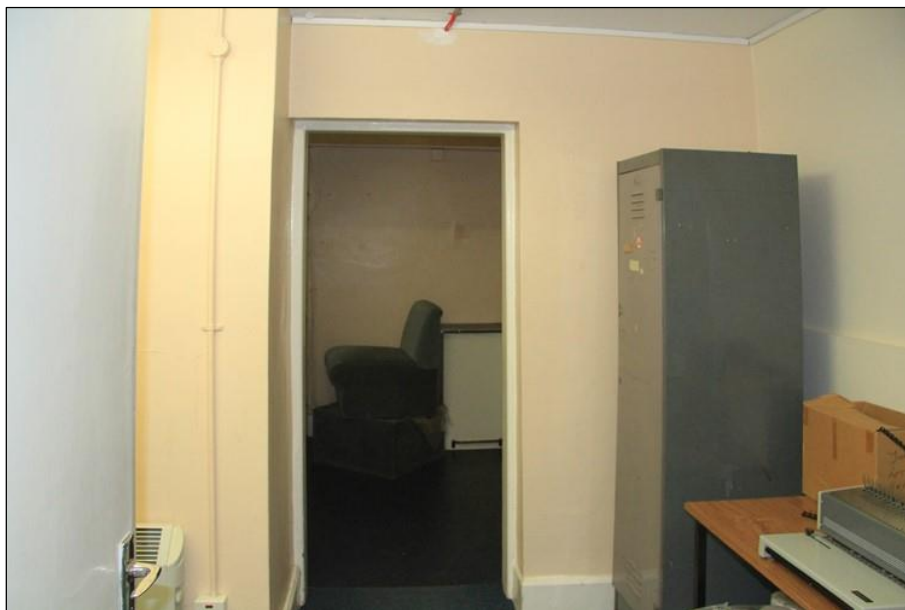
*Plate 76: Doorway from room 19 to room 20*

Leading off the corridor (room 17) is a small room with no walls or windows to the outside. A doorway without architrave leads to another room in the north-western corner of the building. The internal room has a thick wall adjacent to the door to the next room and this appears to have been a chimneybreast, though the hearth is stopped up and there is no chimneypiece.

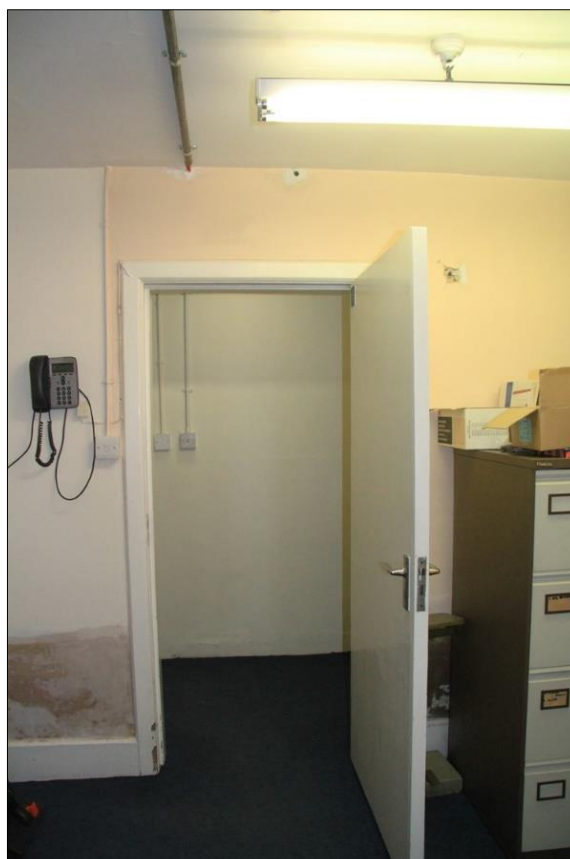
The doorway leading to the adjacent corridor (room 17) has a simple timber architrave and a hollow door. The walls and ceiling in this room are faced with hard-wall plaster.

*Plate 77: Door to adjacent corridor*

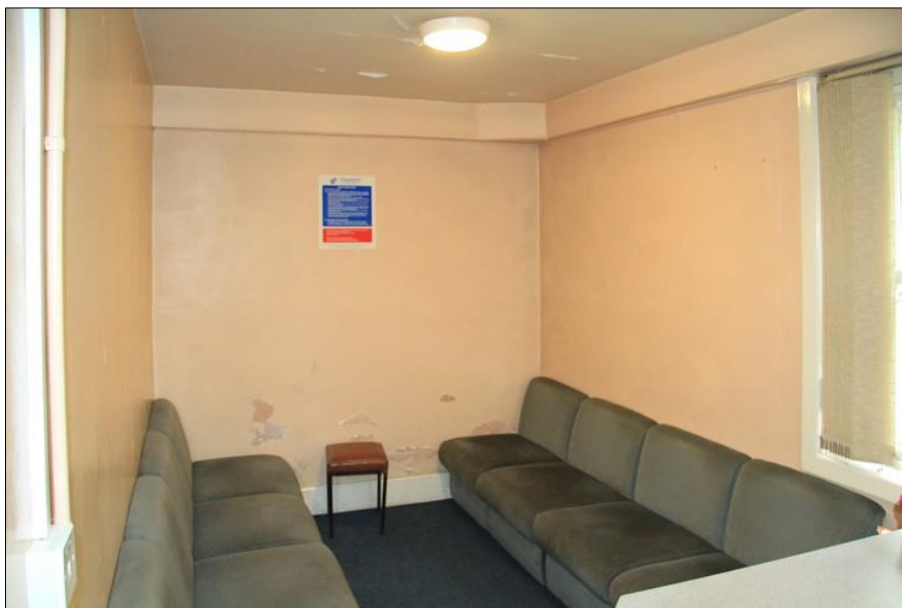
*Plate 78: Rear of room*

The room at the north-western corner of the building is in use as a rest room/kitchenette. This is fitted with kitchen units, tiles and equipment of comparatively recent date. The walls and ceiling are faced with hard-wall plaster.

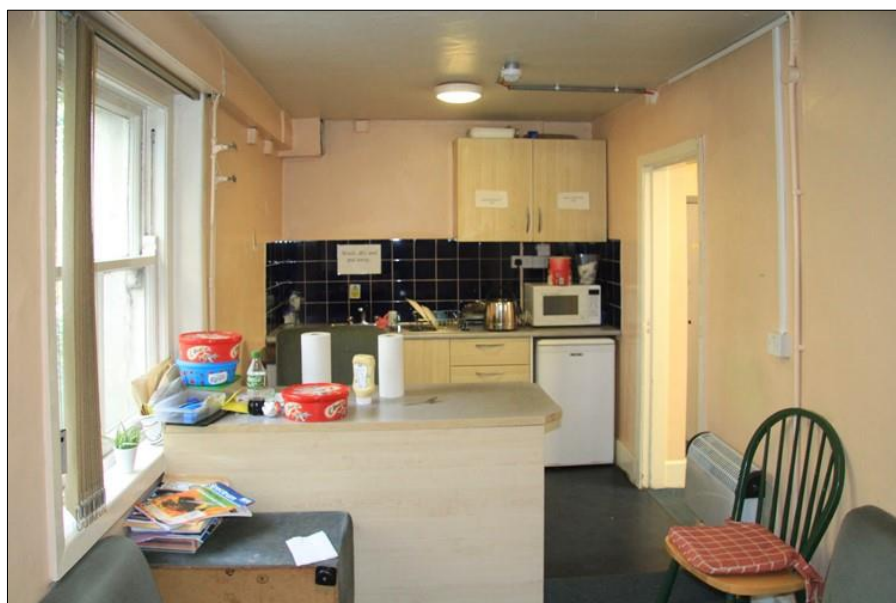
*Plate 79: Eastern end of room with window*

There is no rear-facing window in this room. A two-over-two timber sash window without architrave or shutters faces north and is set in the northern gable end.

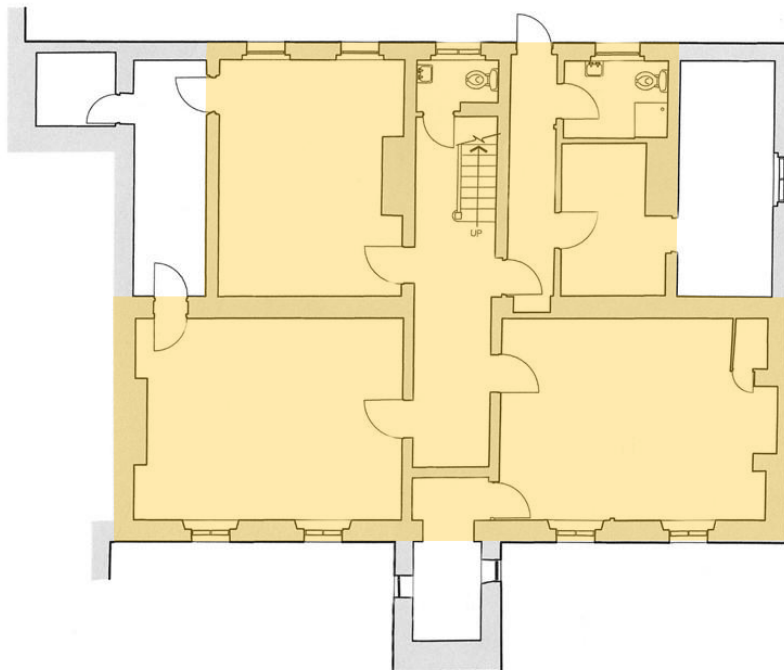
The historical background has shown evidence that Garden Hill was built at some time in the early to mid-1830s and the style of the house would support such a date. The early depictions of the house on Ordnance Survey maps show the house as having a narrower rear section. This may be seen in the plan form of the house, in part on the entrance floor, but more clearly on the lower floor. The coloured overlay on the floor plan reproduced below is the suggested original extent of the building, based on the basement floor plan, with the front of the house at the bottom. .

*Figure 10: Apparent original extent of Garden Hill*

The architectural evidence supports this suggested original layout and the dating. It is evident in the plan in figure 11 above that the windows on the rear elevation are concentrated within the coloured area. It was also noted in the building survey descriptions of the chimney stacks, as given above, showed that those in the front section of the house are quite different to those at the rear – the latter having a later style and simple cylindrical pots, which are also indicative of a later period. The northern chimney stack in the rear of the house is not located on the northern gable, but a distance in from the gable. This corresponds with the suggested original end of the building and it is noted that the large-scale Ordnance Survey maps reproduced in figures 5 and 6 above show a projecting chimney stack on the northern elevation at the rear.

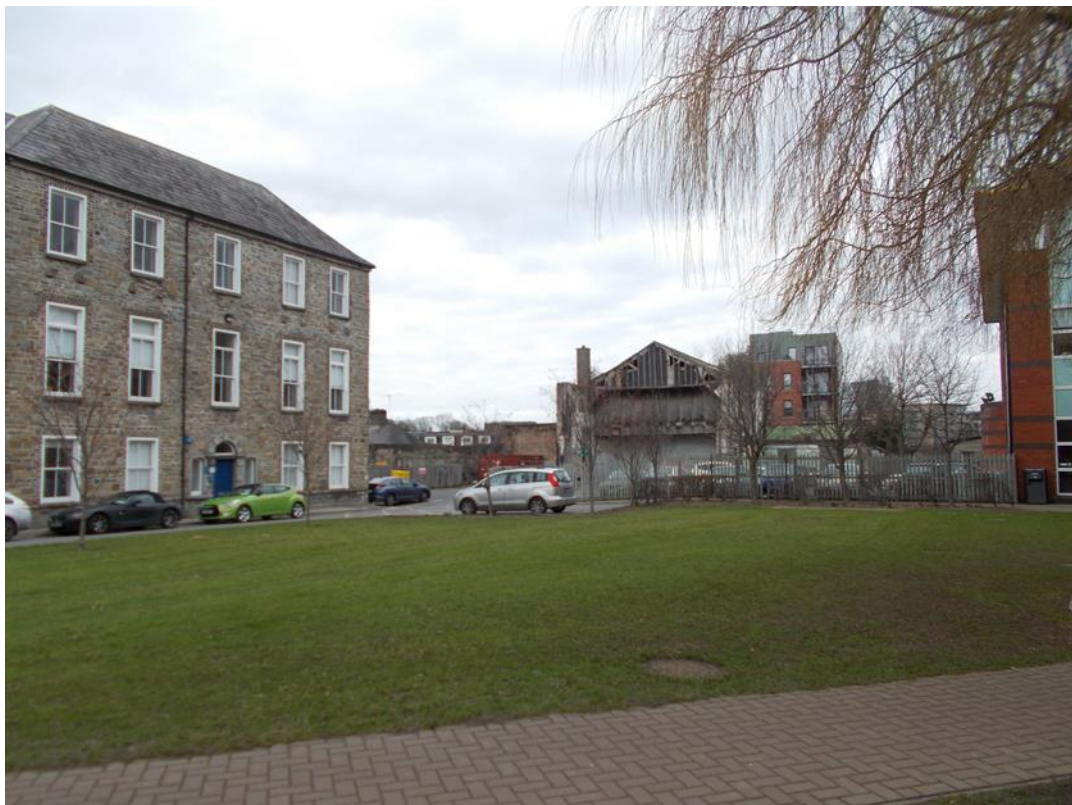
The proposed new CRIC development is located as described earlier under Section 1.1. The general ground level (currently providing surface car parking) is at a level of 20.0 to 20.5 mOD with a considerable drop in level to the footpath along St. James's Street, varying from 17.7m in the northeast corner down to 15.75m in the northwest, a fall of c.2m. Refer to Figure 2.1 below for current topography view, looking north.

*Figure 2.1 General Topography looking north.*

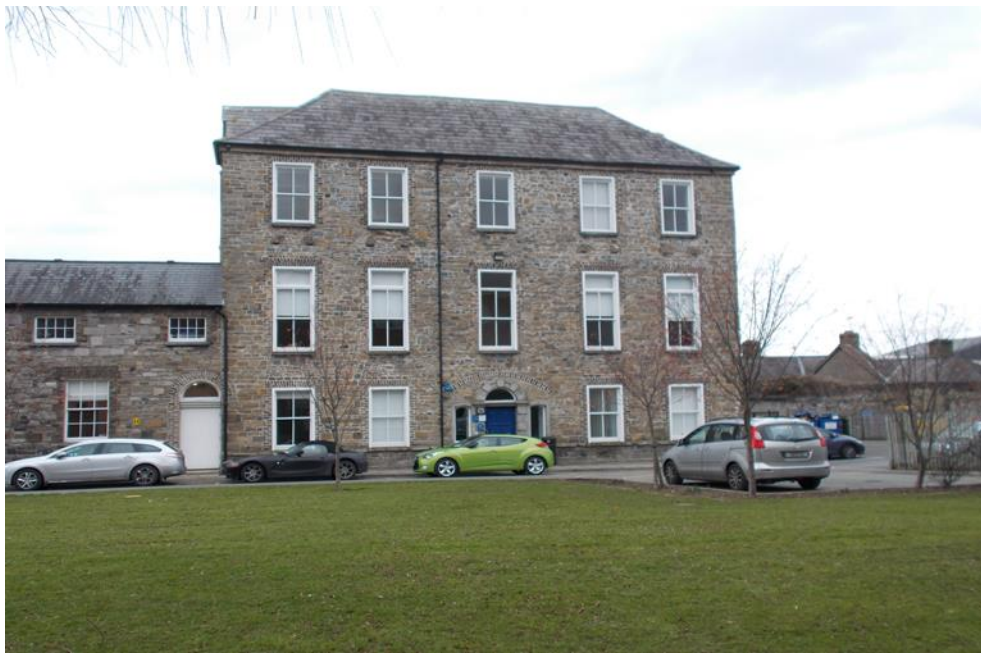
The northern end of the building, adjacent the proposed site of the CRIC development is three-storey, five-bay and double-pile with a hipped roof that has partial gables to the sides. Attached to this is the southern section which is two-storey, sixteen bay and single pile, with a later addition along the rear (west) elevation. The two original parts of the building are constructed in rubble calp limestone (refer Figure 2.2 below) and considered to have been built in the 18<sup>th</sup> century. This building is a protected structure and is considered to be of regional Architectural and Historic interest.

Figure 2.2 Haughton Institute (northern 3-storey end)

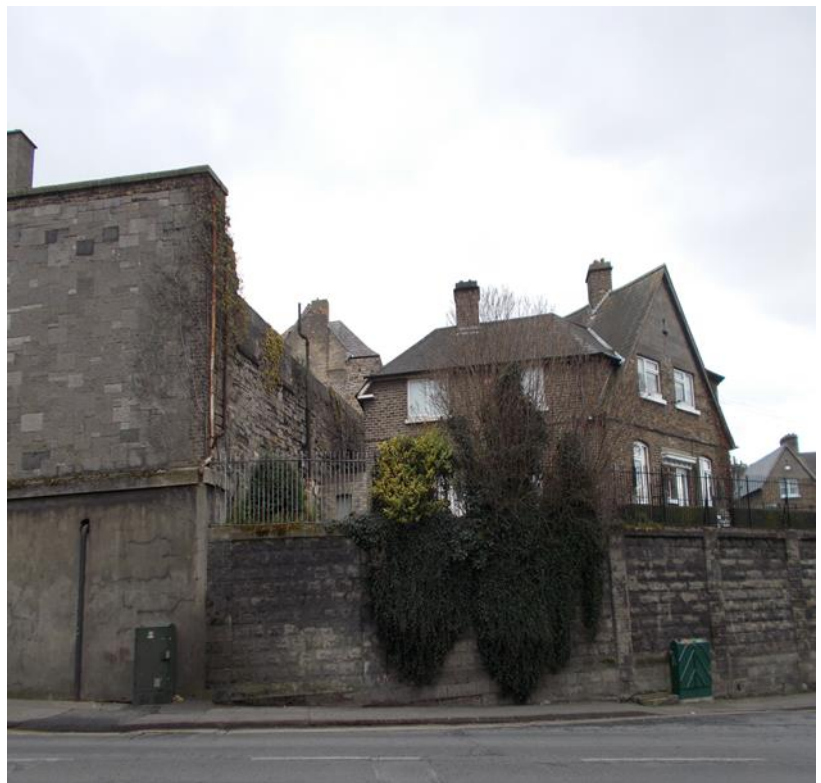
The McDowell Avenue properties and boundary walls are located to the west of the proposed CRIC building and their location with regard to the proposed basement development are described later under section 3.1. The residential properties are primarily 2 storey in nature and of robust brick construction with ground floor levels stepping to follow the varying nature in ground/road profiles. No. 1 McDowell Avenue fronting onto James 'Street is the closest residential property to the site of the proposed CRIC building and is separated and set back from the western side of the boundary wall. The external ground and building floor levels to No. 1 are approximately 1.5 metres below the general current ground level on the SJH campus site.

Figure 2.3 No. 1 McDowell Avenue
