# National Paediatric Hospital Project

## Planning Application

### Appendix 16.1 – Chapel Survey

## Appendix 16.1 Chapel

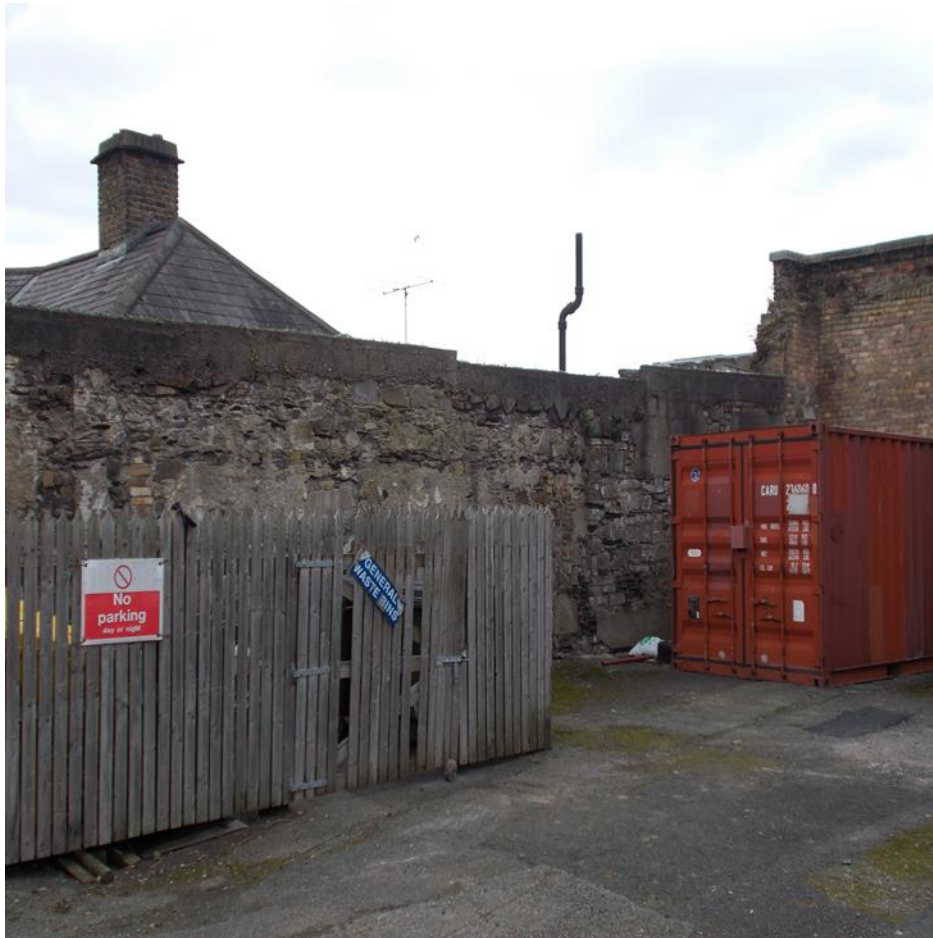
The boundary walls vary in height from approximately 3.0m to 3.5m (measured within the SJH campus side) and are constructed of solid stone (possibly Ashlar with a mixture of brick) with a more recent concrete capping – refer to fig 2.4 below:

Figure 2.4 Adjoining Boundary Walls – Part View

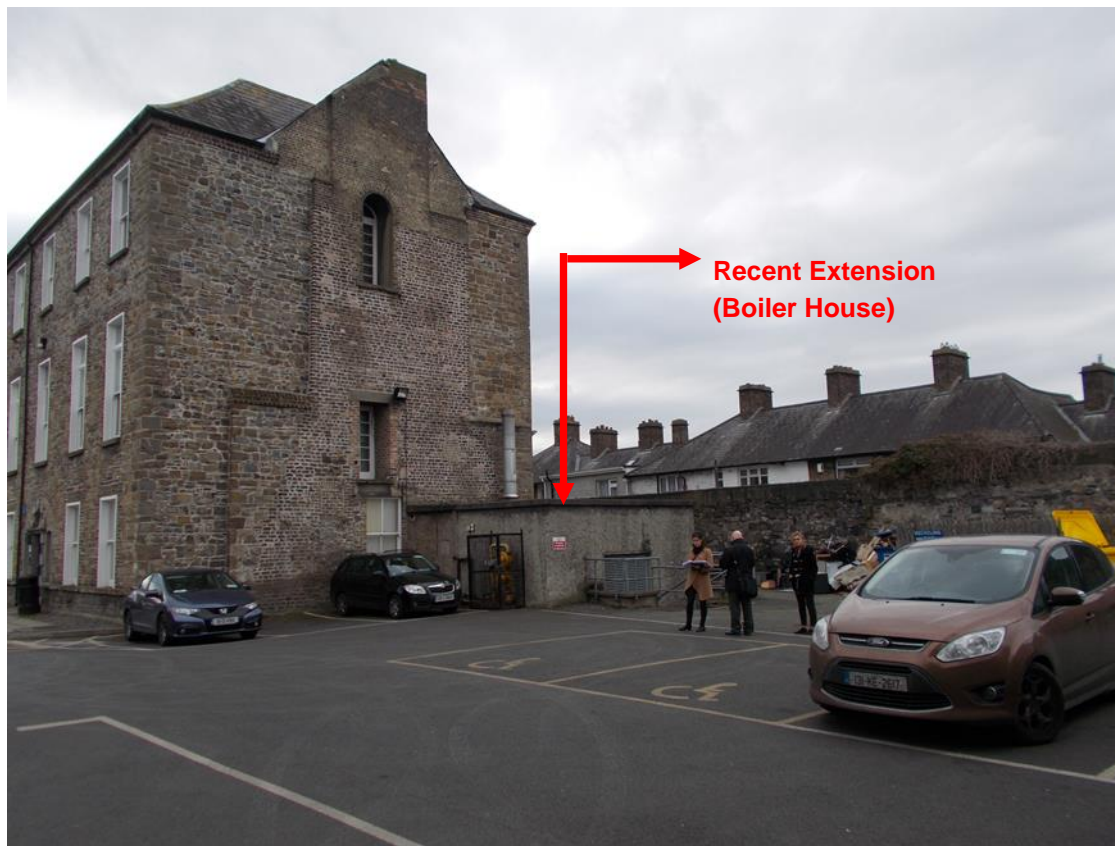
*Fig 2.5 Haughton Institute – North Elevation*

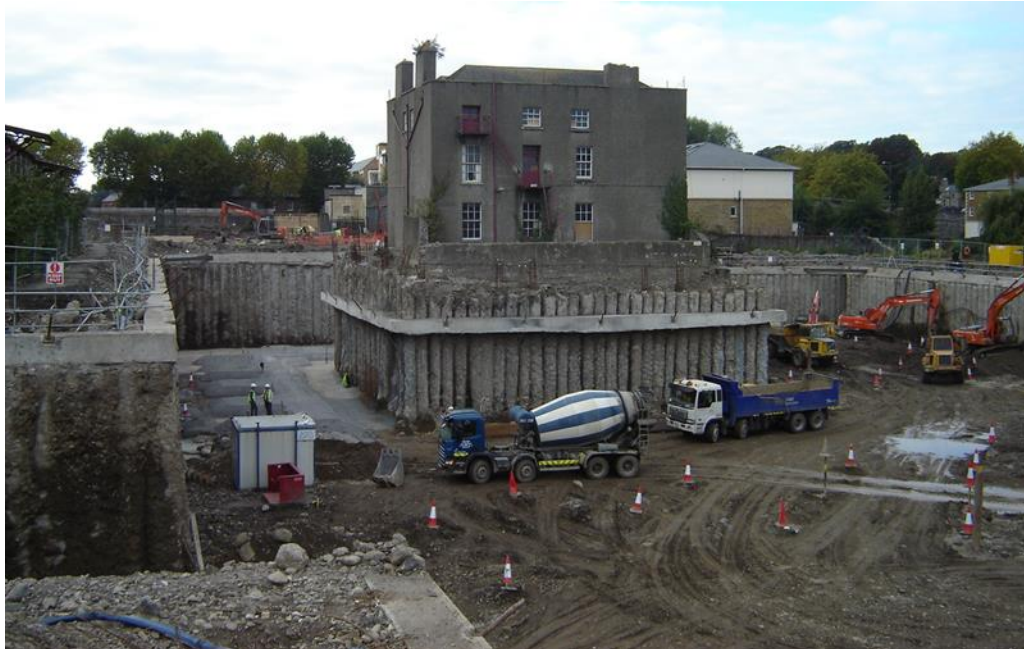
a tried and trusted method of facilitating deep excavations in city centre locations. It is a method that has been adopted by the Project Team on a number of developments within Dublin City Centre including works in close proximity to existing protected/listed structures. Examples of such similar secant pile wall construction adjacent a protected structure is shown below in Figure 3.2.

Figure 3.2 Secant Pile Wall (Temporary Works) Adjacent Protected Building

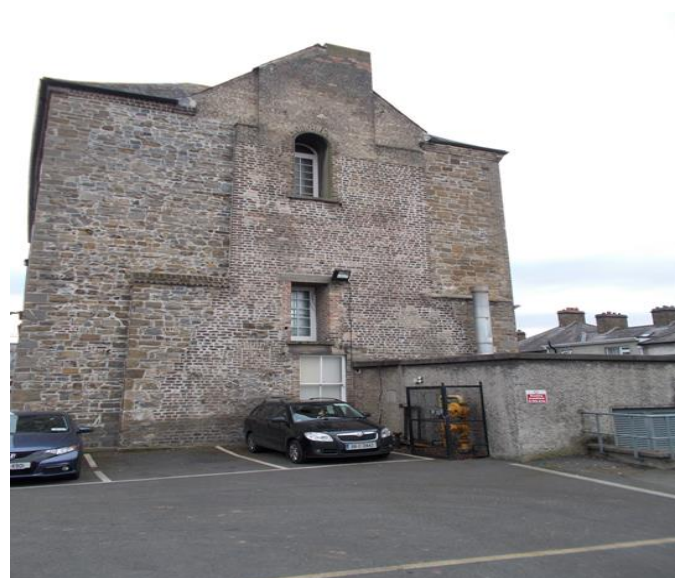
*Fig 3.3 North Gable Elevation*
